MINERALS PROGRAM INSPECTION REPORT**PHONE: (303) 866-3567**

MINE NAME: Rudibaugh Pit	MINE/PROSPECTING ID#: M-1995-057	MINERAL: Sand and gravel	COUNTY: Gunnison
INSPECTION TYPE: Monitoring	INSPECTOR(S): Dustin M. Czaplá	INSP. DATE: June 19, 2018	INSP. TIME: 18:00
OPERATOR: Deb Rudibaugh	OPERATOR REPRESENTATIVE: None	TYPE OF OPERATION: 110c - Construction Limited Impact	
REASON FOR INSPECTION: Normal I&E Program		BOND CALCULATION TYPE: None	
DATE OF COMPLAINT: NA		BOND AMOUNT: \$11,574.00	
POST INSP. CONTACTS: None		JOINT INSP. AGENCY: None	
WEATHER: Clear	INSPECTOR'S SIGNATURE:

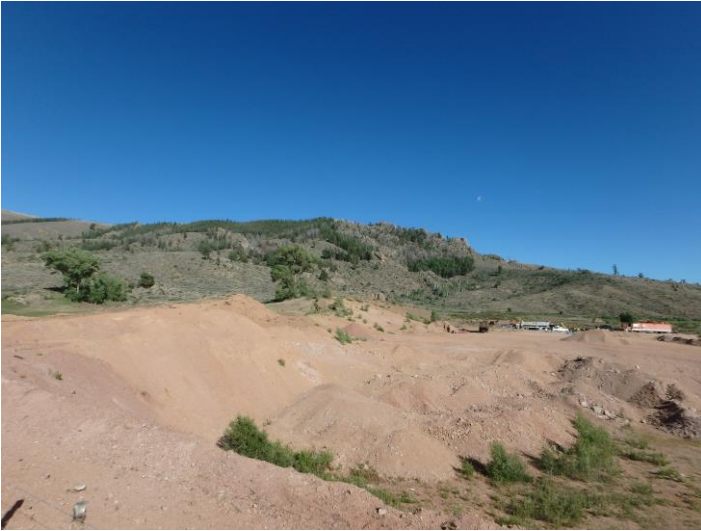
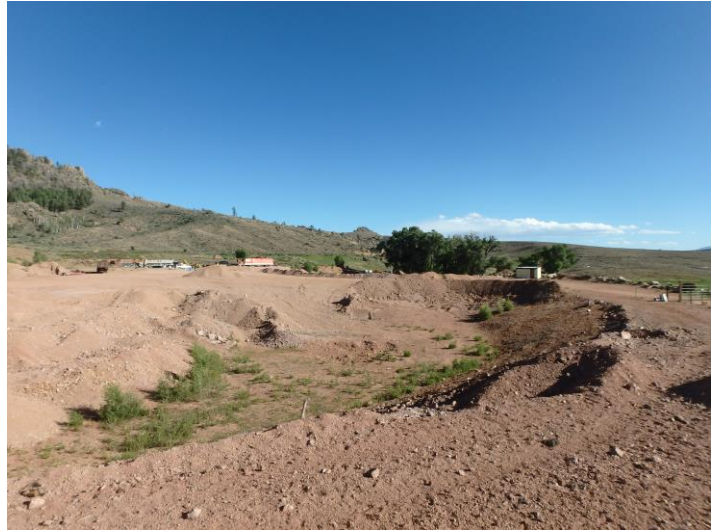
PHOTOGRAPHS

PROBLEM/POSSIBLE VIOLATION: Problem: Trash and refuse was noticed on the site. The south portion of the permit area is being used as a junkyard. Junk vehicles/equipment and various refuse are stored in this area. This is a problem at this time for failure to dispose of refuse in a manner that controls unsightliness or deleterious effects of such refuse pursuant to C.R.S. 34-32.5-116(4)(e).

PROBLEM/POSSIBLE VIOLATION: Problem: The mine identification sign posted at the entrance to the site is dilapidated and the required information is not legible. This is a problem for failure to post a mine identification sign as required by Section 3.1.12(1) of the rule.

The mine identification sign has not been replaced. The mine identification sign posted at the entrance to the site is dilapidated and some of the required information is illegible. This is an unresolved problem that has been noted in previous inspections and is scheduled to be addressed at the June 27, 2018 MLRB hearing.

The south portion of the permit area that is used as a "junkyard" is not yet cleaned up. This is an unresolved problem that has been noted in previous inspections and is scheduled to be addressed at the June 27, 2018 MLRB hearing.

CORRECTIVE ACTIONS: The operator shall submit a written notice to the Division with photo documentation, that the trash and junk vehicles have been removed from the site by the corrective action date.

CORRECTIVE ACTIONS: The operator shall, at the entrance of the mine site, post a sign which shall be clearly visible from the access road with the following: the name of the operator, a statement that a reclamation permit for the operation has been issued by the Colorado Mined Land Reclamation Board; and the permit number. The operator shall submit photo documentation that a proper sign has been posted by the corrective action date.
