**MINERALS PROGRAM INSPECTION REPORT**  
**PHONE: (303) 866-3567**

<b>MINE NAME:</b> Vermillion Creek Borrow Area	<b>MINE/PROSPECTING ID#:</b> M-2015-027	<b>MINERAL:</b> Borrow	<b>COUNTY:</b> Moffat
<b>INSPECTION TYPE:</b> Monitoring	<b>INSPECTOR(S):</b> Amy C. Yeldell	<b>INSP. DATE:</b> July 17, 2018	<b>INSP. TIME:</b> 10:00
<b>OPERATOR:</b> Rancho Greco Limited	<b>OPERATOR REPRESENTATIVE:</b> John Raftopoulos	<b>TYPE OF OPERATION:</b> 110c – Reclamation Only	
<b>REASON FOR INSPECTION:</b> Normal I&E Program	<b>BOND CALCULATION TYPE:</b> Complete Bond	<b>BOND AMOUNT:</b> \$29,206.00	
<b>DATE OF COMPLAINT:</b> NA	<b>POST INSP. CONTACTS:</b> DRMS	<b>JOINT INSP. AGENCY:</b> None	
<b>WEATHER:</b> Clear	<b>INSPECTOR'S SIGNATURE:</b>

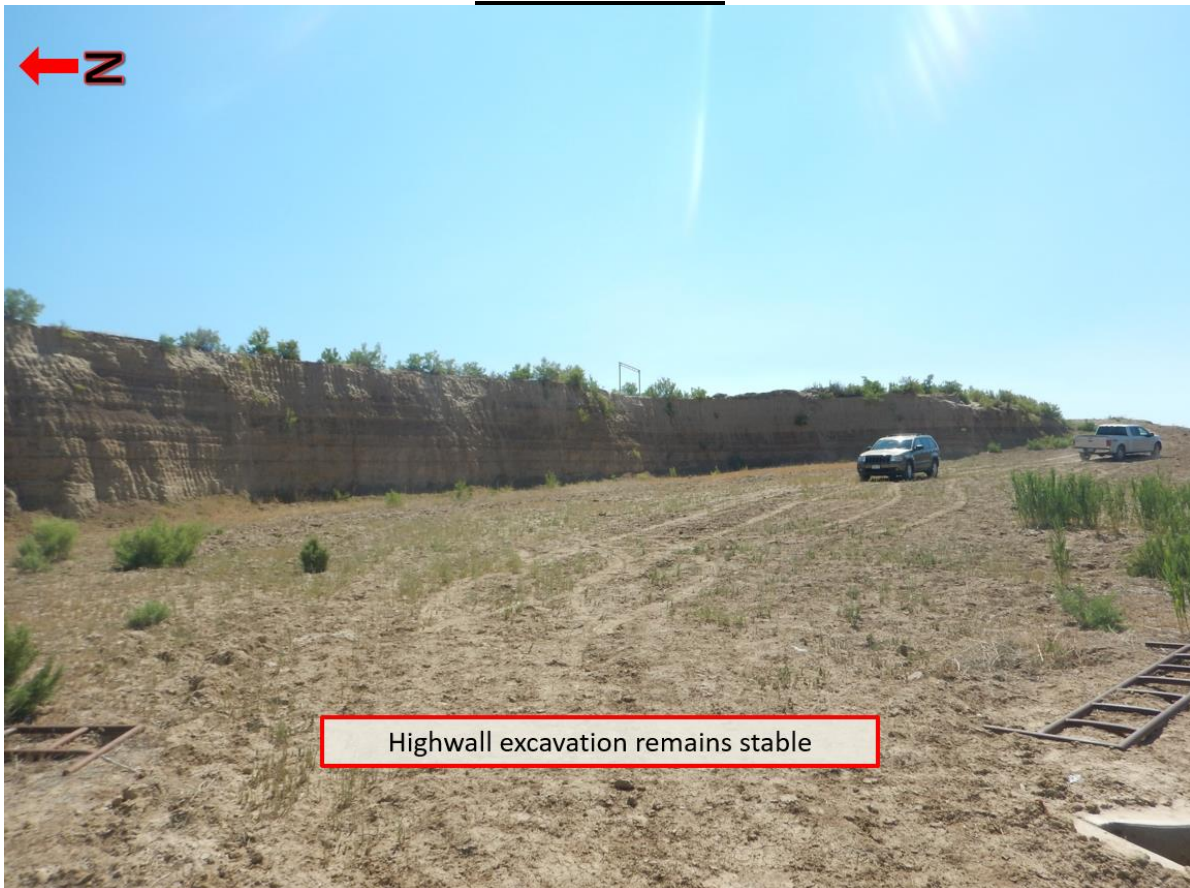
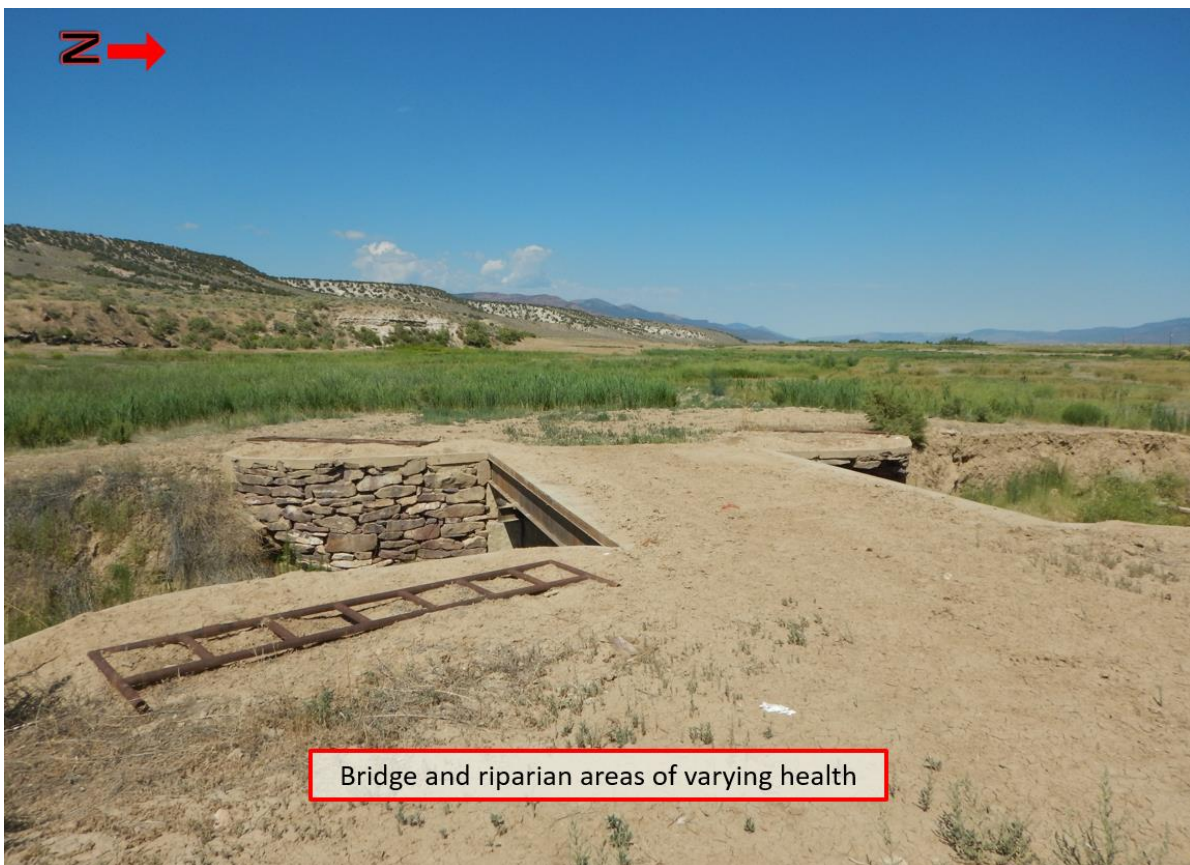
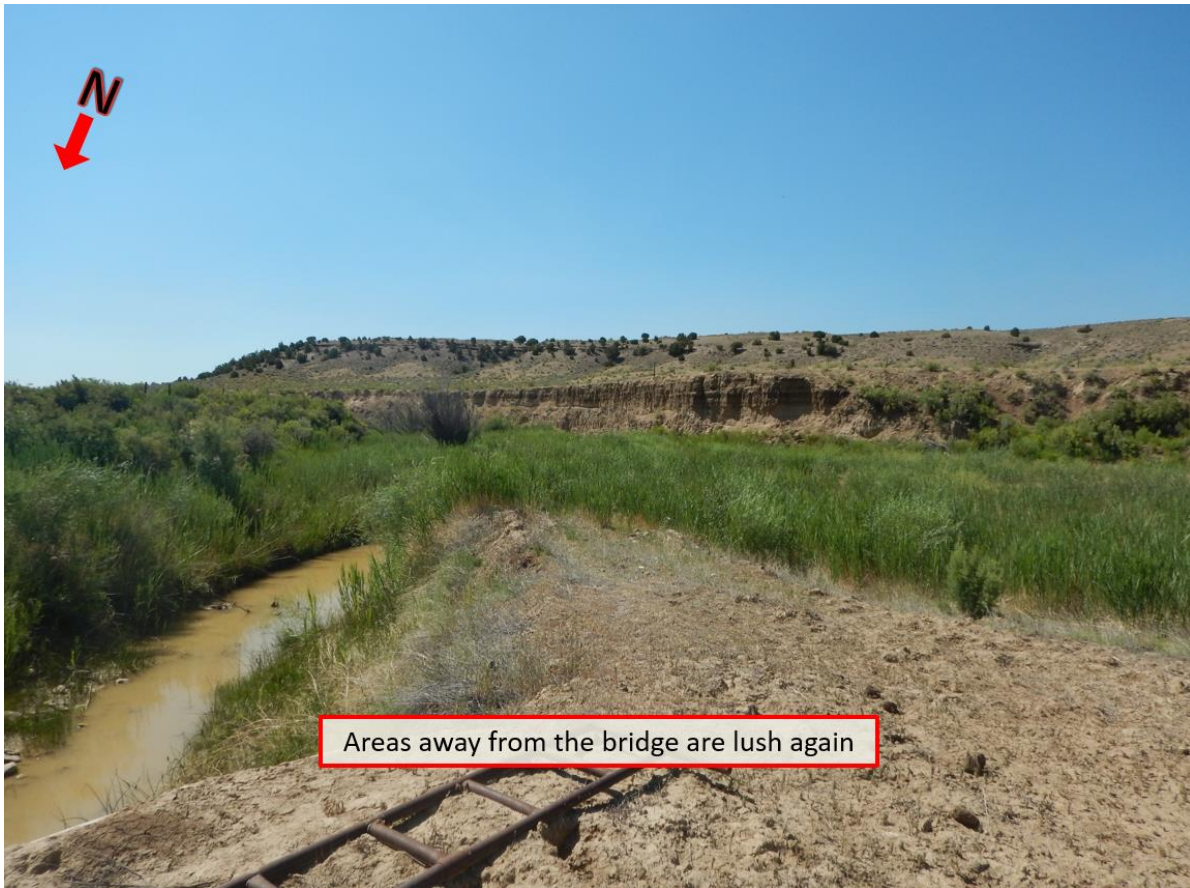
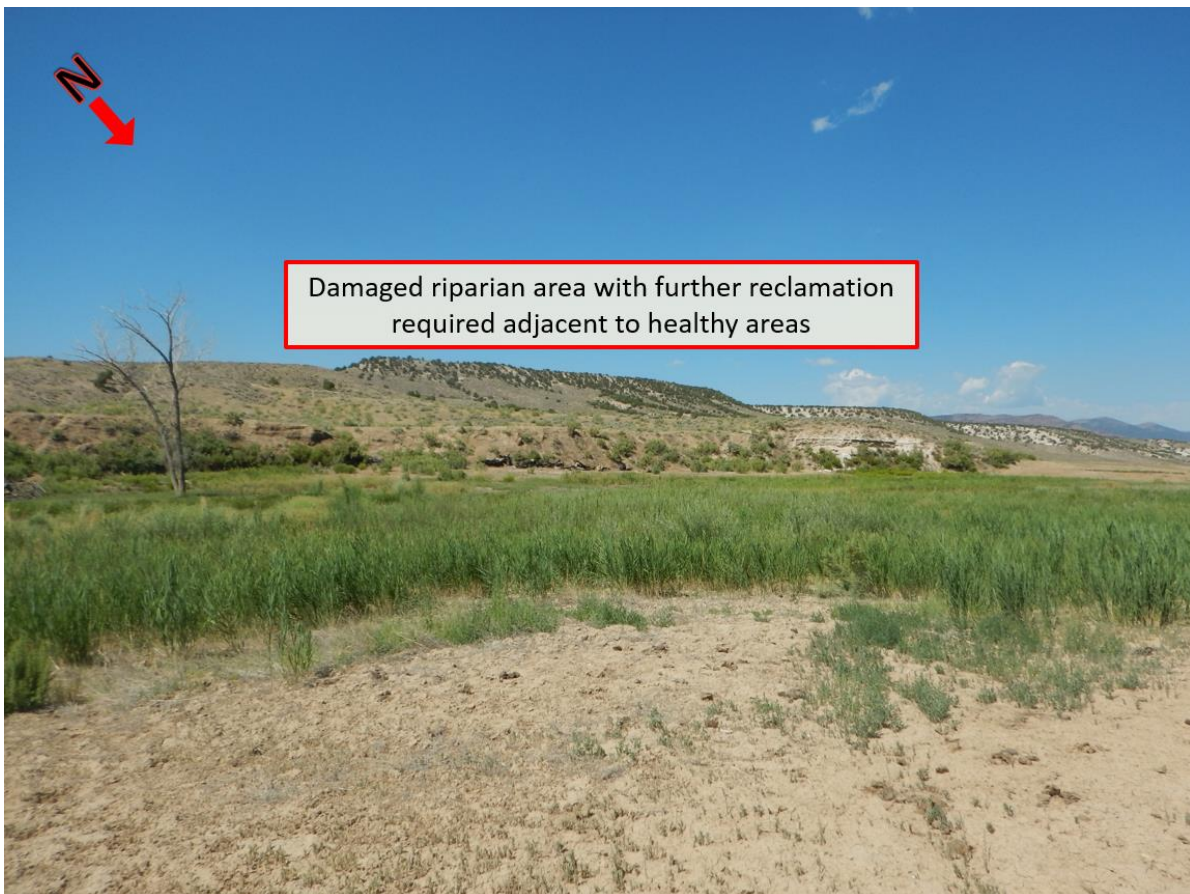
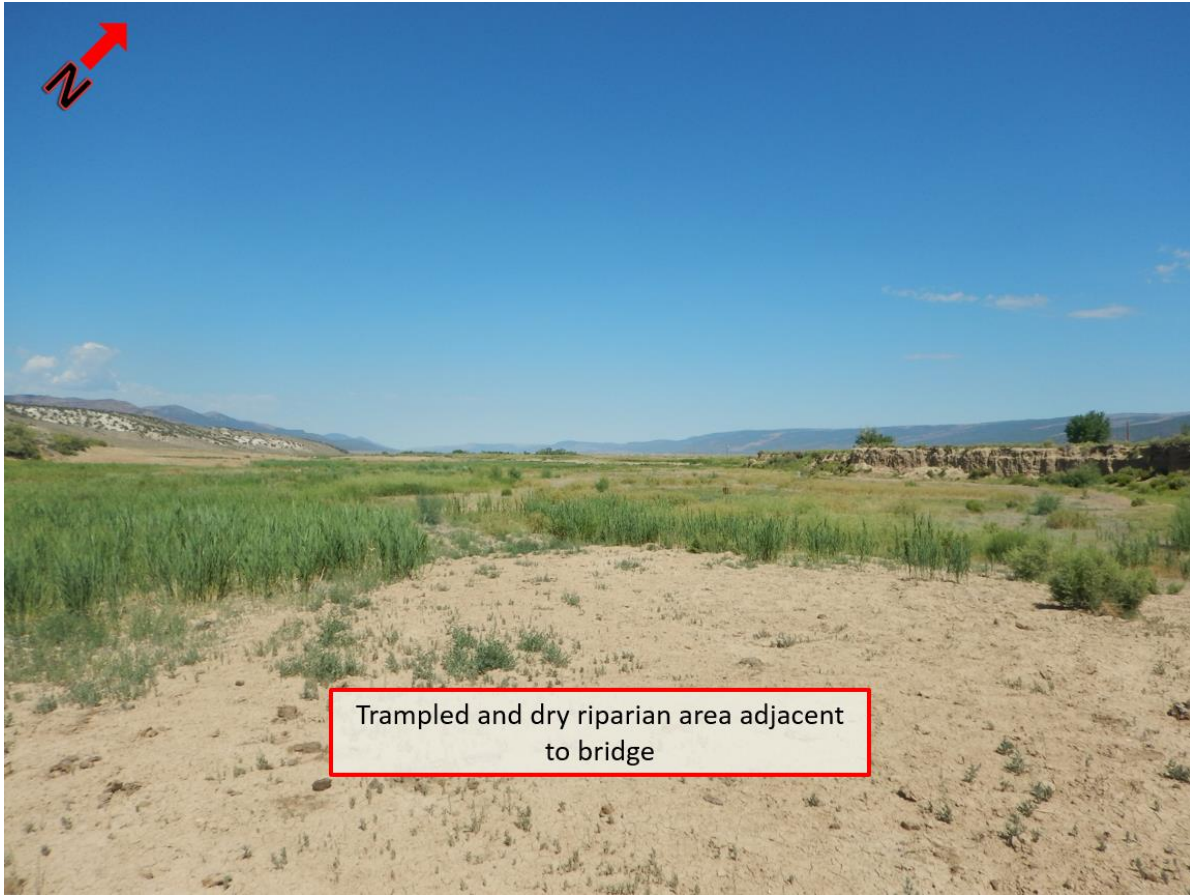
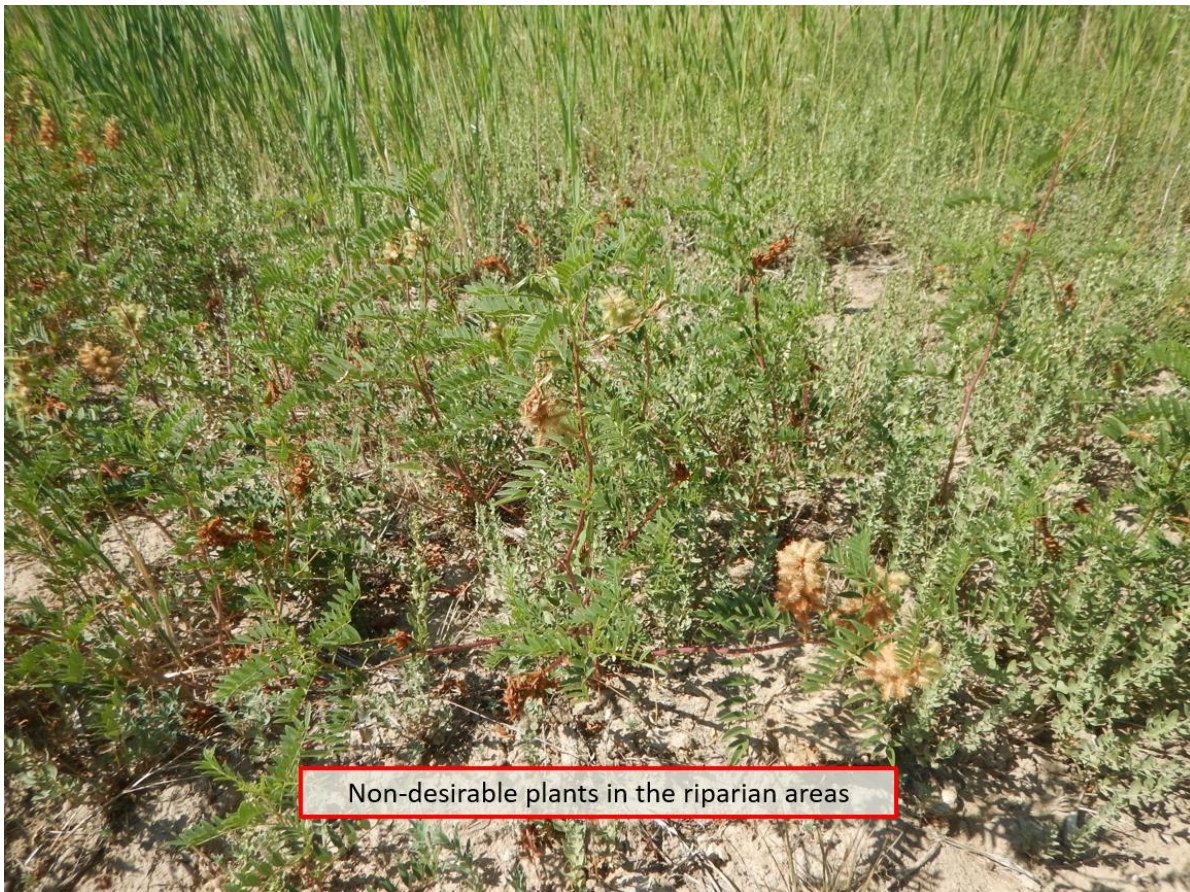
**PHOTOGRAPHS**

There is evidence of cattle grazing based on ground roughening. After reclaimed areas are seeded it is recommended that the cows be kept off until reclamation is considered sustainable to withstand grazing pressures.

The highwall cut remains near vertical and intact. There has been no major sloughing or regrading. A Few greasewood bushes have begun to volunteer. At the toe of the highwall more vegetation has volunteered though the majority of which is Kochia and Halogeton which are non-desirable species.

The Riparian area appears to be mostly self-reclaimed. The moist areas to the south of the bridge appear to be lush and repaired. The northern areas are still slightly dry and have less riparian plants growing. The northern

area also has some weeds such as toadflax, tamarisk and nutsedge. The area adjacent to the bridge (within approximately 50 feet) has little vegetation which is likely due to cattle traffic and use of the bridge.
