Minerals Plan of Operations Inspection
U.S. Department of the Interior
Bureau of Land Management
Royal Gorge Field Office

Date: Jul 25, 2018 Time: 10:33 Weather: Sunny	Operation Name: Field of Dreams Mine Case Number: COC-73930 CDRMS Number: M-2009-056
Attendees BLM: Stephanie Carter Operator(s): Matt Donnelly (Gold Tamers LLC) Other(s): -	General Operation(s) are in compliance with documentation on file <input type="checkbox"/> Yes <input checked="" type="checkbox"/> No <input type="checkbox"/> N/A Operation(s) and disturbance on-site coincide with the operations and access on file <input type="checkbox"/> Yes <input checked="" type="checkbox"/> No <input type="checkbox"/> N/A

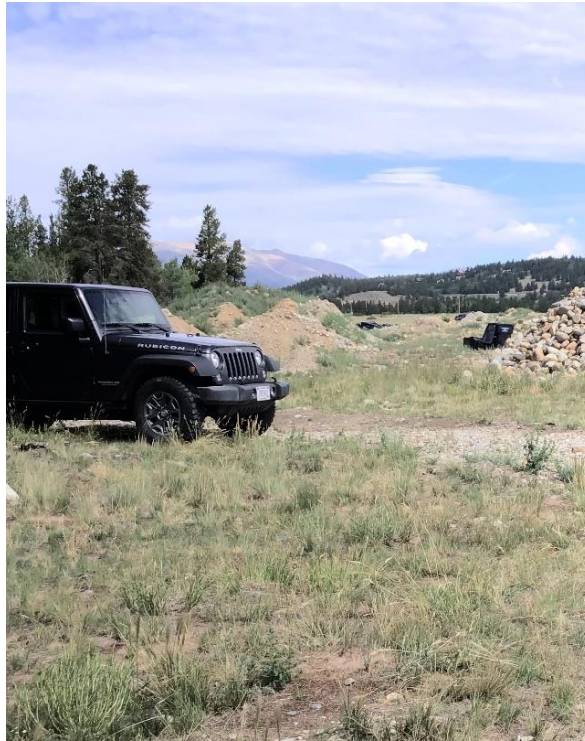
Image 1:

Comment: Camper trailer and porta-potty removed (Non-compliance issues #1 & 2)

#1 Matt stated item was removed. This was verified and documented by BLM during inspection.
COMPLETE

#2 Matt stated item was removed. This was verified and documented by BLM during inspection.
COMPLETE

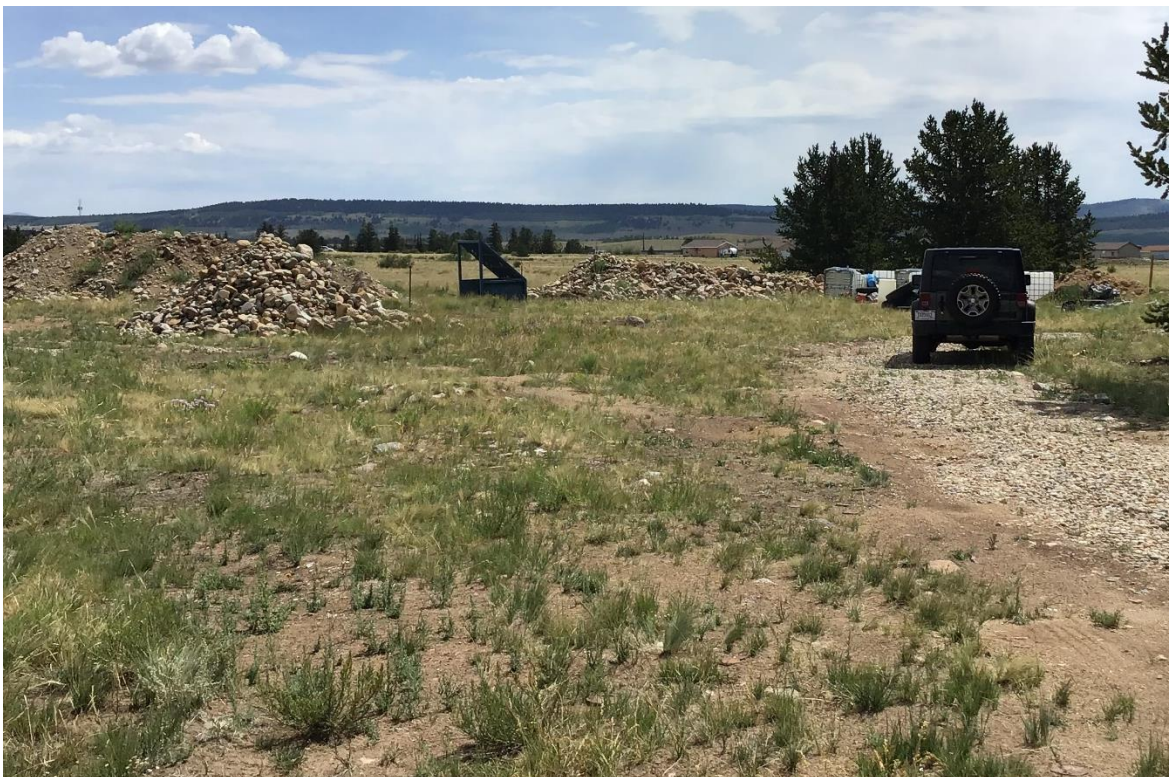
Image 2:

Comment: Area where generators, batteries and propane tanks were concentrated (Non-compliance issue #3 & #5)

#3 Matt stated all items were removed, except one generator that is being removed today. This was verified and documented by BLM during inspection, to include removal of the last generator. COMPLETE

#5 Matt stated item was removed. This was verified and documented by BLM during inspection.
COMPLETE

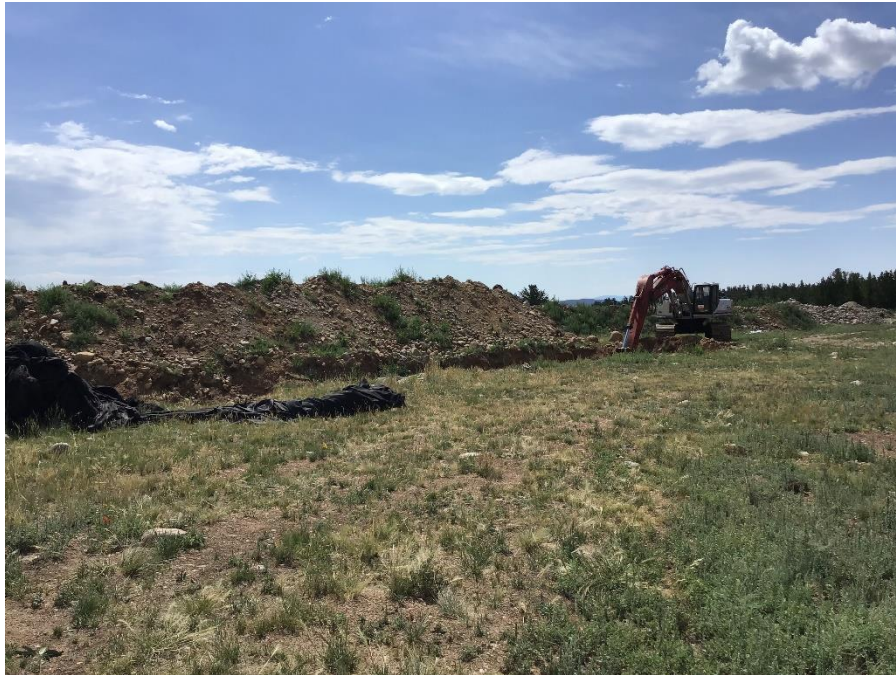
Image 3:

3.a. A majority of the POL containers have been removed from the site to correct non-compliance item #4 that was included with the 07/05/18 BLM non-compliance order. However, there are still some containers remaining.

Comment: Some POL containers at the site (Non-compliance issue #4)

#4 Matt stated all items were removed. BLM verified and documented PARTIAL compliance with this item, as some POL containers are still improperly stored and managed across the site. Pictures will need to be provided to BLM to finalize compliance status.

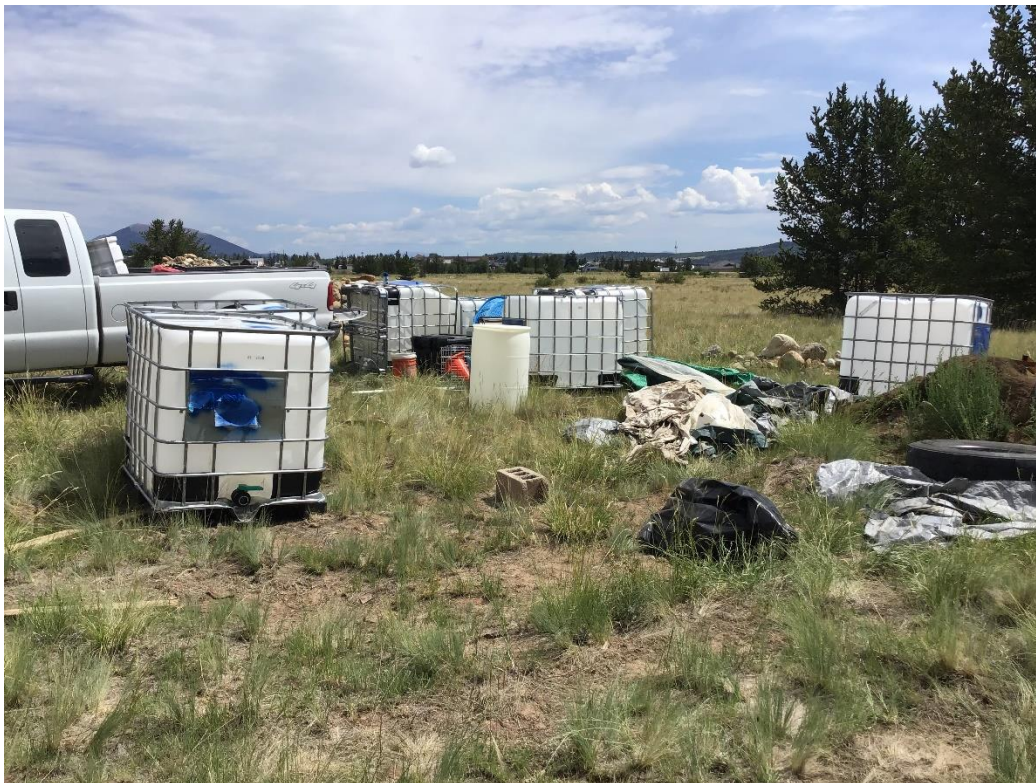
Image 4:

3.d. Some of the trash and other mining related materials have been picked up and removed from the site to correct non-compliance item #6 that was included with the 07/05/18 BLM non-compliance order. However, there is still quite a bit of trash and mining related materials being improperly stored and managed at the site.

Comment: Trash and other mining related materials not properly managed or stored remain (Non-compliance issue #6)

#6 Matt stated some trash was removed, but the rest is being removed today. The tires will be removed tomorrow (along with the dump truck). BLM verified and documented PARTIAL compliance with this item. Pictures will need to be provided to BLM to finalize compliance status.

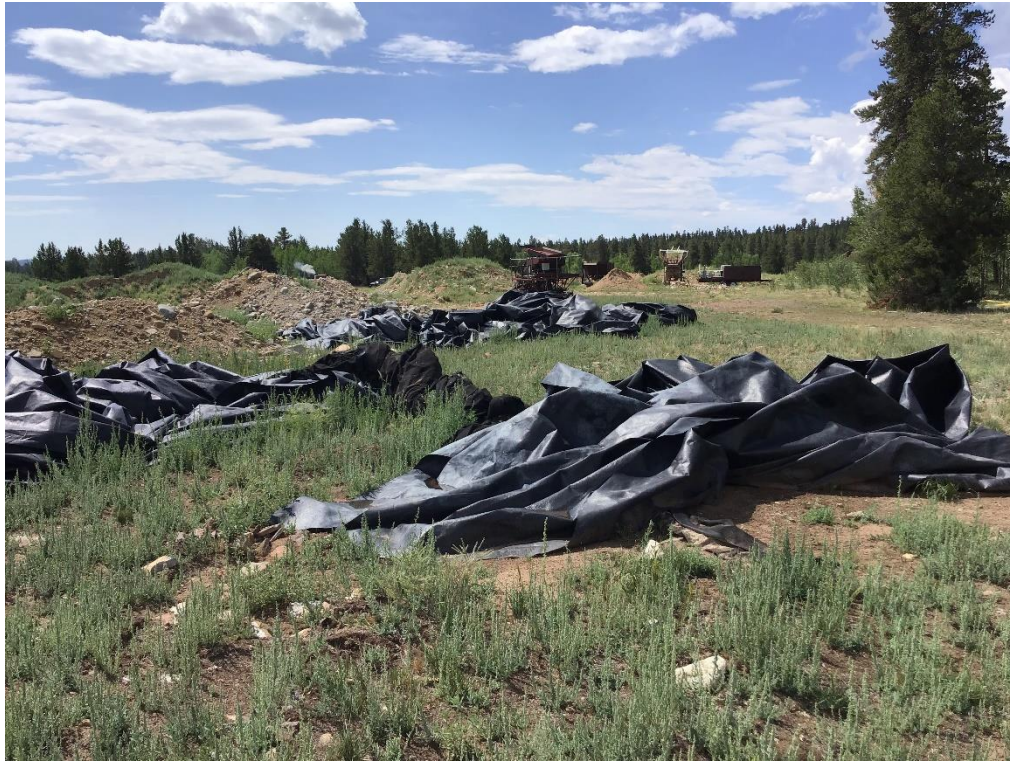
Image 5:

Comment: Liner remaining onsite. (Non-compliance issue #7)

#7 Matt stated item will be removed within the next three days. BLM verified and documented PARTIAL compliance with this item, as efforts have been made to remove the liner, with advertising it for sale. Pictures will need to be provided to BLM to finalize compliance status.

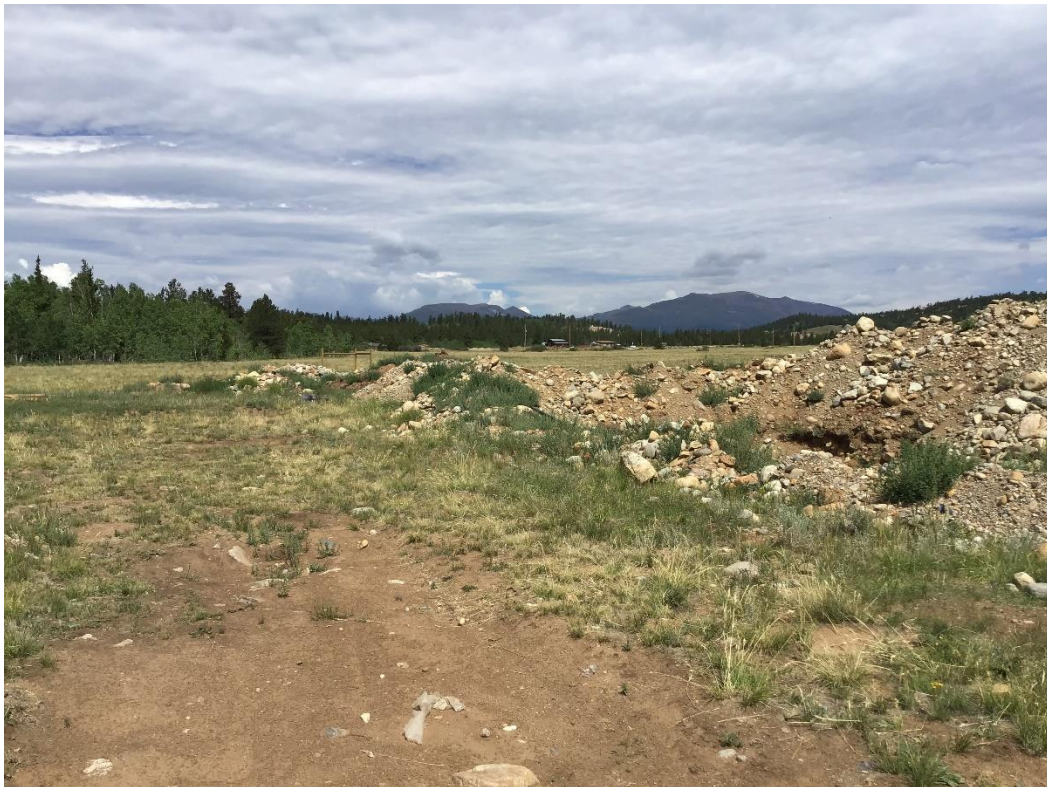
Image 6:

1.b.ii. No dirt work has been performed to correct non-compliance item #8 that was included with the 07/05/18 BLM non-compliance order.

Comment: No stockpiles were re-located to inside the operational boundary (Non-compliance issue #8)

#8 Matt stated item could not be completed as of yet, because they have no equipment available.
INCOMPLETE. This item will need to be completed NLT 8/8/18.

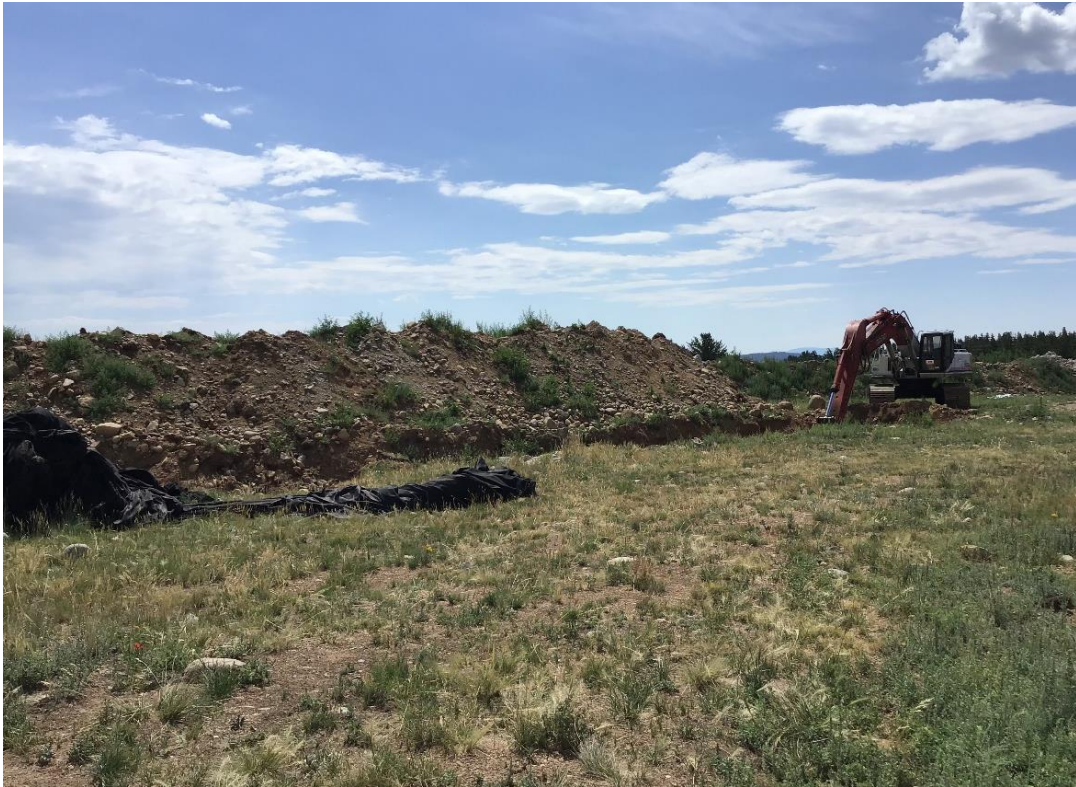
Image 7:

1.b.i. No dirt work has been performed to correct non-compliance item #9 that was included with the 07/05/18 BLM non-compliance order.

2.e. No dirt work has been performed to correct non-compliance item #9 that was included with the 07/05/18 BLM non-compliance order.

Comment: Stockpiles along NE trench have not been addressed (Non-compliance issue #9)

#9 Matt stated item could not be completed as of yet, because they have no equipment available. INCOMPLETE. This item will need to be completed NLT 8/8/18.

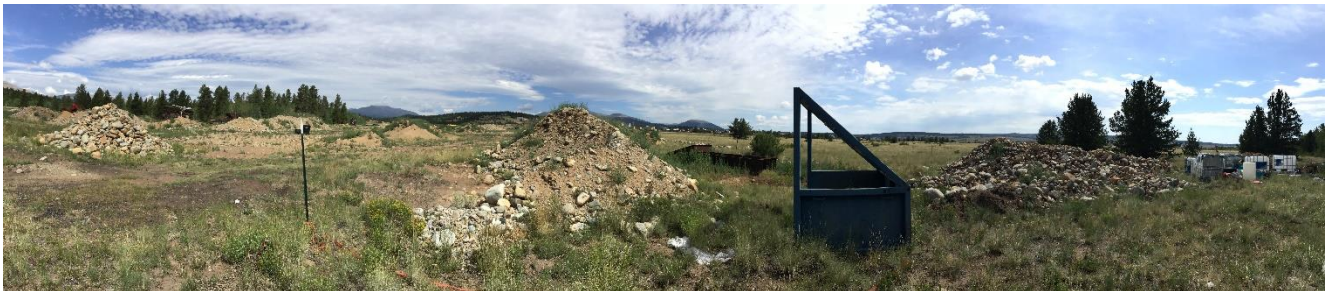
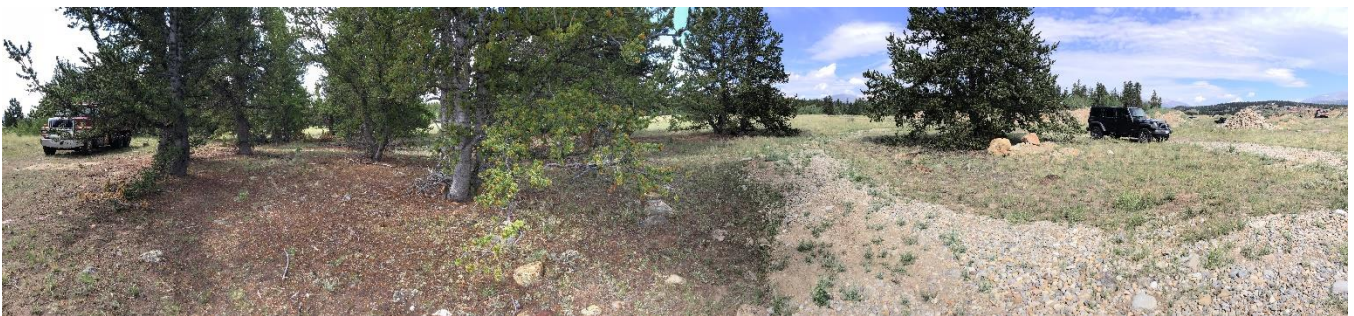
Images 8&9:

Comment: General site overviews
