COLORADO DIVISION OF RECLAMATION, MINING AND SAFETY
MINERALS PROGRAM INSPECTION REPORT
PHONE: (303) 866-3567

MINE NAME: Savage Mining - Mamie Jewell Placer	MINE/PROSPECTING ID#: P-2010-006	MINERAL: Gold	COUNTY: Chaffee
INSPECTION TYPE: Monitoring	INSPECTOR(S): Dustin M. Czapla	INSP. DATE: August 8, 2018	INSP. TIME: 14:00
OPERATOR: Earl T Savage	OPERATOR REPRESENTATIVE:	TYPE OF OPERATION: MP - Mineral Prospecting

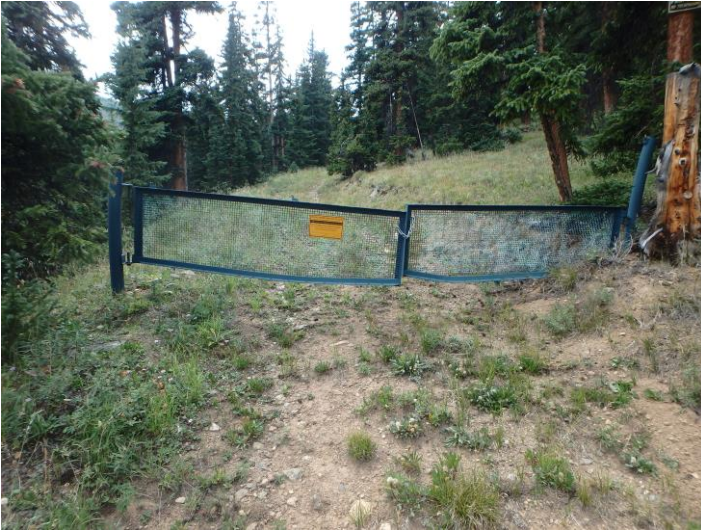
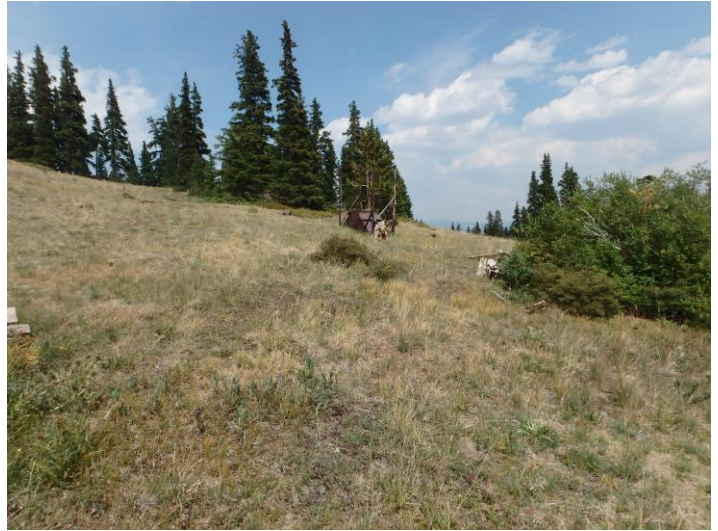
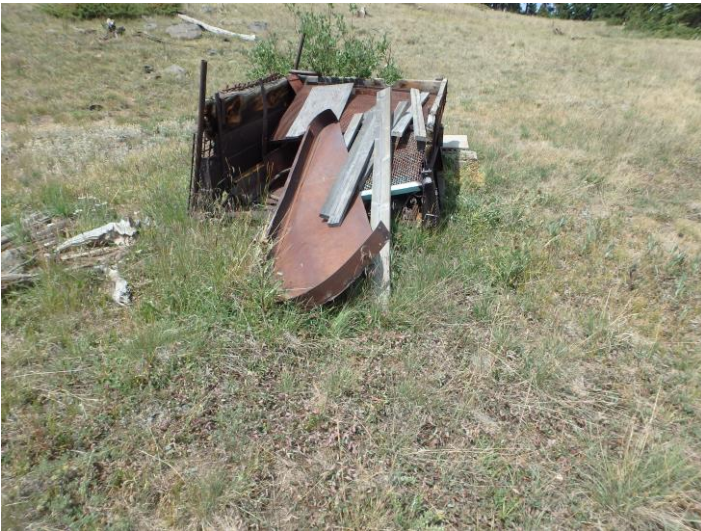
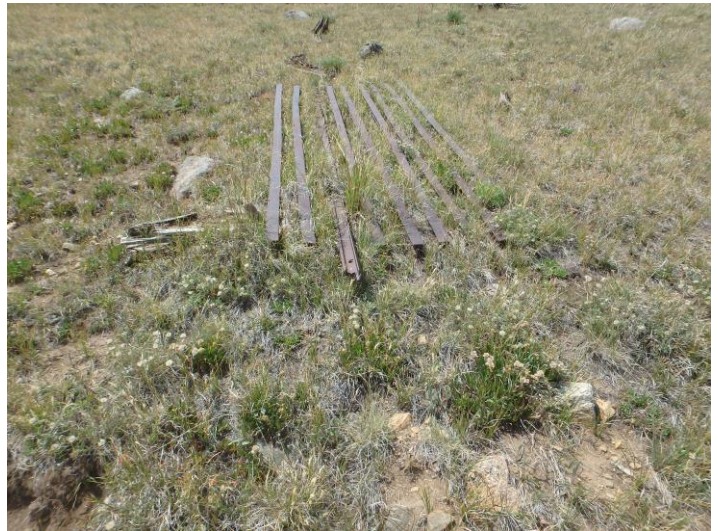
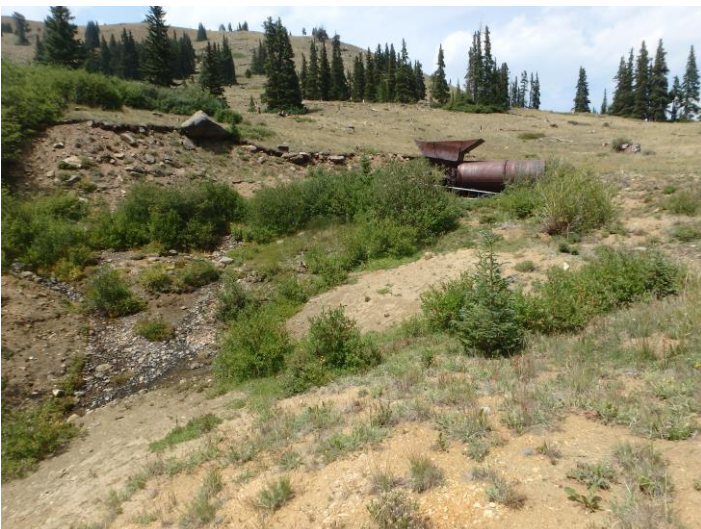
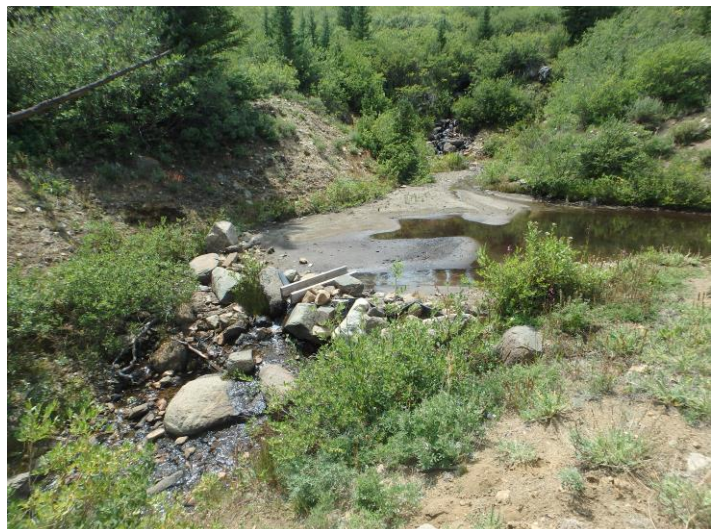
PHOTOGRAPHS

PROBLEM/POSSIBLE VIOLATION: Problem: A trommel assembly was noted on site. Use of the trommel was not proposed in the NOI, nor approved by the Division. The existing financial warranty does not include costs to cover removal of the trommel assembly.

The approved prospecting plan for this NOI authorized excavation of three test pits, approximately 10' wide by 10' long by 10' deep. The reclamation plan calls for backfilling the pits and reseeding the disturbed areas. There were no open pits observed during this inspection. Overall the site is orderly and disturbance is minimal. There are several piles of scrap metal and lumber that will need to be removed during reclamation. A trommel unit was set up above the settling pond. During review of the NOI application it was noted that the trommel unit was not mentioned and therefore removal costs for the trommel are not included in the financial warranty. This has been noted as a problem with corrective actions on page one of this report.

CORRECTIVE ACTIONS: Submit a modification to the NOI describing the trommel use, plans for removal, and measures to be taken in order to minimize disturbance to the prevailing hydrologic balance in accordance with Rule 3.1.6.
