August 22, 2018

**Re: Permit No. M-1980-244; Cripple Creek & Victor Gold Mining Company ("CC&V"); Cresson Project
– Notification of Water Quality Analysis Parameter Exceedances August 21, 2018**

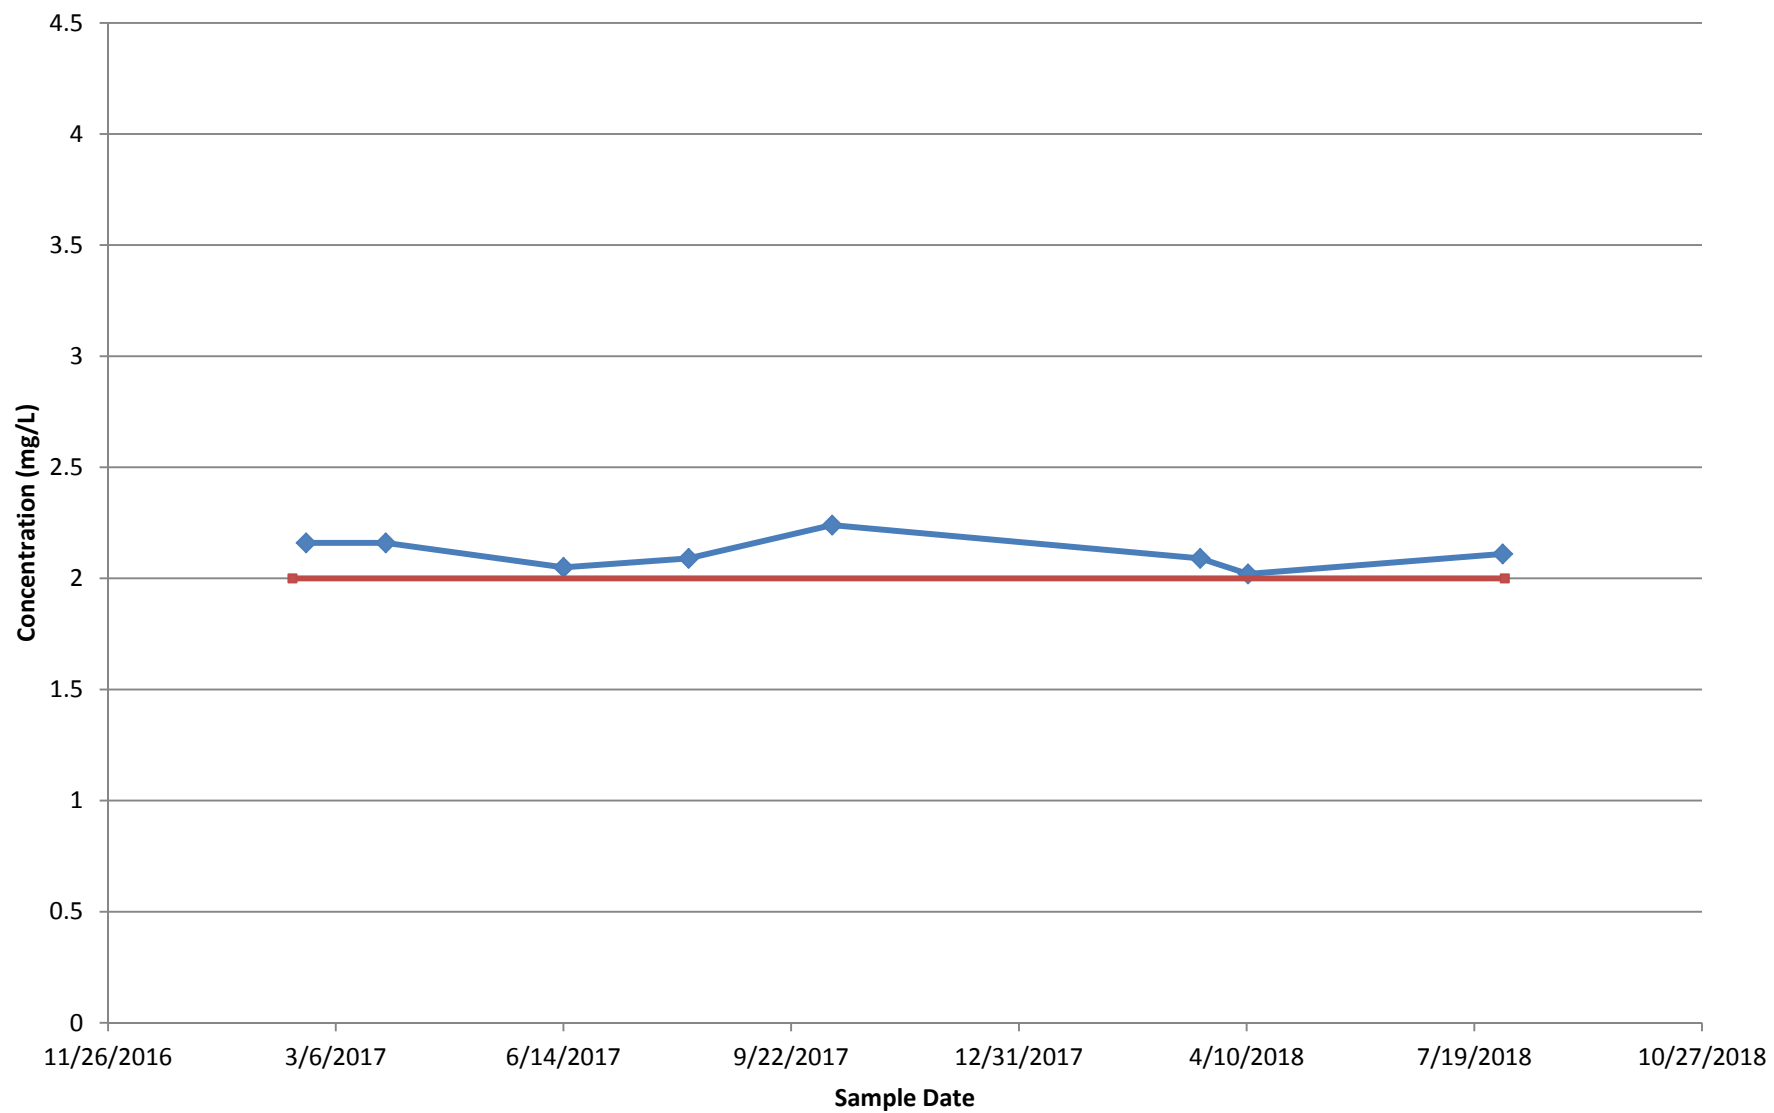
GVMW-8A

Fluoride Fluoride - NPL

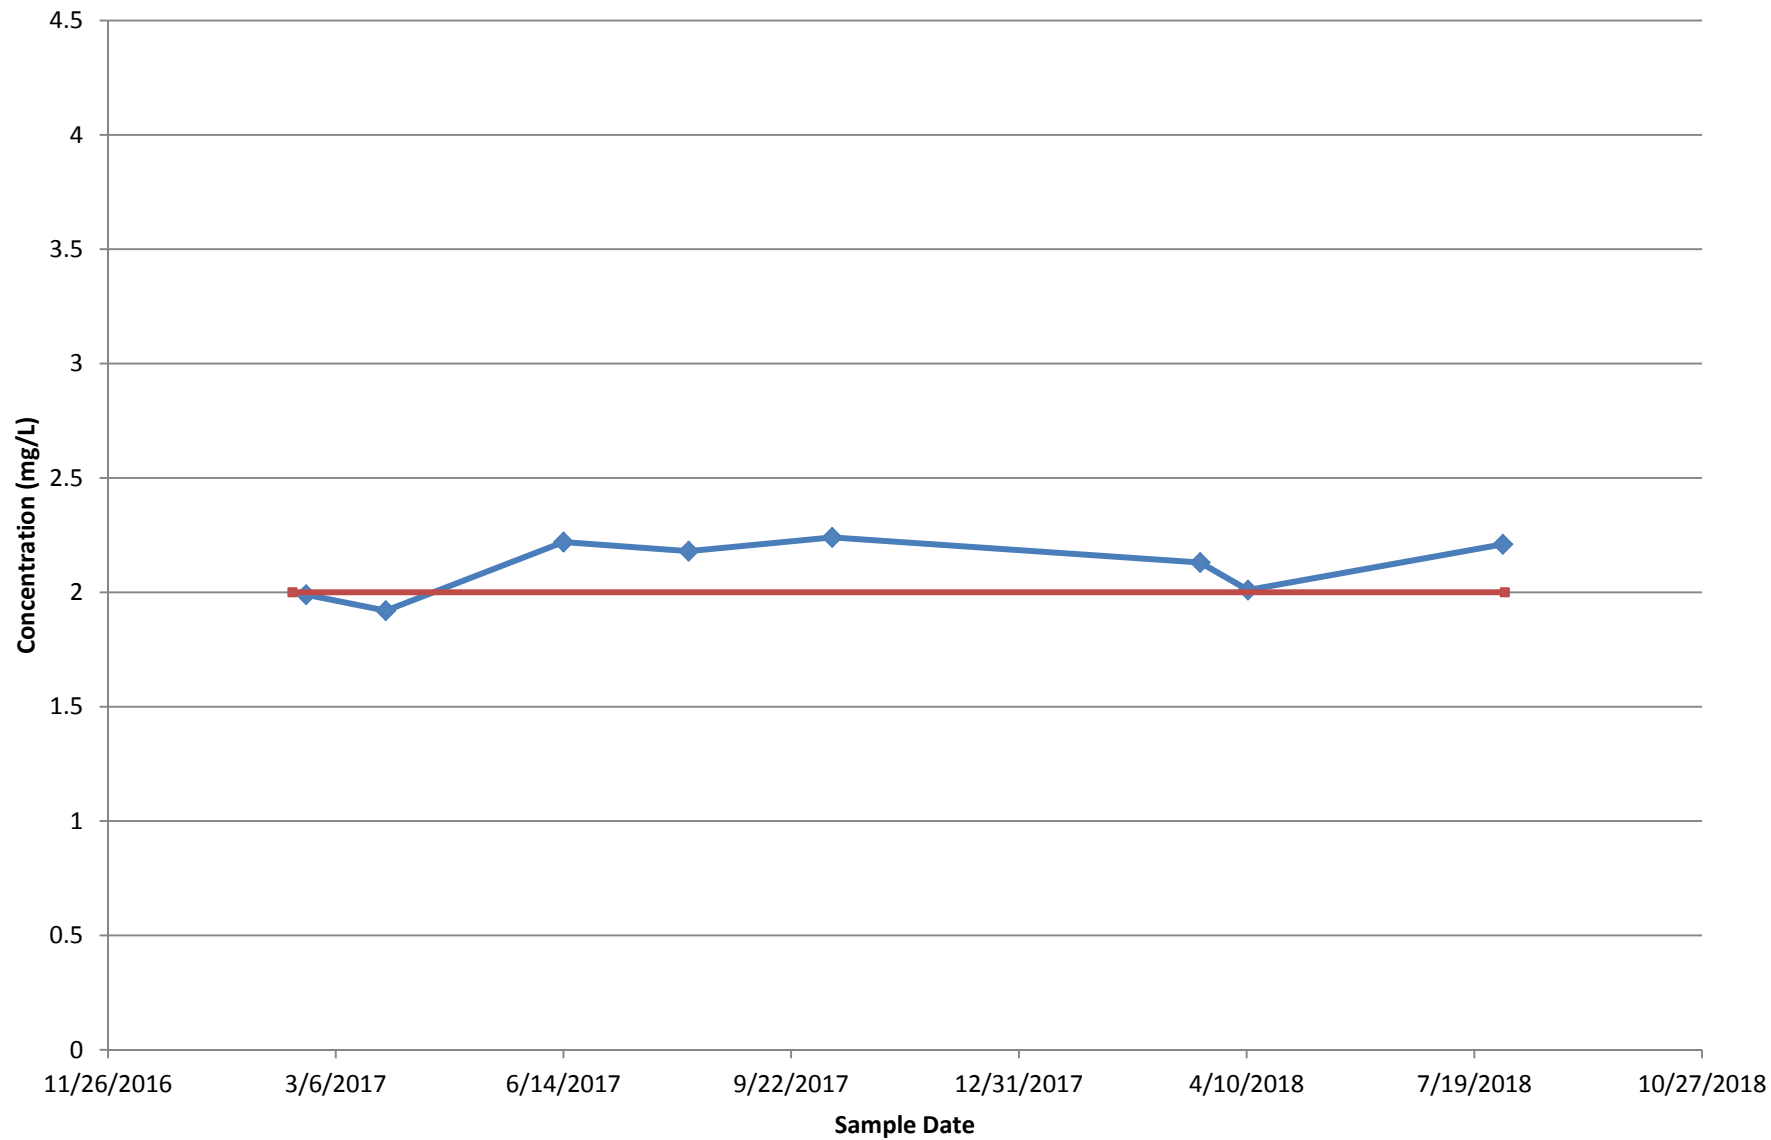
GVMW-8B

Fluoride Fluoride - NPL
