CHEVRON U.S.A., INC.

IIILE SHEEI	1
EXHIBIT E - MINING MAP	2
EXHIBIT E - RECLAMATION MAP	3

RECLAMATION MAP NOTES

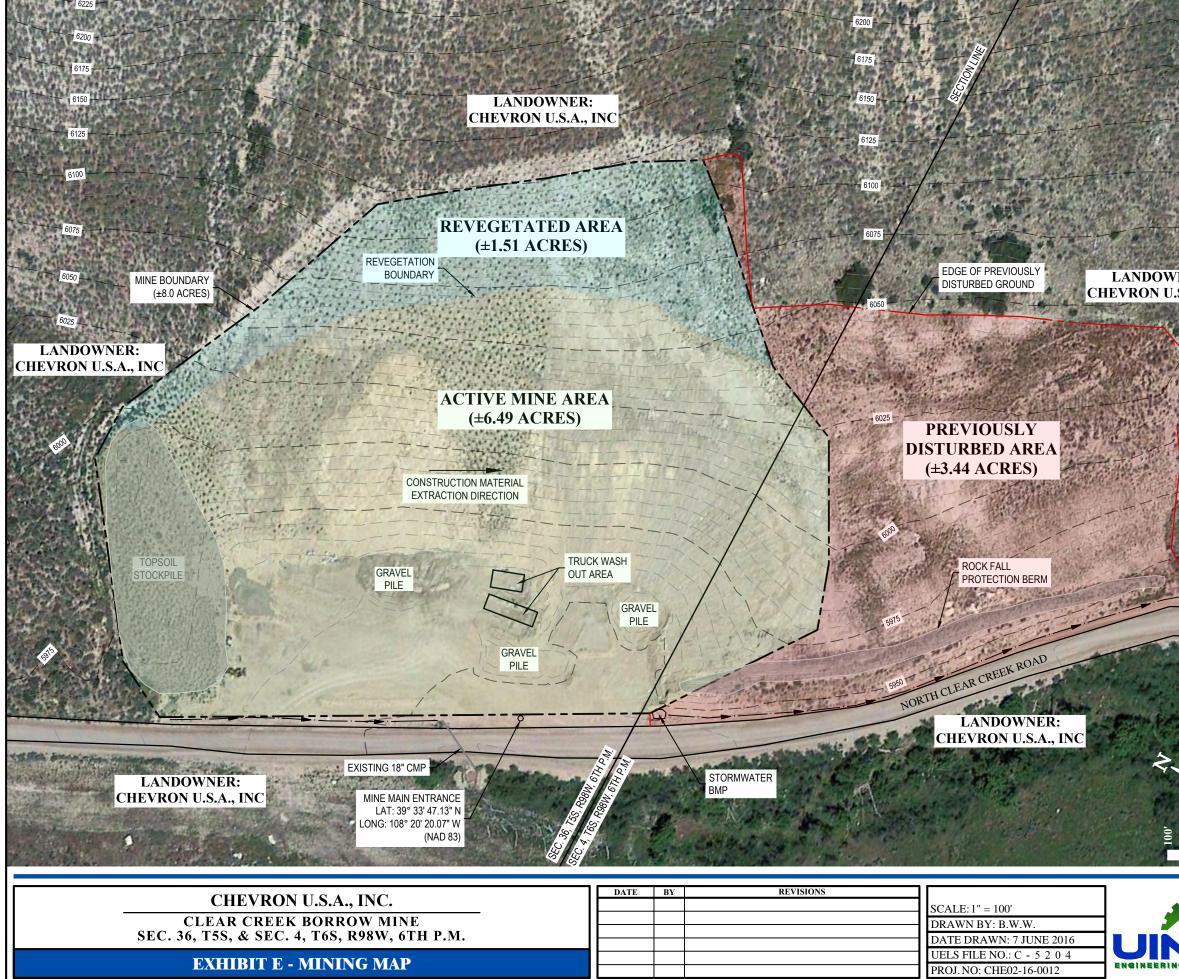
Martin Color and Color and Color and Color	
	MINING MAP NOTES
	1. CHEVRON U.S.A., INC. IS THE ONLY LANDOWNER WITHIN 200 FEET OF THE AFFECTED AREA.
	 THERE ARE NO PERMANENT OR MAN-MADE STRUCTURES WITHIN 200 FEET OF THE AFFECTED AREA.
	, w.e., e
	MINE BOUNDARY DESCRIPTION
VNER:	 THE MINING BOUNDARY IS DESCRIBED AS BEING LOCATED IN TRACT 108 OF SECTION 4, T6S, R98W, 6TH P.M. AND THE SE 1/4 SW 1/4 AND SW 1/4 SE 1/4 OF SECTION 36, T5S, R98W, 6TH P.M.
J.S.A., INC	
	LEGEND
50' SO'	45606 JUNE 9, 2016
	CIVIL ENGINEERING AND
	CIVIL ENGINEERING AND LAND SURVEYING SERVICES 85 South 200 East, Vernal, UT 84078 O: 435.789.1017 www.uintahgroup.com - SINCE 1964 - OF 3

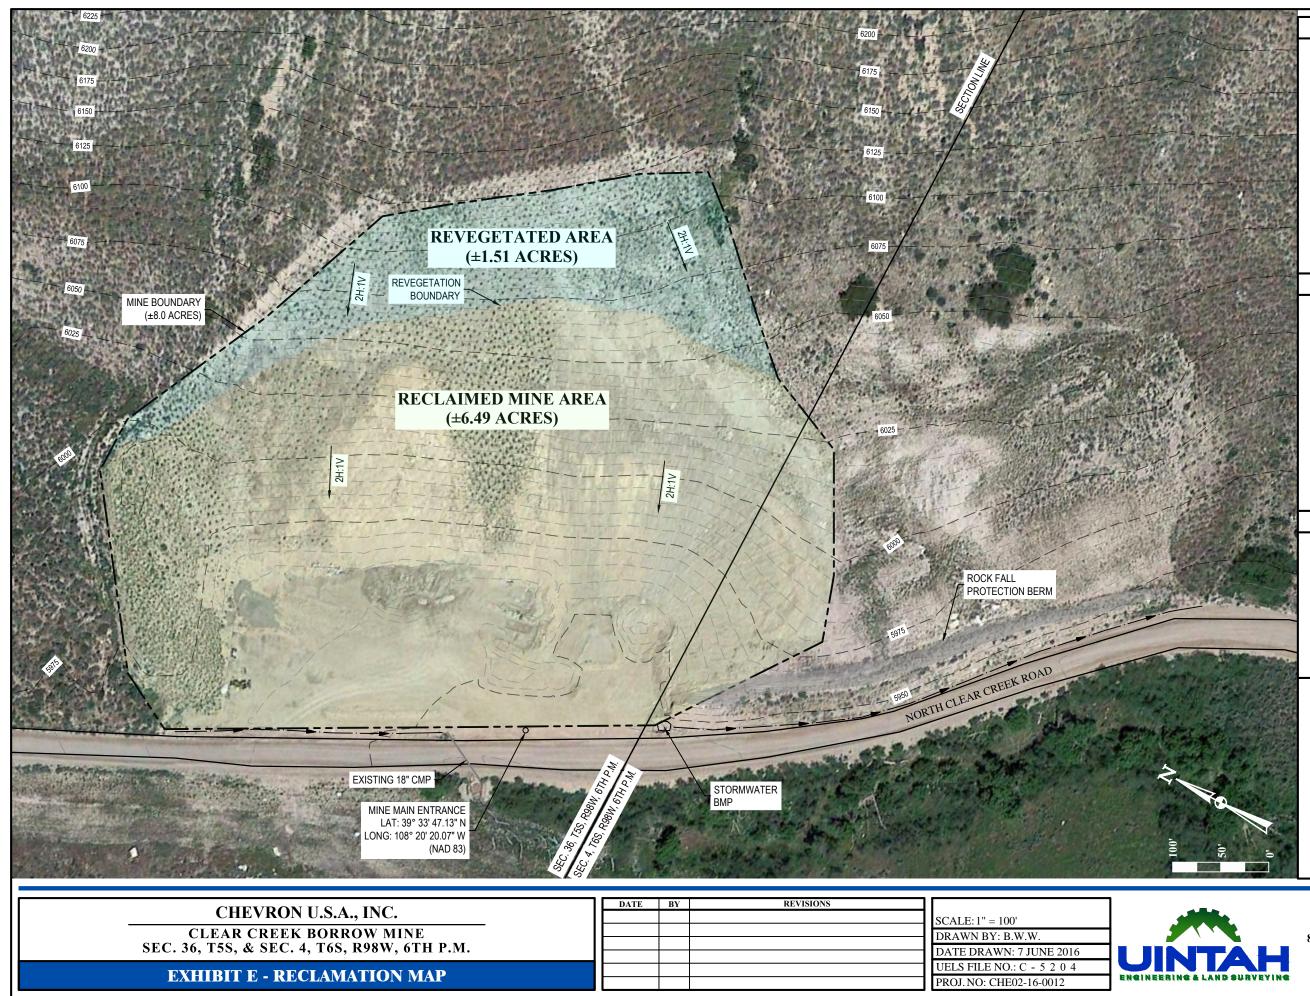
- REVEGETATED AREA HAS BEEN RECLAIMED USING POCKETING METHODS TO ESTABLISH SHRUB GROWTH.
- 2. AS MINING OPERATIONS CONTINUE, PARTS OF THE ACTIVE MINE AREA WILL BE RECLAIMED USING POCKETING METHODS TO ESTABLISH SHRUB GROWTH.
- 3. THERE ARE NO PONDS AT THIS SITE.
- 4. THERE IS NO OVERBURDEN TO BE REPLACED.
- 5. 3 INCHES TO 6 INCHES OF TOPSOIL WILL BE REPLACED IN ALL RECLAIMED/REVEGETATED AREAS.

1. THE MINING BOUNDARY IS DESCRIBED AS BEING LOCATED IN TRACT 108 OF SECTION 4, T6S, R98W, 6TH P.M. AND THE SE 1/4 SW 1/4 AND SW 1/4 SE 1/4 OF SECTION 36, T5S, R98W, 6TH P.M.
