Newmont Mining Corporation
Cripple Creek & Victor Mine
100 N 3rd St
P.O. Box 191
Victor, CO 80860

Re: **Permit No. M-1980-244; Cripple Creek & Victor Gold Mining Company; Cresson Project;
Written Notification – Process Water Spill, February 18, 2019**

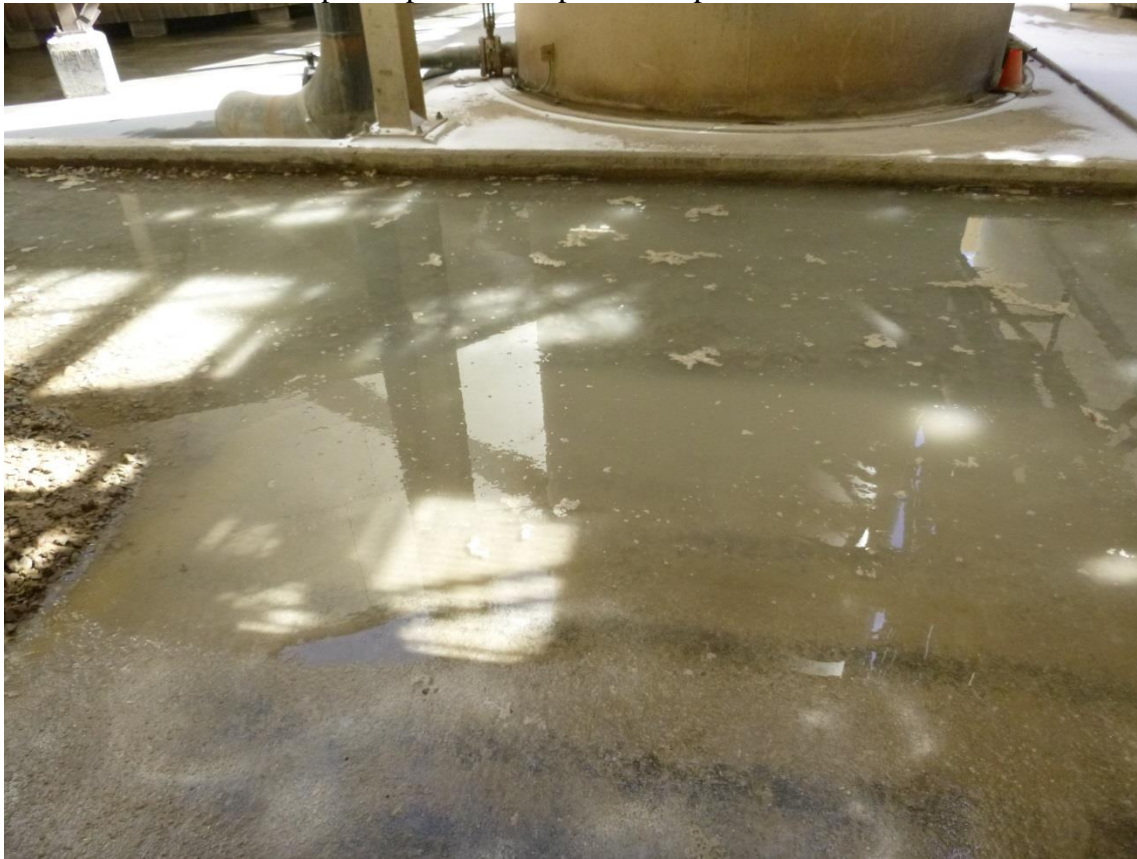
- At approximately 10:30 am on February 18, 2019, a process water conveyance pipeline broke. The separation occurred on the East side of the HGM near the Neutral Water Tank. Approximately 400 gallons of process water spilled on the HGM pad that is over liner. The process water consists of fresh water and sediment originating from the grinding, flotation, and filtering processes that occur in the HGM. No cyanide is utilized anywhere in the mill circuit, therefore there is no risk that this process water contains cyanide.
- Upon discovery, the leaking conveyance pipeline was isolated and the broken pipe was repaired.
- A skid steer was used to over-excavate the spill-impacted soil.
- The excavated soil was transferred to the ore feed pile to be re-processed in the HGM. Approximately 4 cubic yards of soil was excavated in the cleanup efforts.

Photo 1. Process water spill impacted area pre-cleanup.

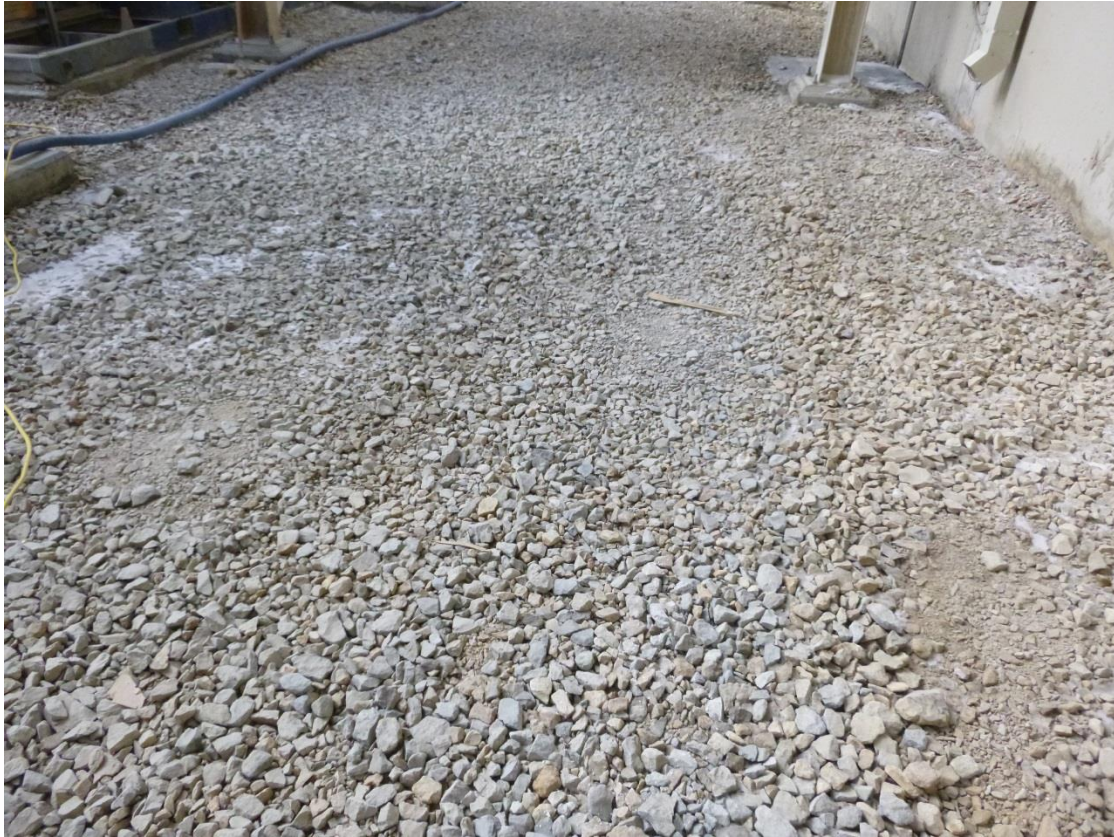
Photo 2. Process water spill impacted area post-cleanup.

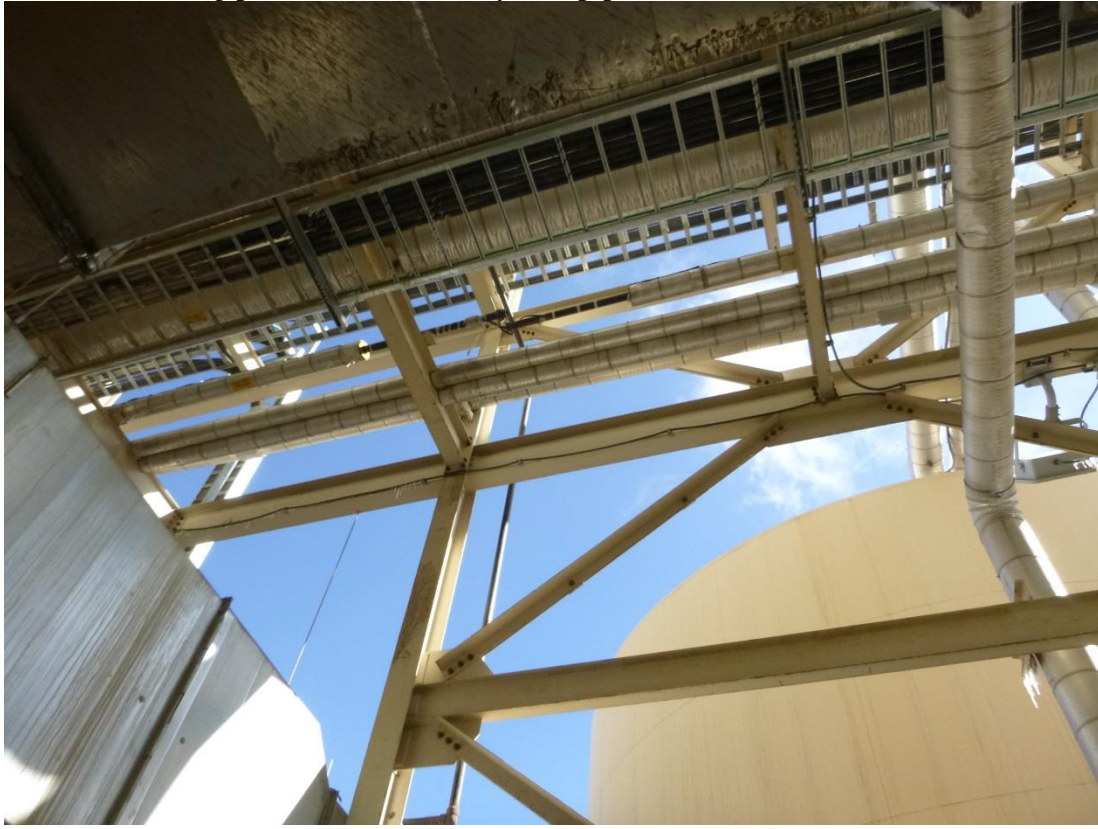
The root cause of the spill was determined to be the broken pipe, likely caused by extreme temperature fluctuations. Photos of the spill impacted area before and after cleanup efforts are included as an attachment to this submittal. In addition, a photo of the broken process water conveyance pipe is included.

Photo 3. Leaking process water conveyance pipeline.
