Re: King II Mine
Pond Quarterly Inspection
1st Quarter 2019

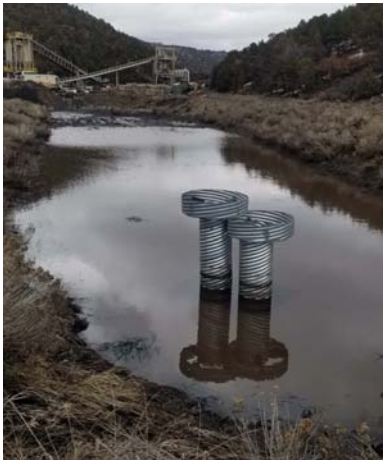
An inspection of the pond at the King II mine was performed on March 7, 2019 for the 1st quarter of 2019. The pond contained several feet of water from recent snowmelt, but is still several feet from the discharge spillway levels. The pond embankment, in-slopes and spillway all appeared stable with no evidence of slumping, settling or excessive erosion. All features appeared to be in place and functioning as designed.
