MINERALS PROGRAM INSPECTION REPORT**PHONE: (303) 866-3567**

MINE NAME: Rudibaugh Pit	MINE/PROSPECTING ID#: M-1995-057	MINERAL: Sand and gravel	COUNTY: Gunnison
INSPECTION TYPE: Monitoring	INSPECTOR(S): Dustin M. Czapla	INSP. DATE: May 15, 2019	INSP. TIME: 11:00
OPERATOR: Deb Rudibaugh	OPERATOR REPRESENTATIVE: Jessie Schoonover	TYPE OF OPERATION: 110c - Construction Limited Impact

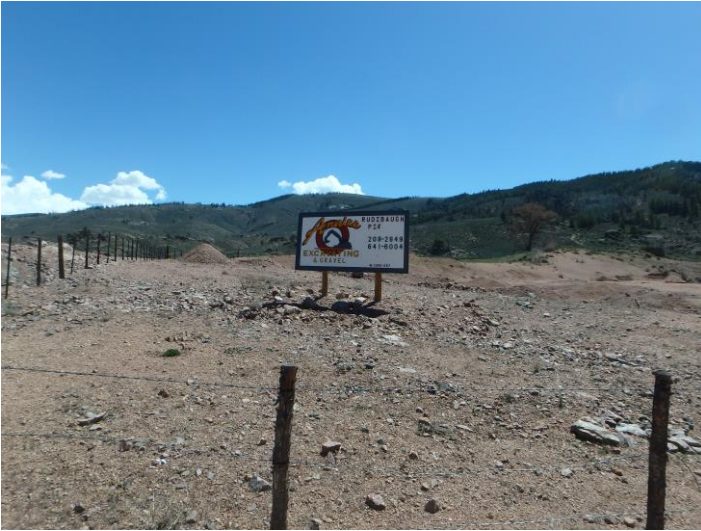
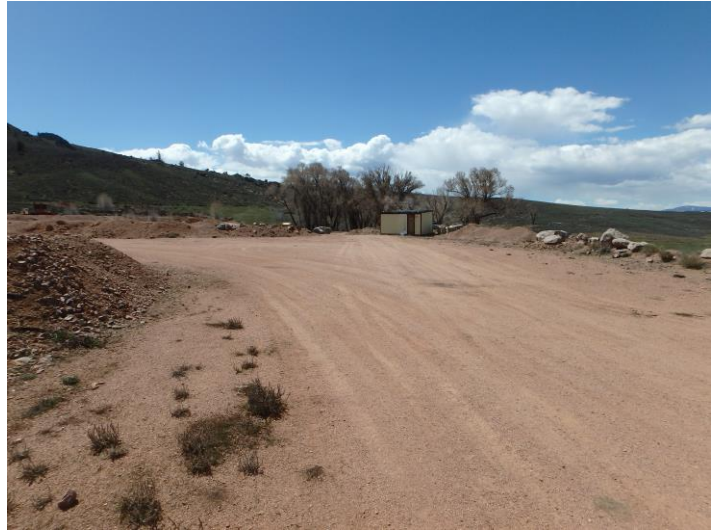
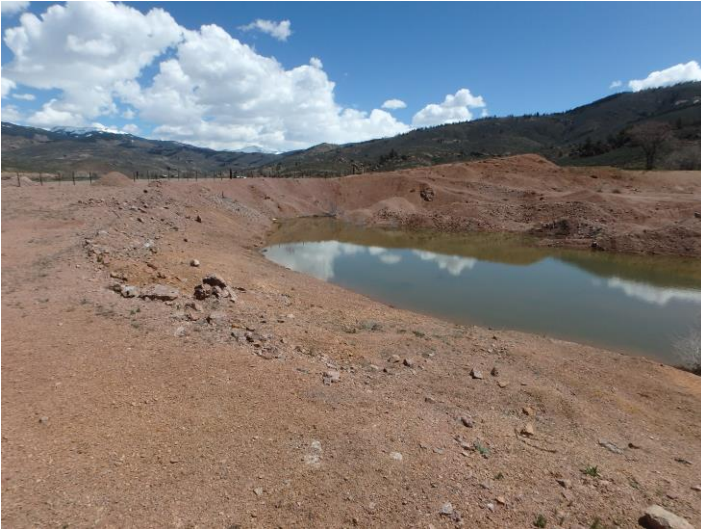
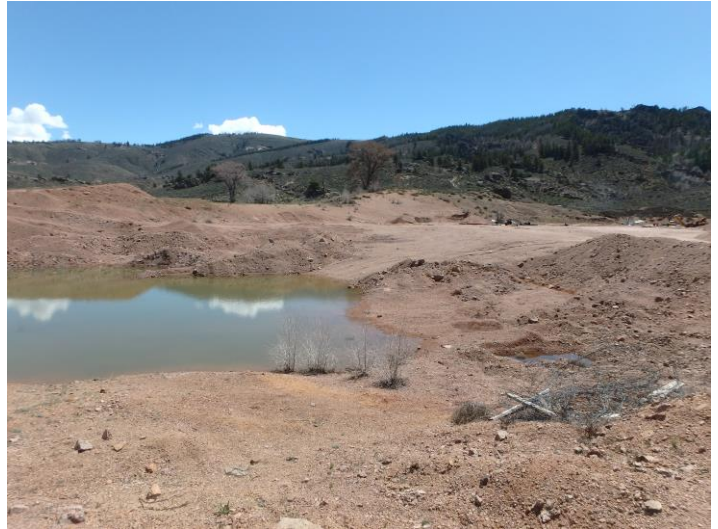
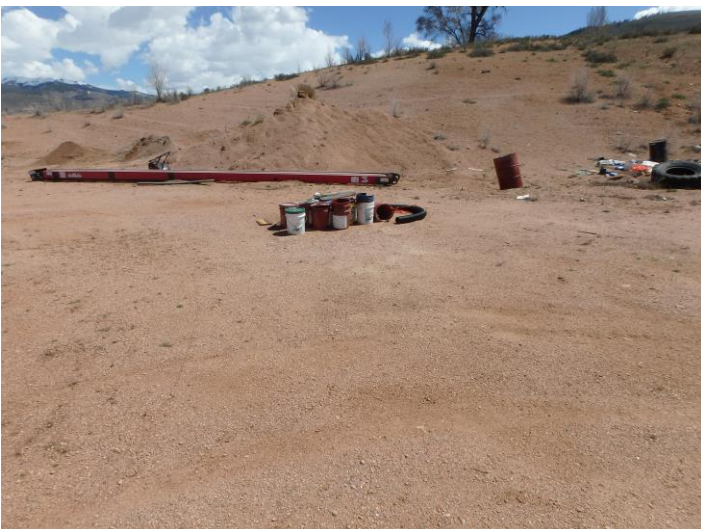
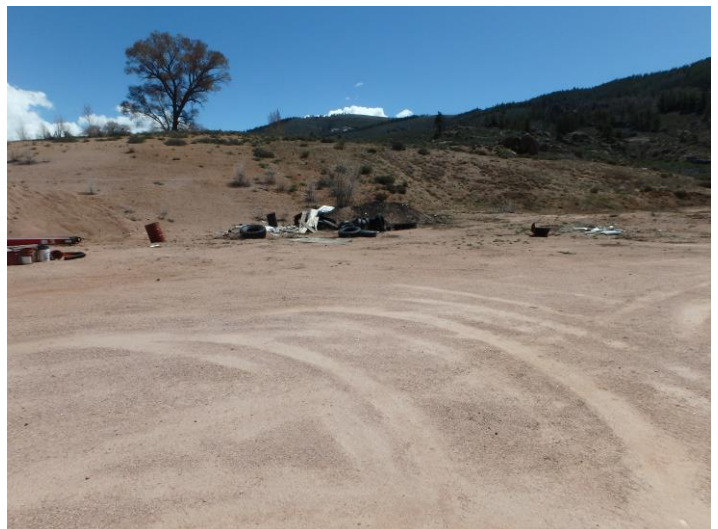
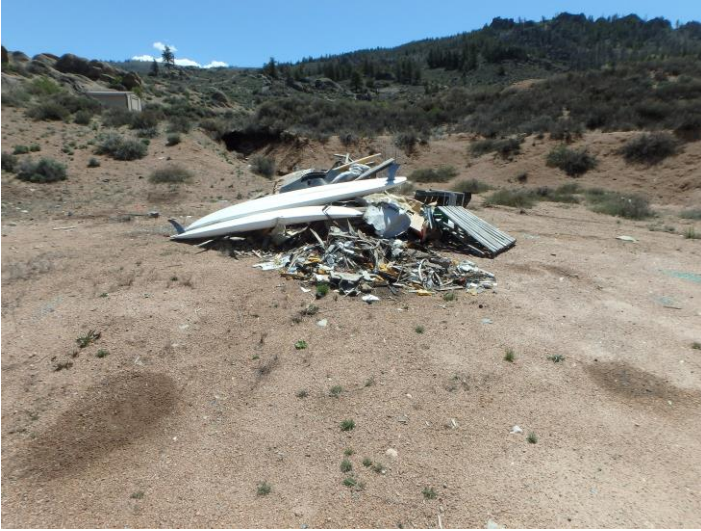
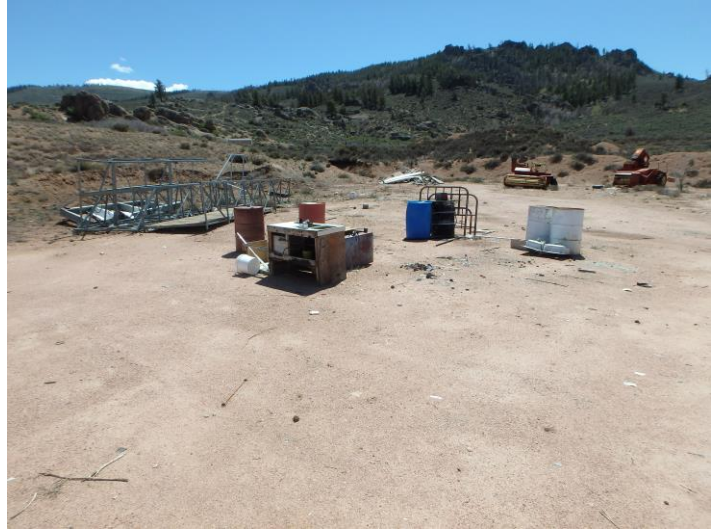
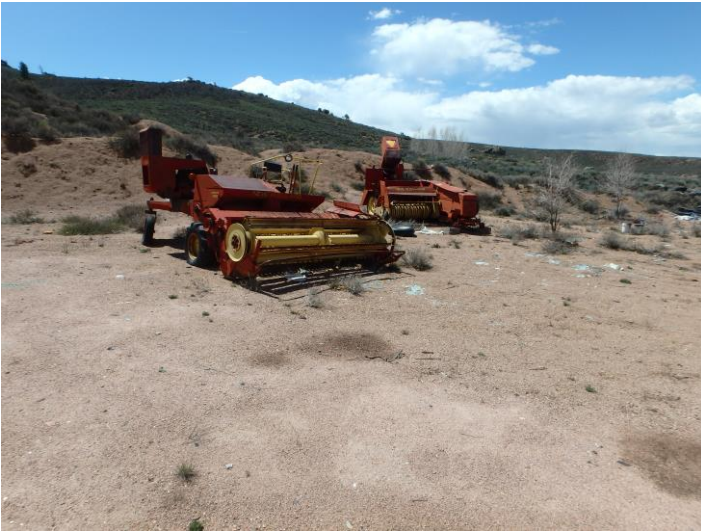
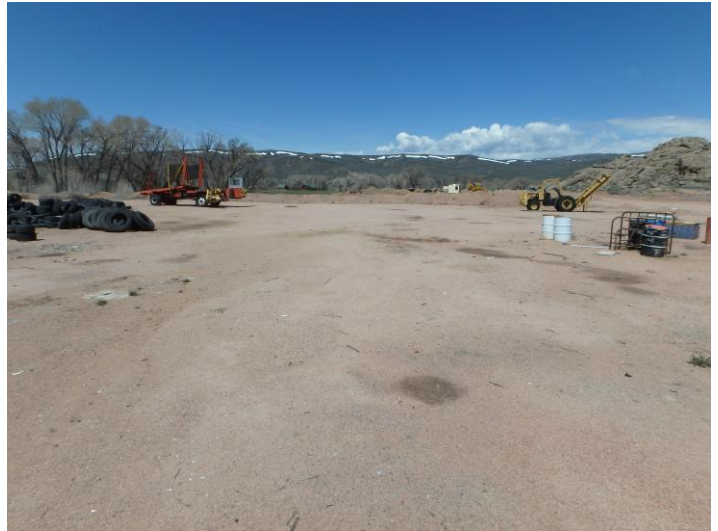
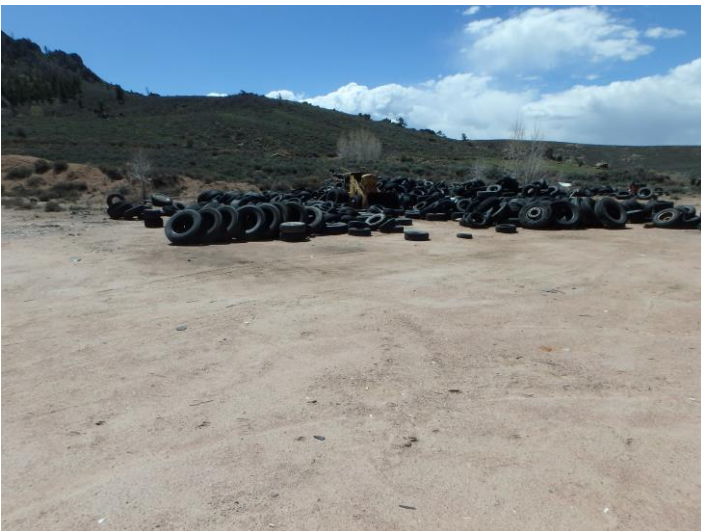
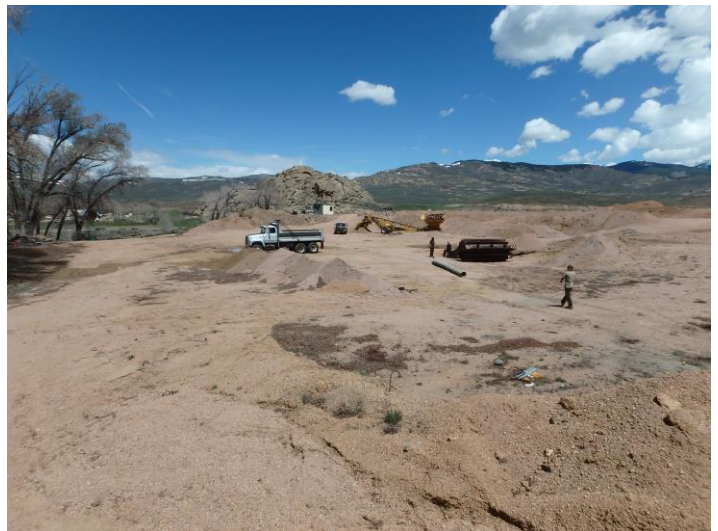
PHOTOGRAPHS

POSSIBLE VIOLATION: Excessive trash and refuse were observed within the permit area. The south portion of the permit area has been used as a junkyard. Junk vehicles/equipment and various refuse were stored in this area. On August 28, 2018 the Mined Land Reclamation Board issued an order finding the operator in violation for failing to control the unsightliness or deleterious effects of refuse and imposed a corrective action requiring the operator to remove all trash and scrap vehicles from the site by November 26, 2018. Although the operator has made significant progress, cleanup of the site has not yet been completed.

Excessive trash and refuse were observed within the permit area. The south portion of the permit area has been used as a junkyard. Junk vehicles/equipment and various refuse were stored in this area. This issue has been documented in previous inspection reports. On August 28, 2018 the Mined Land Reclamation Board issued an order finding the operator in violation for failing to control the unsightliness or deleterious effects of refuse and imposed a corrective action requiring the operator to remove all trash and scrap vehicles from the site by November 26, 2018. Although the operator has made significant progress, cleanup of the site has not yet been completed. Various trash/scrap piles, a large pile of old tires, and several pieces of dilapidated farm equipment remain on site. During the inspection, it was reiterated to the operator that all remaining refuse must be removed from the site and properly disposed of.

Adequate mine identification signage is now in place at the entrance to the site.

The affected area is marked by posts and fencing that is adequate to delineate the affected area boundary.

CORRECTIVE ACTION: Remove all remaining scrap vehicles and farm machinery, old tires and junk piles by June 21, 2019.
