**MINERALS PROGRAM INSPECTION REPORT****PHONE: (303) 866-3567**

<b>MINE NAME:</b> Juniper Mountain Gravel	<b>MINE/PROSPECTING ID#:</b> M-2003-073	<b>MINERAL:</b> Gravel	<b>COUNTY:</b> Moffat
<b>INSPECTION TYPE:</b> Monitoring	<b>INSPECTOR(S):</b> Amy C. Yeldell	<b>INSP. DATE:</b> July 10, 2019	<b>INSP. TIME:</b> 14:45
<b>OPERATOR:</b> Moffat Limestone Company	<b>OPERATOR REPRESENTATIVE:</b> Mike Anson	<b>TYPE OF OPERATION:</b> 112c - Construction Regular Operation	
<b>REASON FOR INSPECTION:</b> Normal I&E Program	<b>BOND CALCULATION TYPE:</b> Complete Bond	<b>BOND AMOUNT:</b> \$28,135.00	
<b>DATE OF COMPLAINT:</b> NA	<b>POST INSP. CONTACTS:</b> None	<b>JOINT INSP. AGENCY:</b> None	
<b>WEATHER:</b> Clear	<b>INSPECTOR'S SIGNATURE:</b>

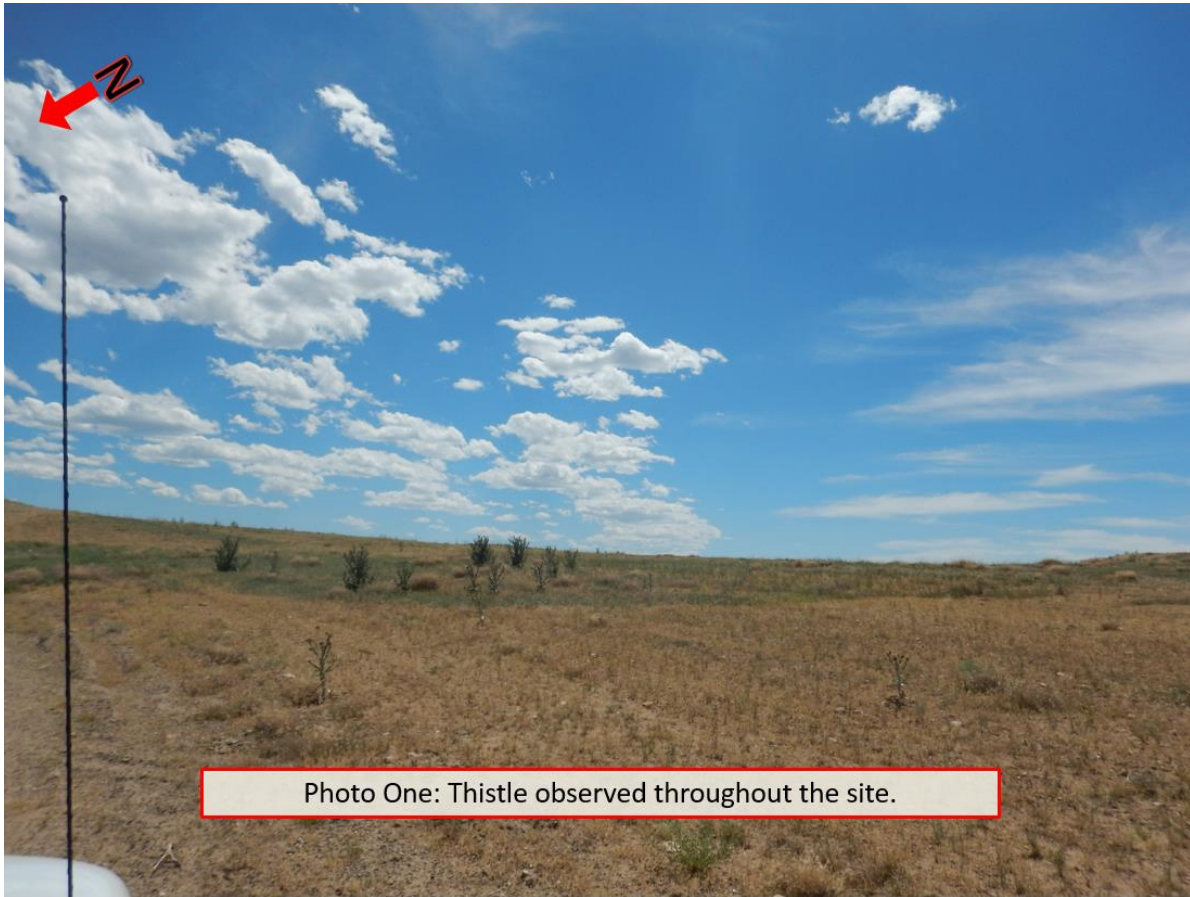
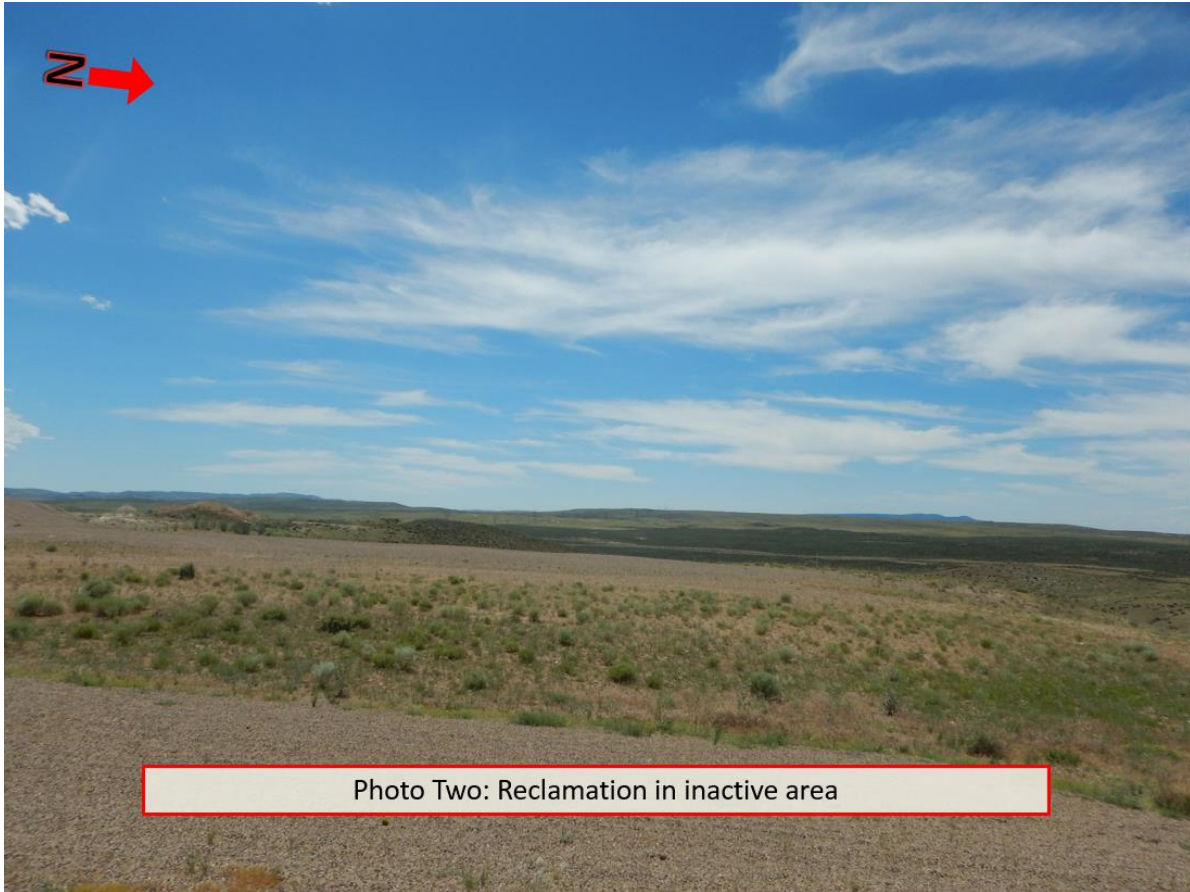
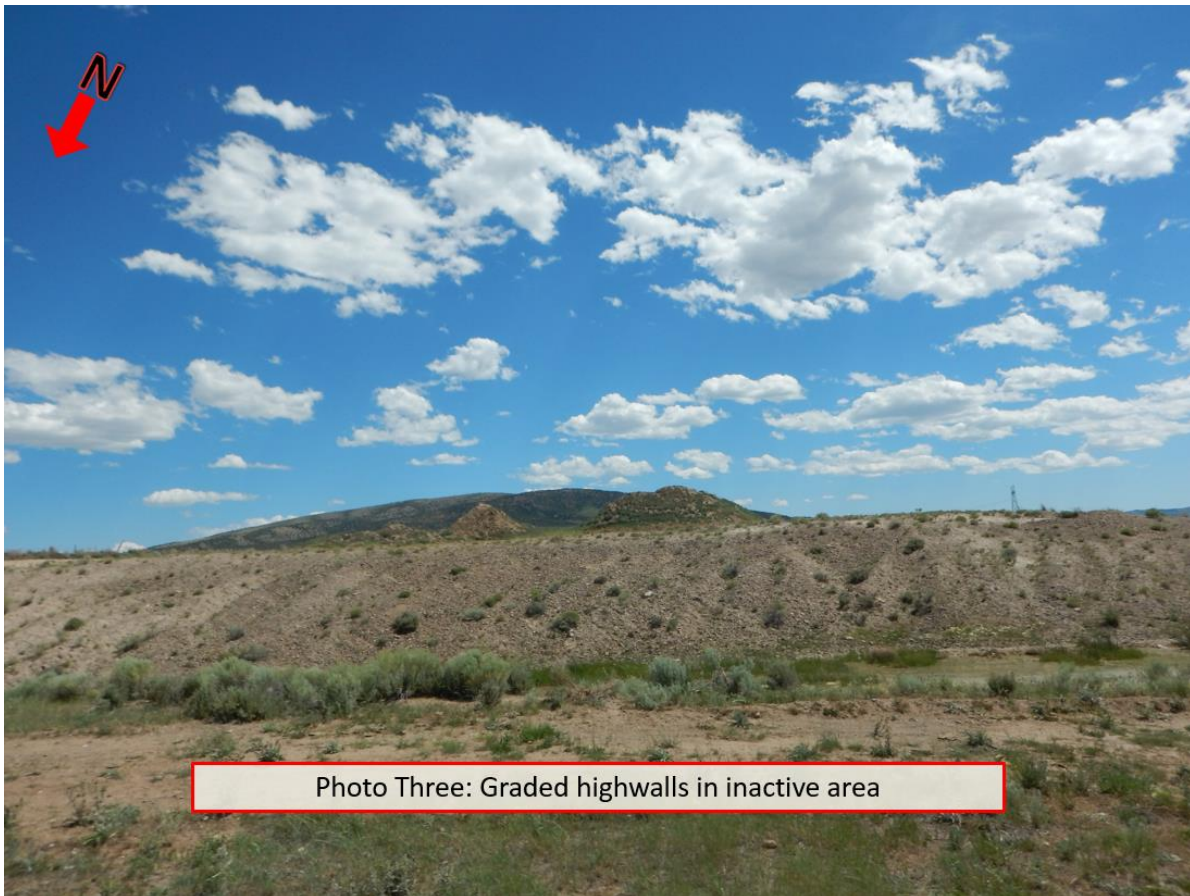
**PHOTOGRAPHS**

The active portion of the mine site still remains within the 5 acre footprint. The reclaimed portions associated with TR-3 and reducing the overall liability has had poor success. Only a small portion of the reclaimed areas has established vegetation. The majority of the reclaimed areas remains bare or has mostly undesirable vegetation growing. This site would likely benefit from a secondary seeding of areas with poor reclamation success thus far.

Large amounts of scotch thistle were observed throughout the site. This site has a Noxious Weed Management Plan (TR-1). Failure to control noxious weeds is cited as an inspection problem. Please submit photo documentation that noxious weeds have been treated by the corrective action date. If the current noxious weed management plan is inadequate the Operator may also revise their plan in the form of a technical revision by the corrective action date.

**CORRECTIVE ACTIONS:** Implement approved weed control plan and provide proof to the Division that this has been done. If a weed control plan is not already in place, the operator shall develop a weed control and management plan in accordance with Section 3.1.10 (6) of the Rule. This plan should be developed in consultation with the county extension agency, or weed control district office and should include specific control measures to be applied, a schedule for when control measures will be applied and a post-treatment monitoring plan. This weed control plan shall be submitted to the Division as a Technical Revision to the approved plan with the appropriate Technical Revision fee of \$216.00 by the corrective action date.
