Henderson Development M-1980-110

Re: Sandy Acres Pit, DRMS Permit No. M-1980-110
Hydrologic Balance response

This is in response to the Hydrologic Balance topic in the Minerals Program Inspection Report from July 17, 2019.

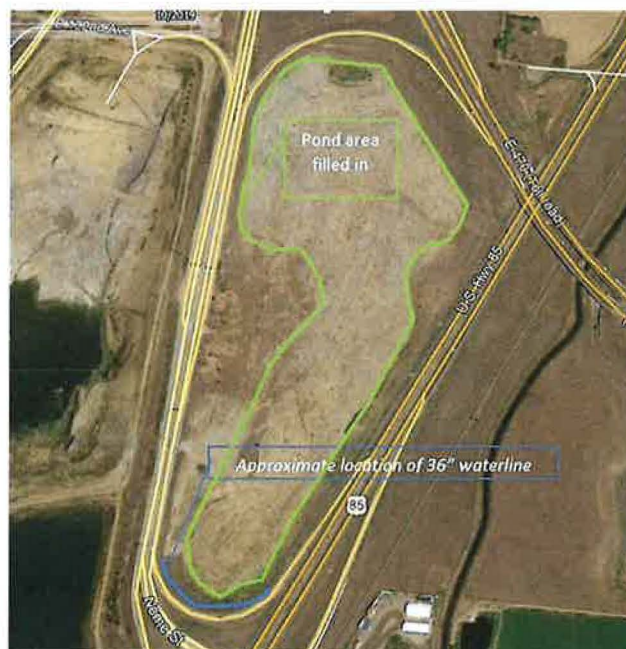
In the spring of 2016 the pond was backfilled to a depth of 4 feet above the pond water elevation at a cost of just under \$3 million. All parties involved at that point in time concurred that backfilling to that elevation should eliminate issues with ground water causing a pond. Initially after the backfill was completed the pond bottom was dry but as time has progressed more of the area is being covered by water. At two points in time, July 1, 2016 and September 19, 2019, test pits were dug in the bottom of the backfilled pond area in an effort to determine if the water was ground water or ponding storm water. Both times pits were excavated to a depth of 4-5 feet below the water surface elevation and no water was encountered even though the pits were less than 100 feet laterally from the surface water. That would lead one to believe that the ponding water is storm water but we have observed that the area covered by water has continued to increase even during periods with little to no precipitation. It also appears that the area being covered by water is expanding from the south to the north. Because of these observations we have also met with the water district that has a 36 inch waterline traversing around the southern end of the pond. A site investigation did not uncover any telltale signs that the line is leaking.

In an effort to determine a solution to the ponding water we have engaged our water consultant and water attorney, dug test pits, and met with the waterline owner. To date we have not been able to determine the source of the water and therefore have not been able to determine the appropriate solution. We have included funding in our proposed 2020 budget to implement or begin to implement a solution in 2020 if a solution is found. We believe we have been diligent in working toward finding a solution but determining the source of the water has proven to be very complex. We are therefore requesting that we be allowed to continue to investigate and observe the area to determine the source of the water and report back on our findings on or before July 1, 2020.
