RE: Facility Inspection / Compliance Advisory
Gillette Sand and Gravel
CDPS Permit Certification - COG501770

SAND AND GRAVEL MINING AND PROCESSING INSPECTION REPORT

Gillette Sand and Gravel

Permittee: Gillette Sand and Gravel
Legally Responsible Person: V Chris Pyles
Facility: Gillette Sand and Gravel
Address: Gillette

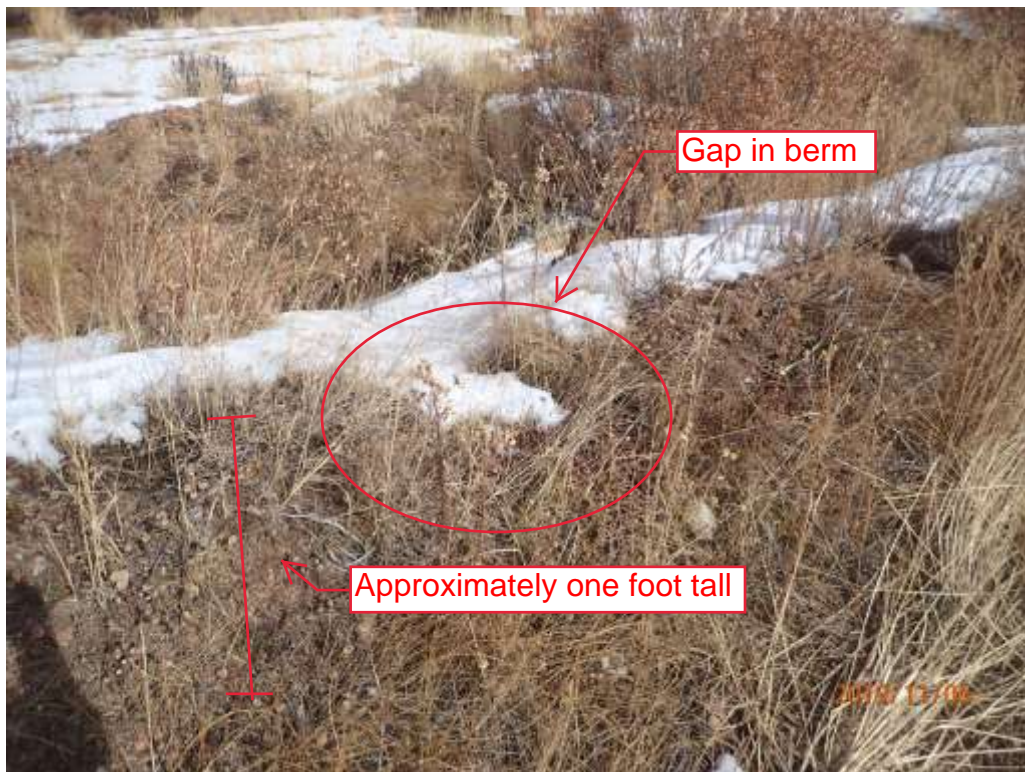
Photograph: 1 - A portion of the berm adjacent to the small tributary stream was approximately one foot tall, and there was a gap in a section of the berm

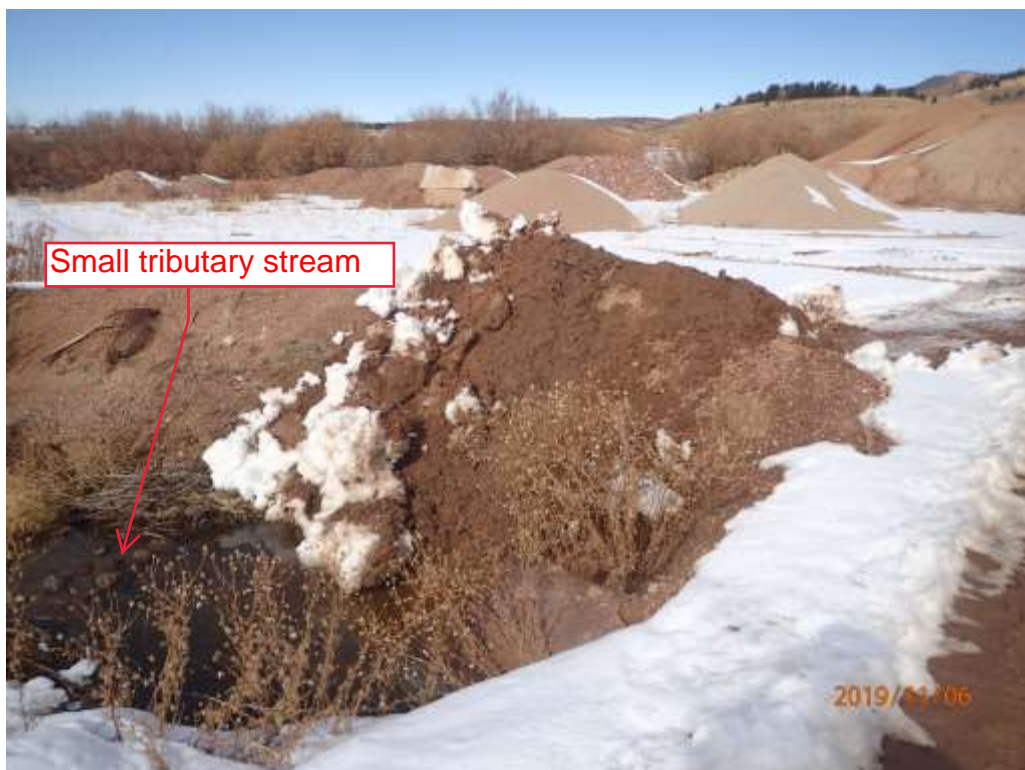
Photograph: 2 - Control measures were not implemented to manage runoff from sediment pushed over the berm during snow plowing operations

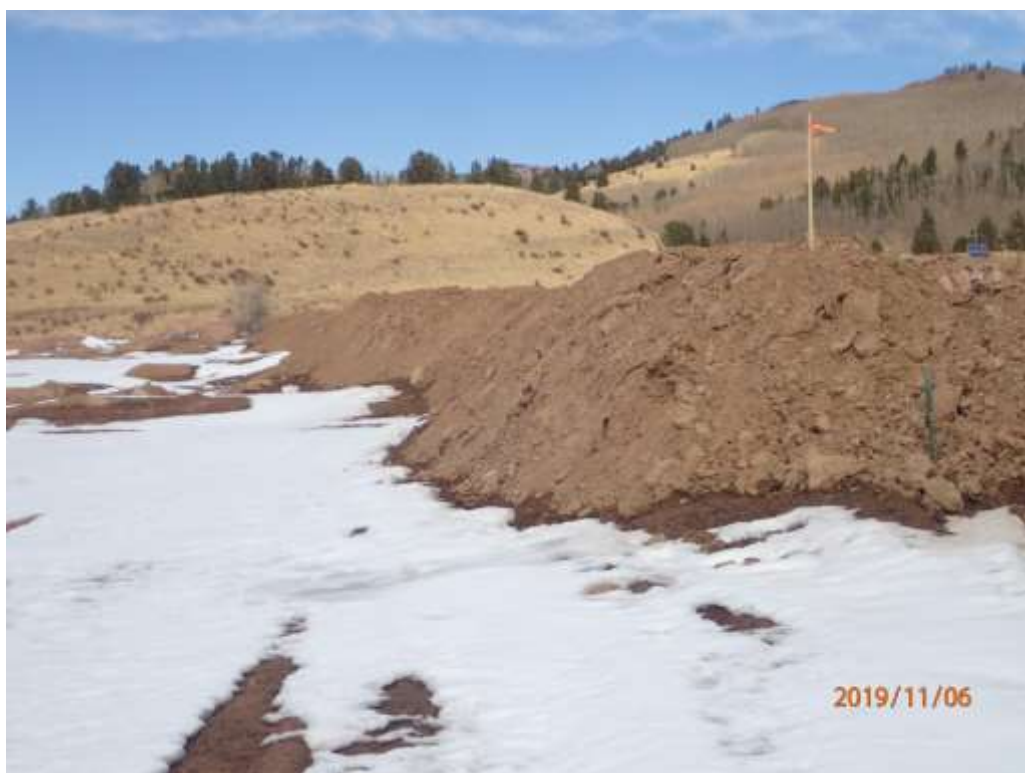
Photograph: 3 - Berm was not compacted

- o In accordance with industry standards and good engineering, hydrologic, and pollution control practices, the installation and implementation specifications for earth dikes developed by Mile High Flood District's Urban Storm Drainage Criteria Manual Vol 3 directs that the embankment is to be compacted to 90% of maximum density and within 2% of optimum moisture content according to ASTM D698.

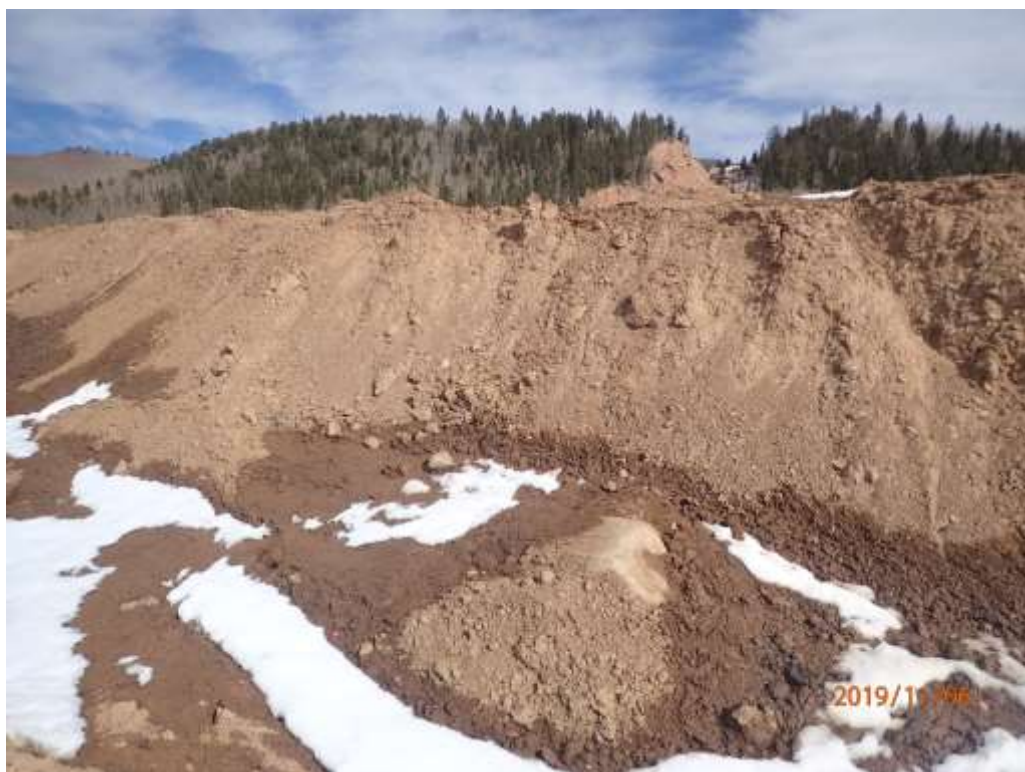
Photograph: 4 - Berm was not compacted

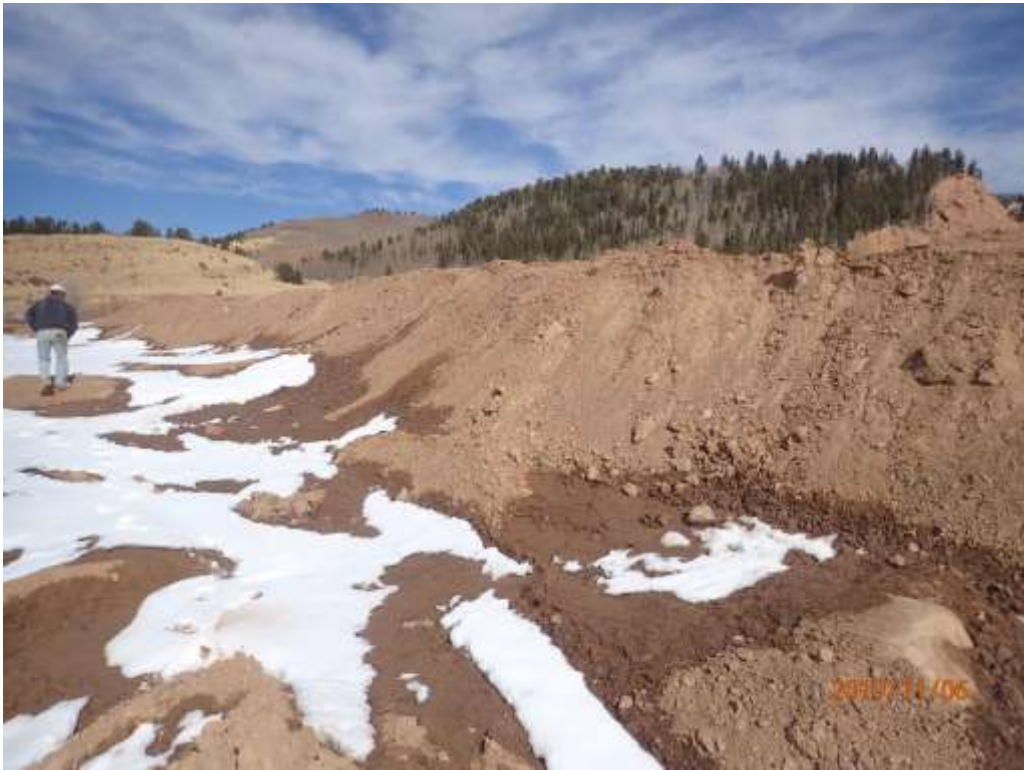
Photograph: 5 - Berm was not compacted

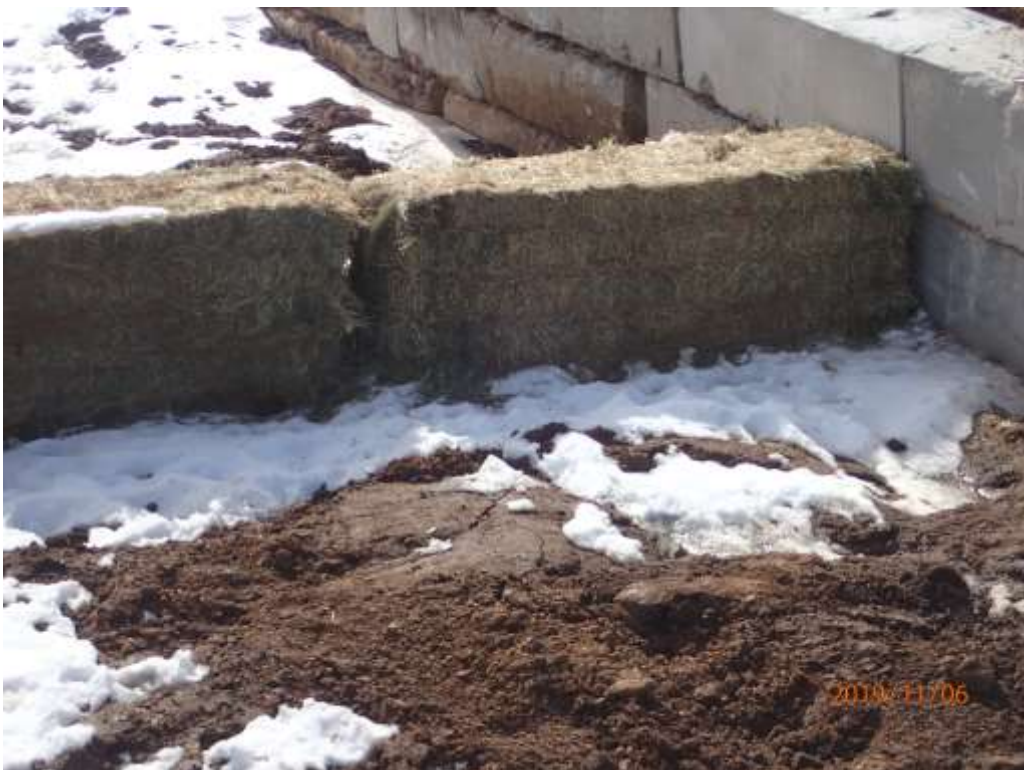
Photograph: 6 - Hay bales were not tightly adjoined, and bales were not staked into the ground

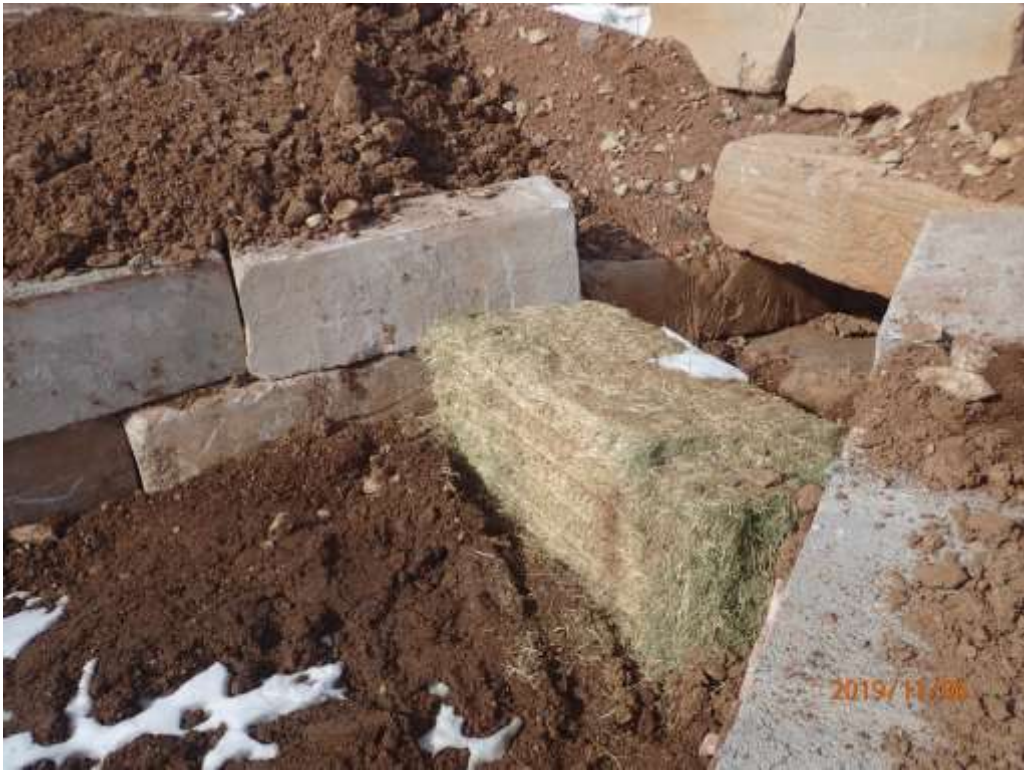
Photograph: 7 - Hay bales were not staked into the ground

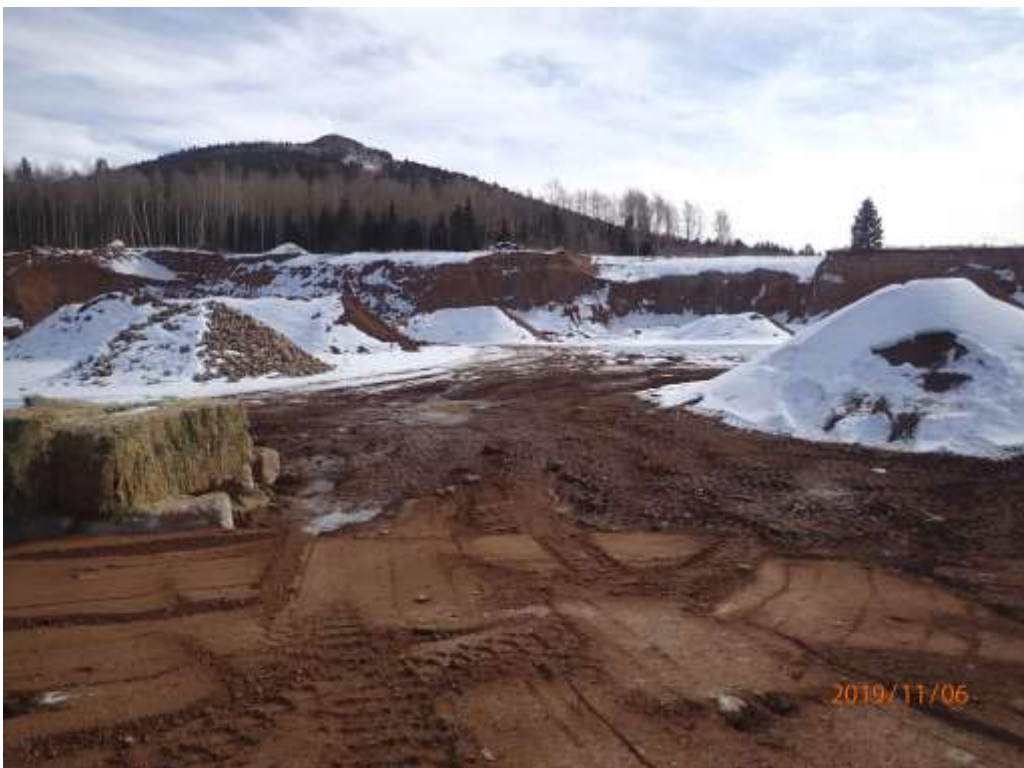
Drainage Path D: Process water (stormwater that gathers in and is discharged from the active mining area) from the eastern portion of the site flows via sheet flow to the eastern sediment pond and discharges to the upper portion of the small tributary stream that discharges to the West Fork of West Beaver Creek. This is currently an unauthorized outfall.

Photograph: 8 - Mining area discharging to the eastern sediment pond

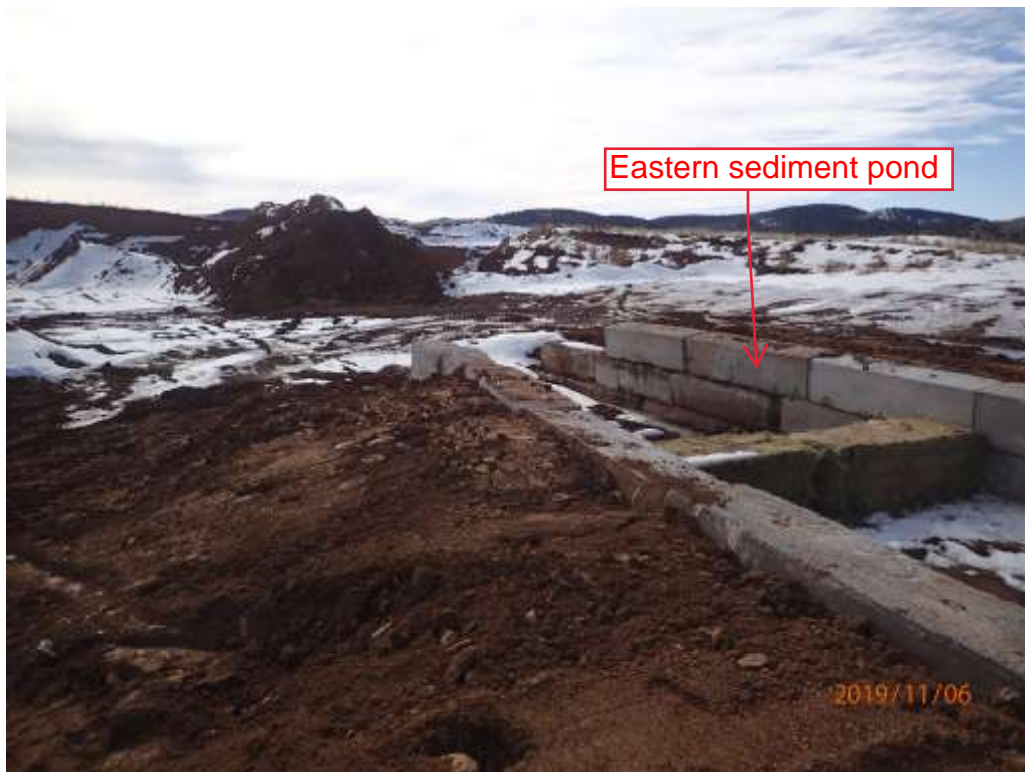
Photograph: 9 - Mining area discharging to the eastern sediment pond

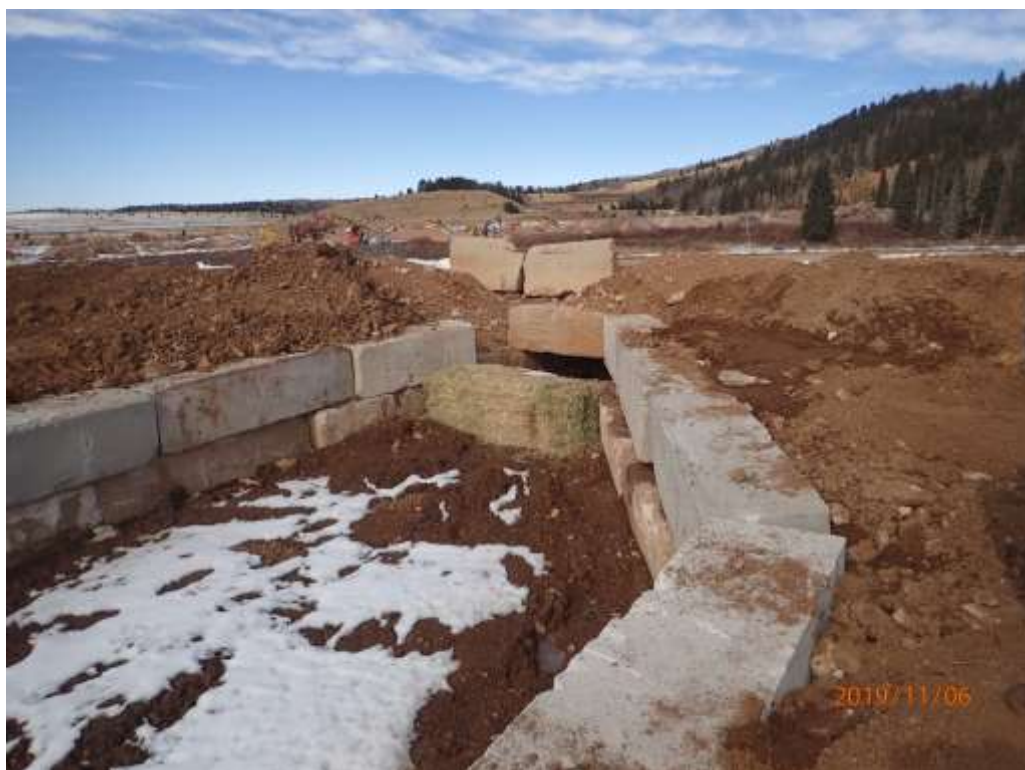
- Location: Eastern sediment pond
 - Pollutant Source: Sediment from disturbed areas
 - Down Gradient Control Measures: Additional control measures (14 inch grade differential at pond outlet) were implemented down gradient of this location. However, these controls were implemented as part of a treatment train, dependent on the inadequate control measure in this finding. As a result, the system of control measures was inadequate to manage pollutant contribution from the above pollutant source.

Photograph: 10 - Eastern sediment pond outlet structure

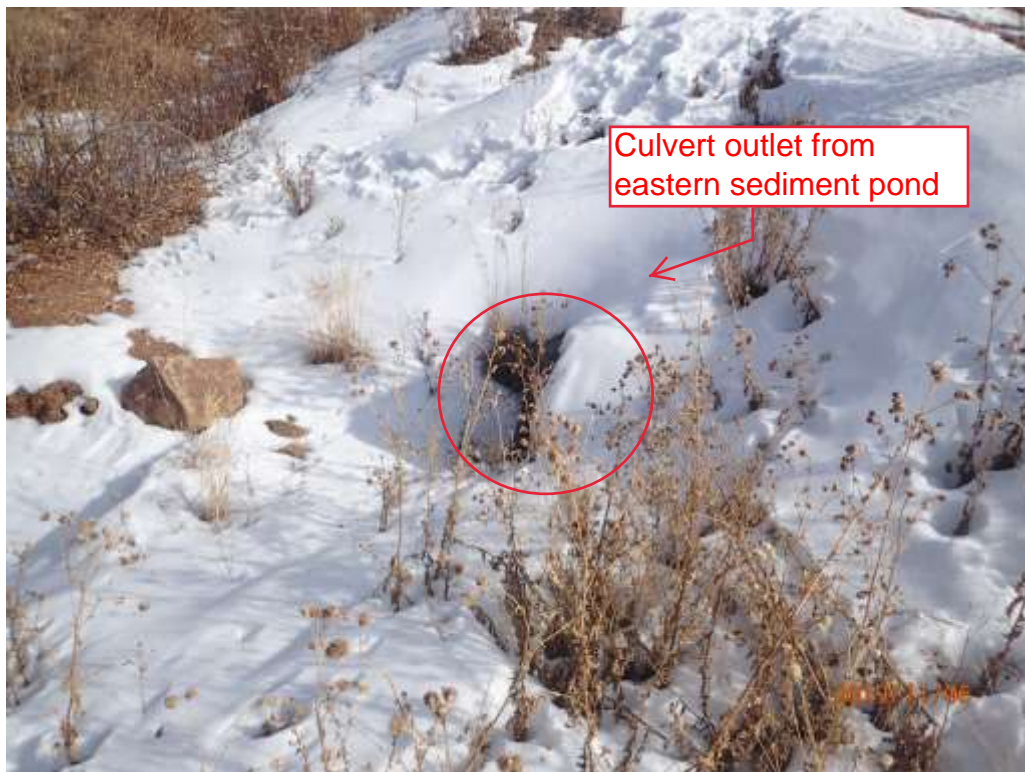
The unauthorized process water outfall is located at the culvert outfall from the eastern sediment pond, where mine dewatering water is discharged (refer to Note 6, Drainage Path D, and photographs 8 - 12). Per Part I.A.1.a.i of the permit, mine dewatering includes any water, including groundwater, seepage, and stormwater (precipitation and surface runoff), that is impounded or that collects in the mine pit (surface or underground workings) and is pumped, drained, or otherwise removed from the mine through the efforts of the mine operator. While the division inspector did not observe discharge from this location, according to Ken Depoy, discharge was observed from this location last spring.

Photograph: 11 - Outfall from eastern sediment pond

The division expects the permittee to modify the certification to include all potential stormwater and process water outfalls.

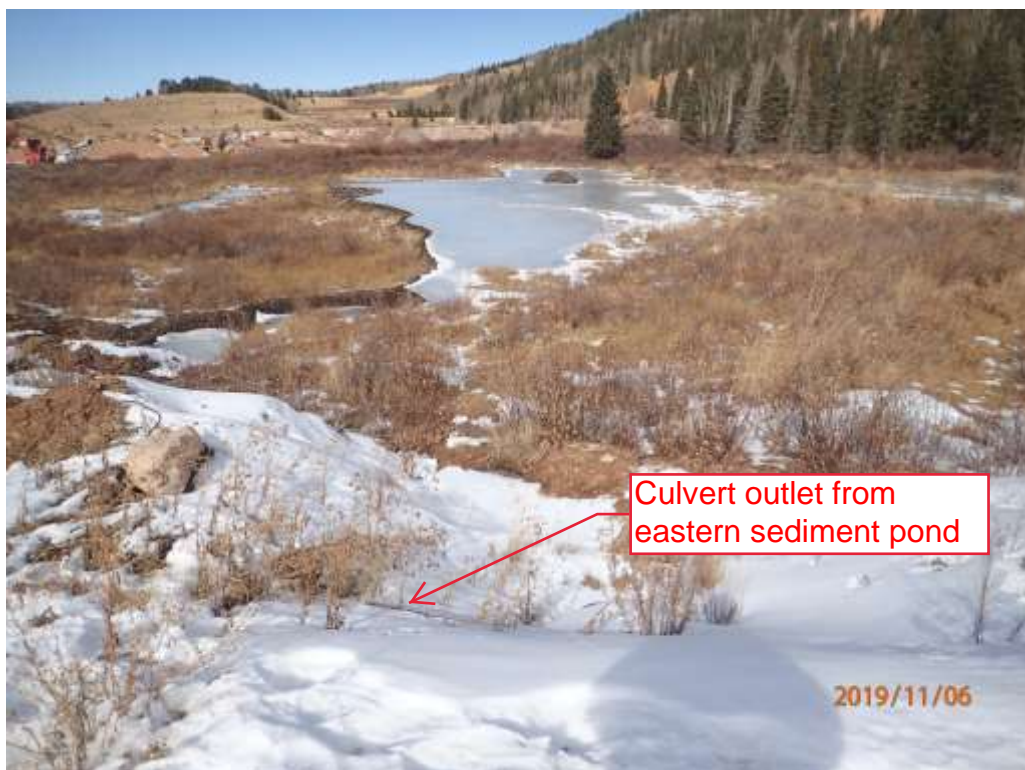
Photograph: 12 - Small tributary stream with wetlands and beaver dams that receives discharge from the eastern sediment pond
