**PERMIT INFORMATION**

<b>Permit Number:</b> C-1981-014 <b>Mine Name:</b> Southfield Mine <b>Operator:</b> Energy Fuels Coal, Inc. <b>Operator Address:</b> Mr John Adams P.O. Box 773457 Steamboat Springs, CO 80477	<b>County:</b> Fremont <b>Operation Type:</b> Underground <b>Permit Status:</b> Revoked <b>Ownership:</b> Private
	<b>Operator Representative Present:</b>  None
<b>Operator Representative Signature:</b> (Field Issuance Only)

<b>Inspection Start Date:</b> December 23, 2019 <b>Inspection Start Time:</b> 09:00 <b>Inspection End Date:</b> <b>Inspection End Time:</b>		<b>Inspection Type:</b> Coal Complete Inspection <b>Inspection Reason:</b> Normal I&E Program <b>Weather:</b> Cloudy	
<b>Joint Inspection Agency:</b>  None		<b>Joint Inspection Contacts:</b>  None	
<b>Post Inspection Agency:</b>  None		<b>Post Inspection Contacts:</b>  None	
<b>Inspector(s):</b>  Zach Trujillo	<b>Inspector's Signature:</b>

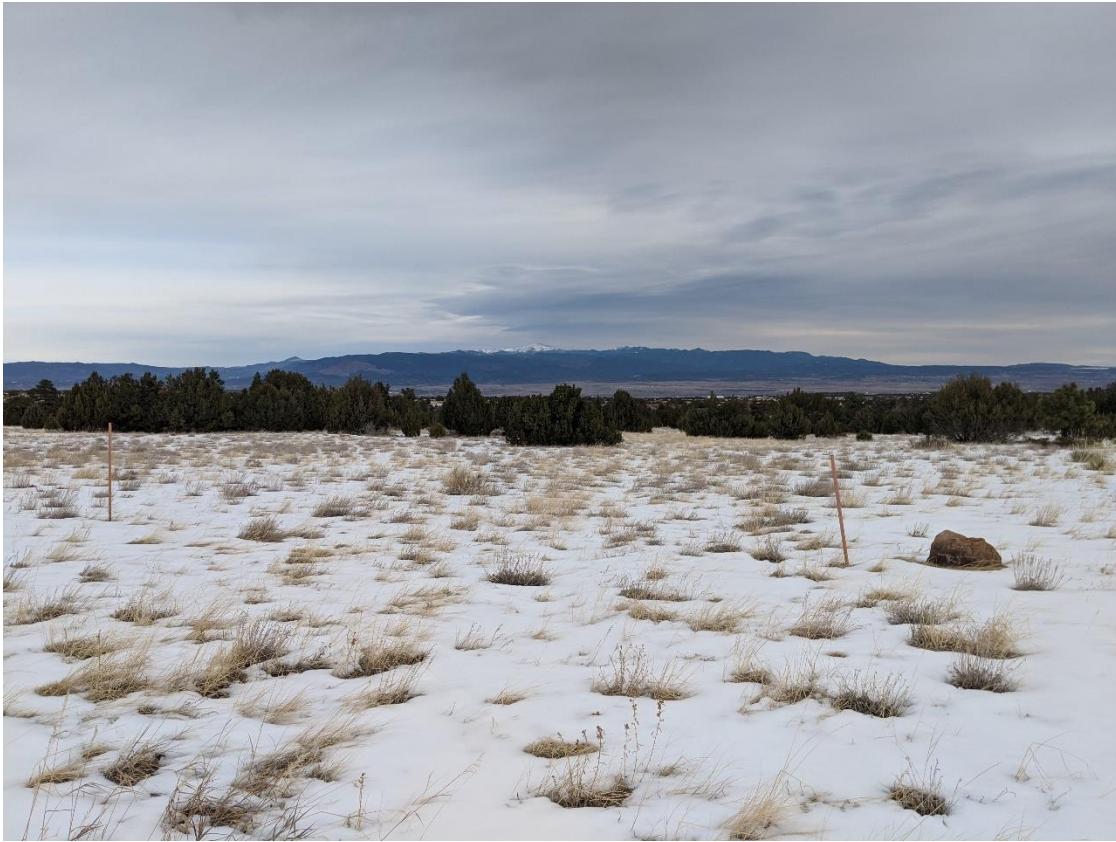
The Road Spur remains stable with good vegetation. Vegetation can be seen established through the snow cover. The two track was snow covered but noticeable vegetation was observed.

Road spur.
