**MINERALS PROGRAM INSPECTION REPORT**  
**PHONE: (303) 866-3567**

<b>MINE NAME:</b> Robinson Sons Gravel Pit No.1	<b>MINE/PROSPECTING ID#:</b> M2008-076	<b>MINERAL:</b> Sand and Gravel	<b>COUNTY:</b> Las Animas
<b>INSPECTION TYPE:</b> Aerial Inspection	<b>INSPECTOR(S):</b> Patrick Lennberg	<b>INSP. DATE:</b> January 24, 2020	<b>INSP. TIME:</b> 11:30
<b>OPERATOR:</b> Robinson Sons Inc.	<b>OPERATOR REPRESENTATIVE:</b> None	<b>TYPE OF OPERATION:</b> 112c - Construction Regular Operation	
<b>REASON FOR INSPECTION:</b> Priority	<b>BOND CALCULATION TYPE:</b> None	<b>BOND AMOUNT:</b> \$52,815.00	
<b>DATE OF COMPLAINT:</b> NA	<b>POST INSP. CONTACTS:</b> None	<b>JOINT INSP. AGENCY:</b> None	
<b>WEATHER:</b> Clear	<b>INSPECTOR'S SIGNATURE:</b>

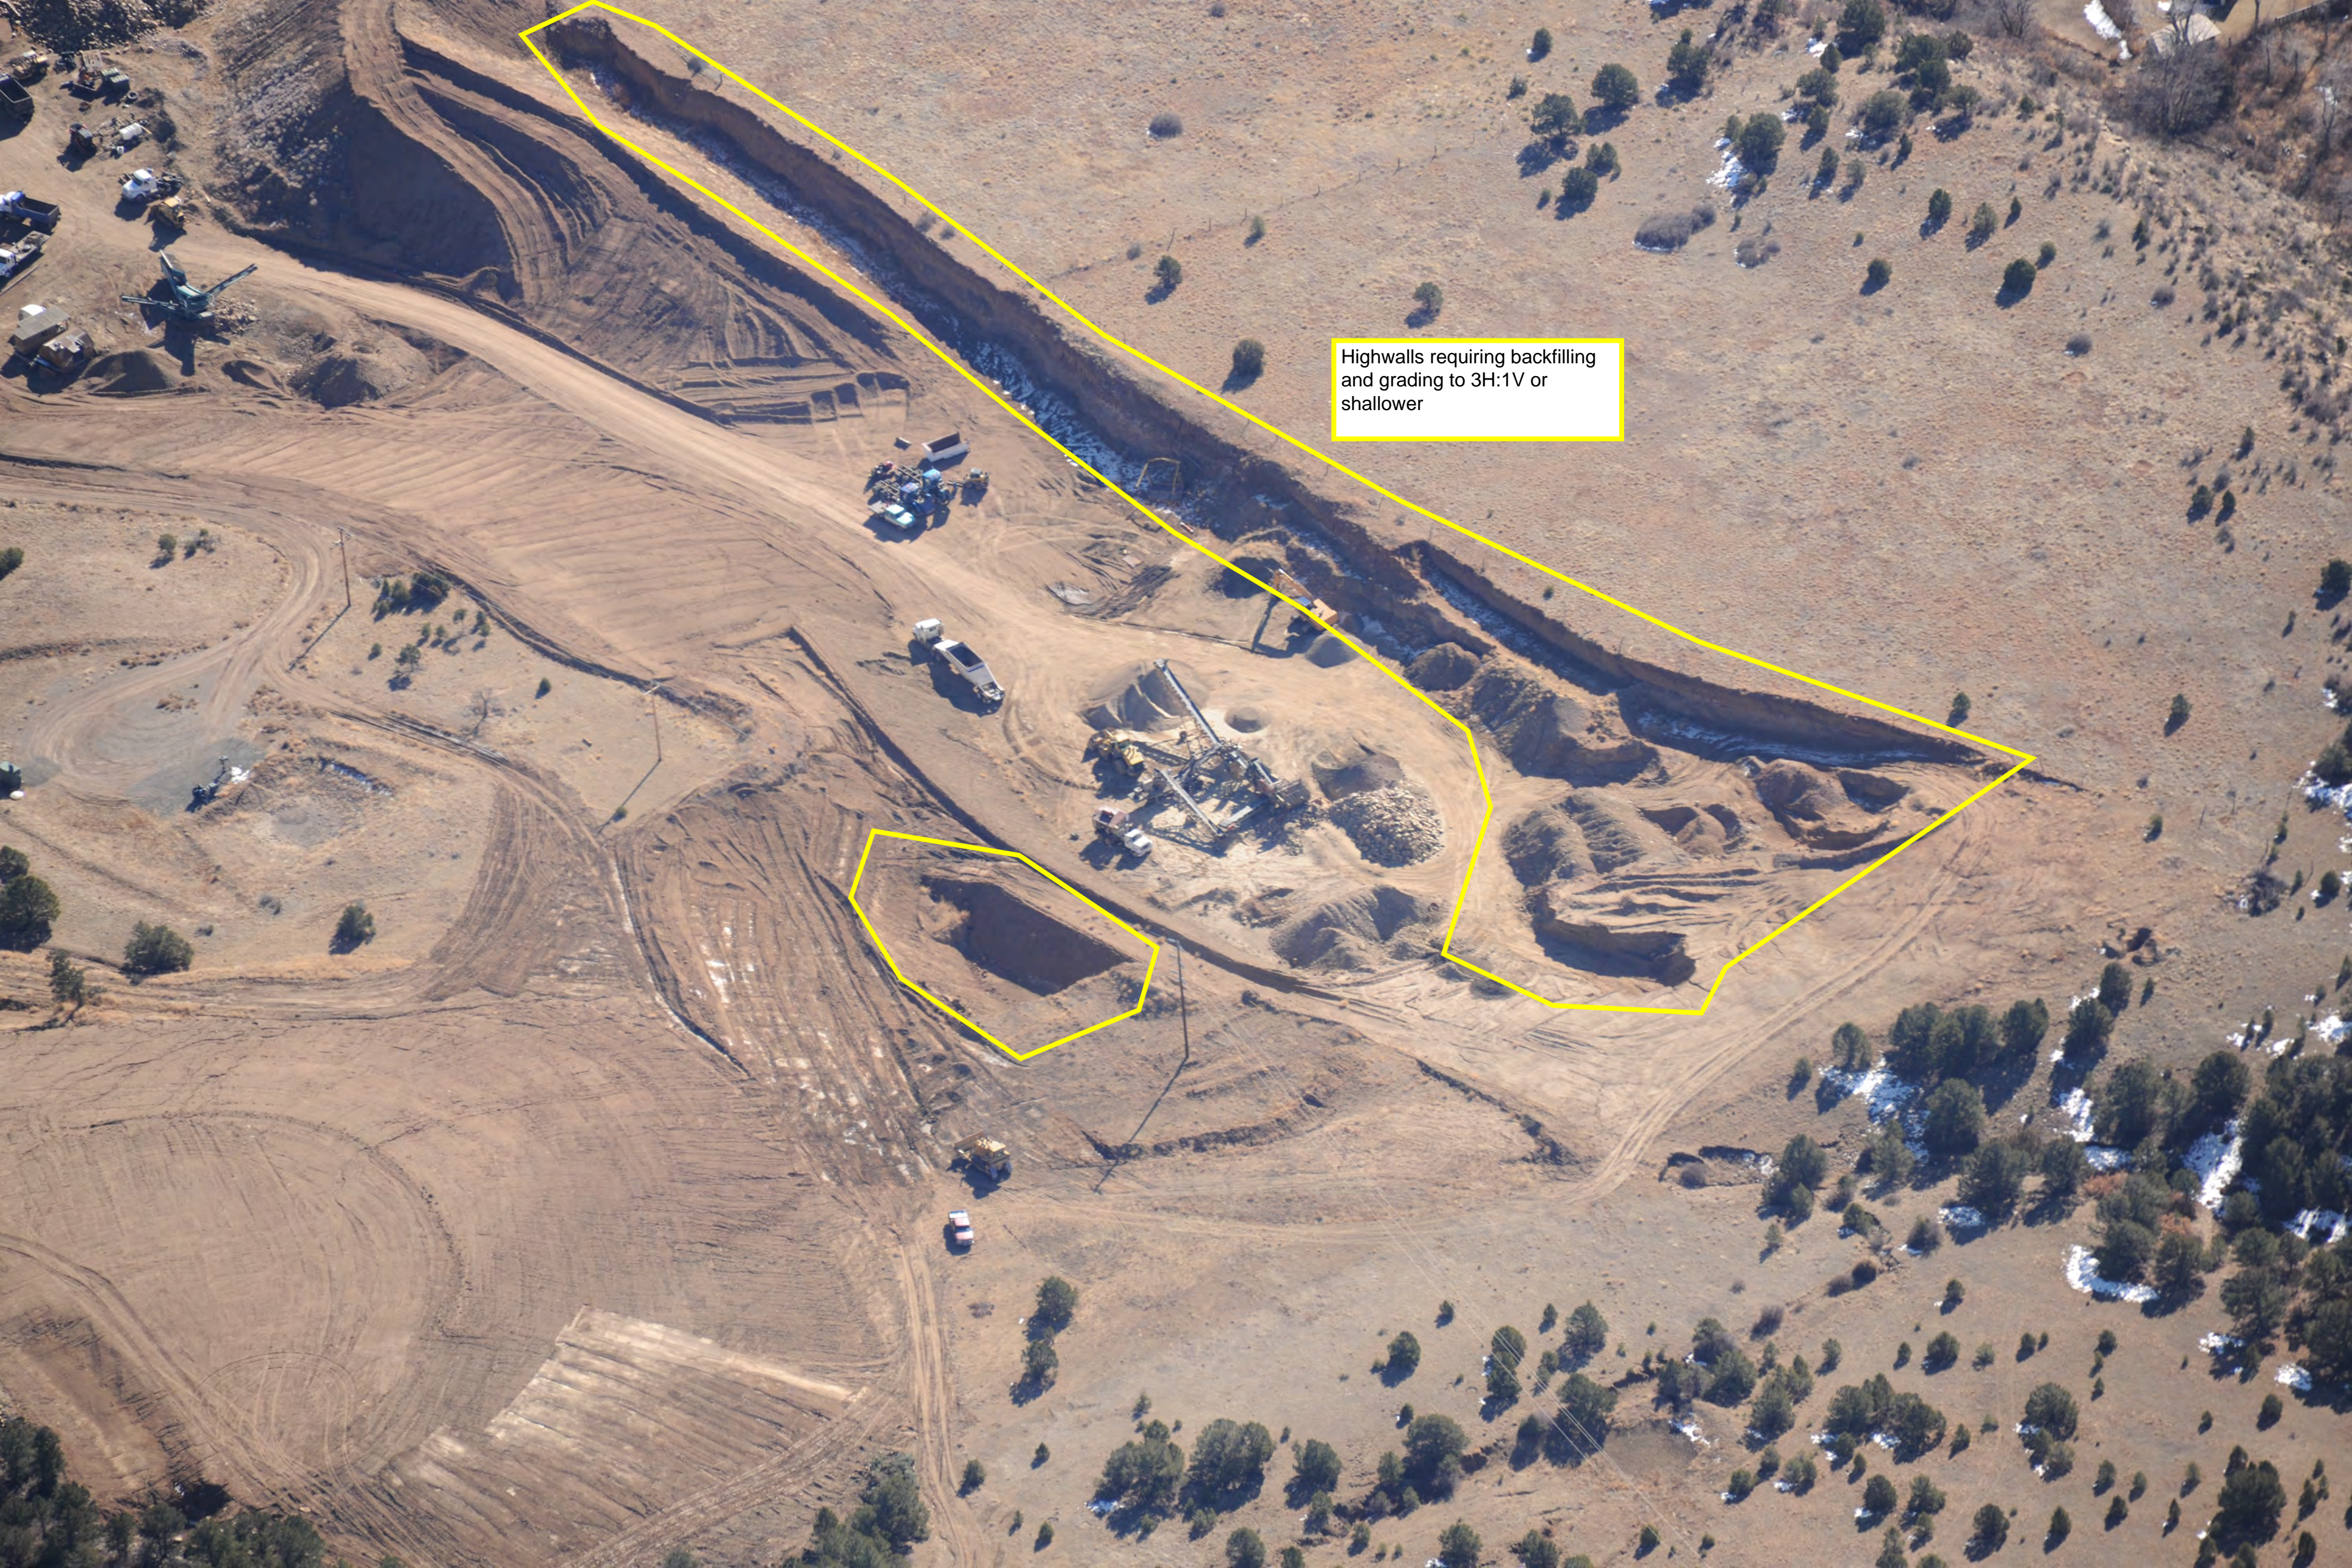
Highwalls requiring backfilling  
and grading to 3H:1V or  
shallower

Based on the recent aerial photographs taken the Operator has begun to grade the slopes and highwalls of the large rectangular pit to 3H:1V or shallower. However, there is still a large portion of the highwall along the southern border that still needs to be backfilled. A large basin has been created during reclamation efforts to the east of the rectangular pit. The Operator was told by the Division in September that this basin cannot remain and the natural drainage needs to be reestablished.

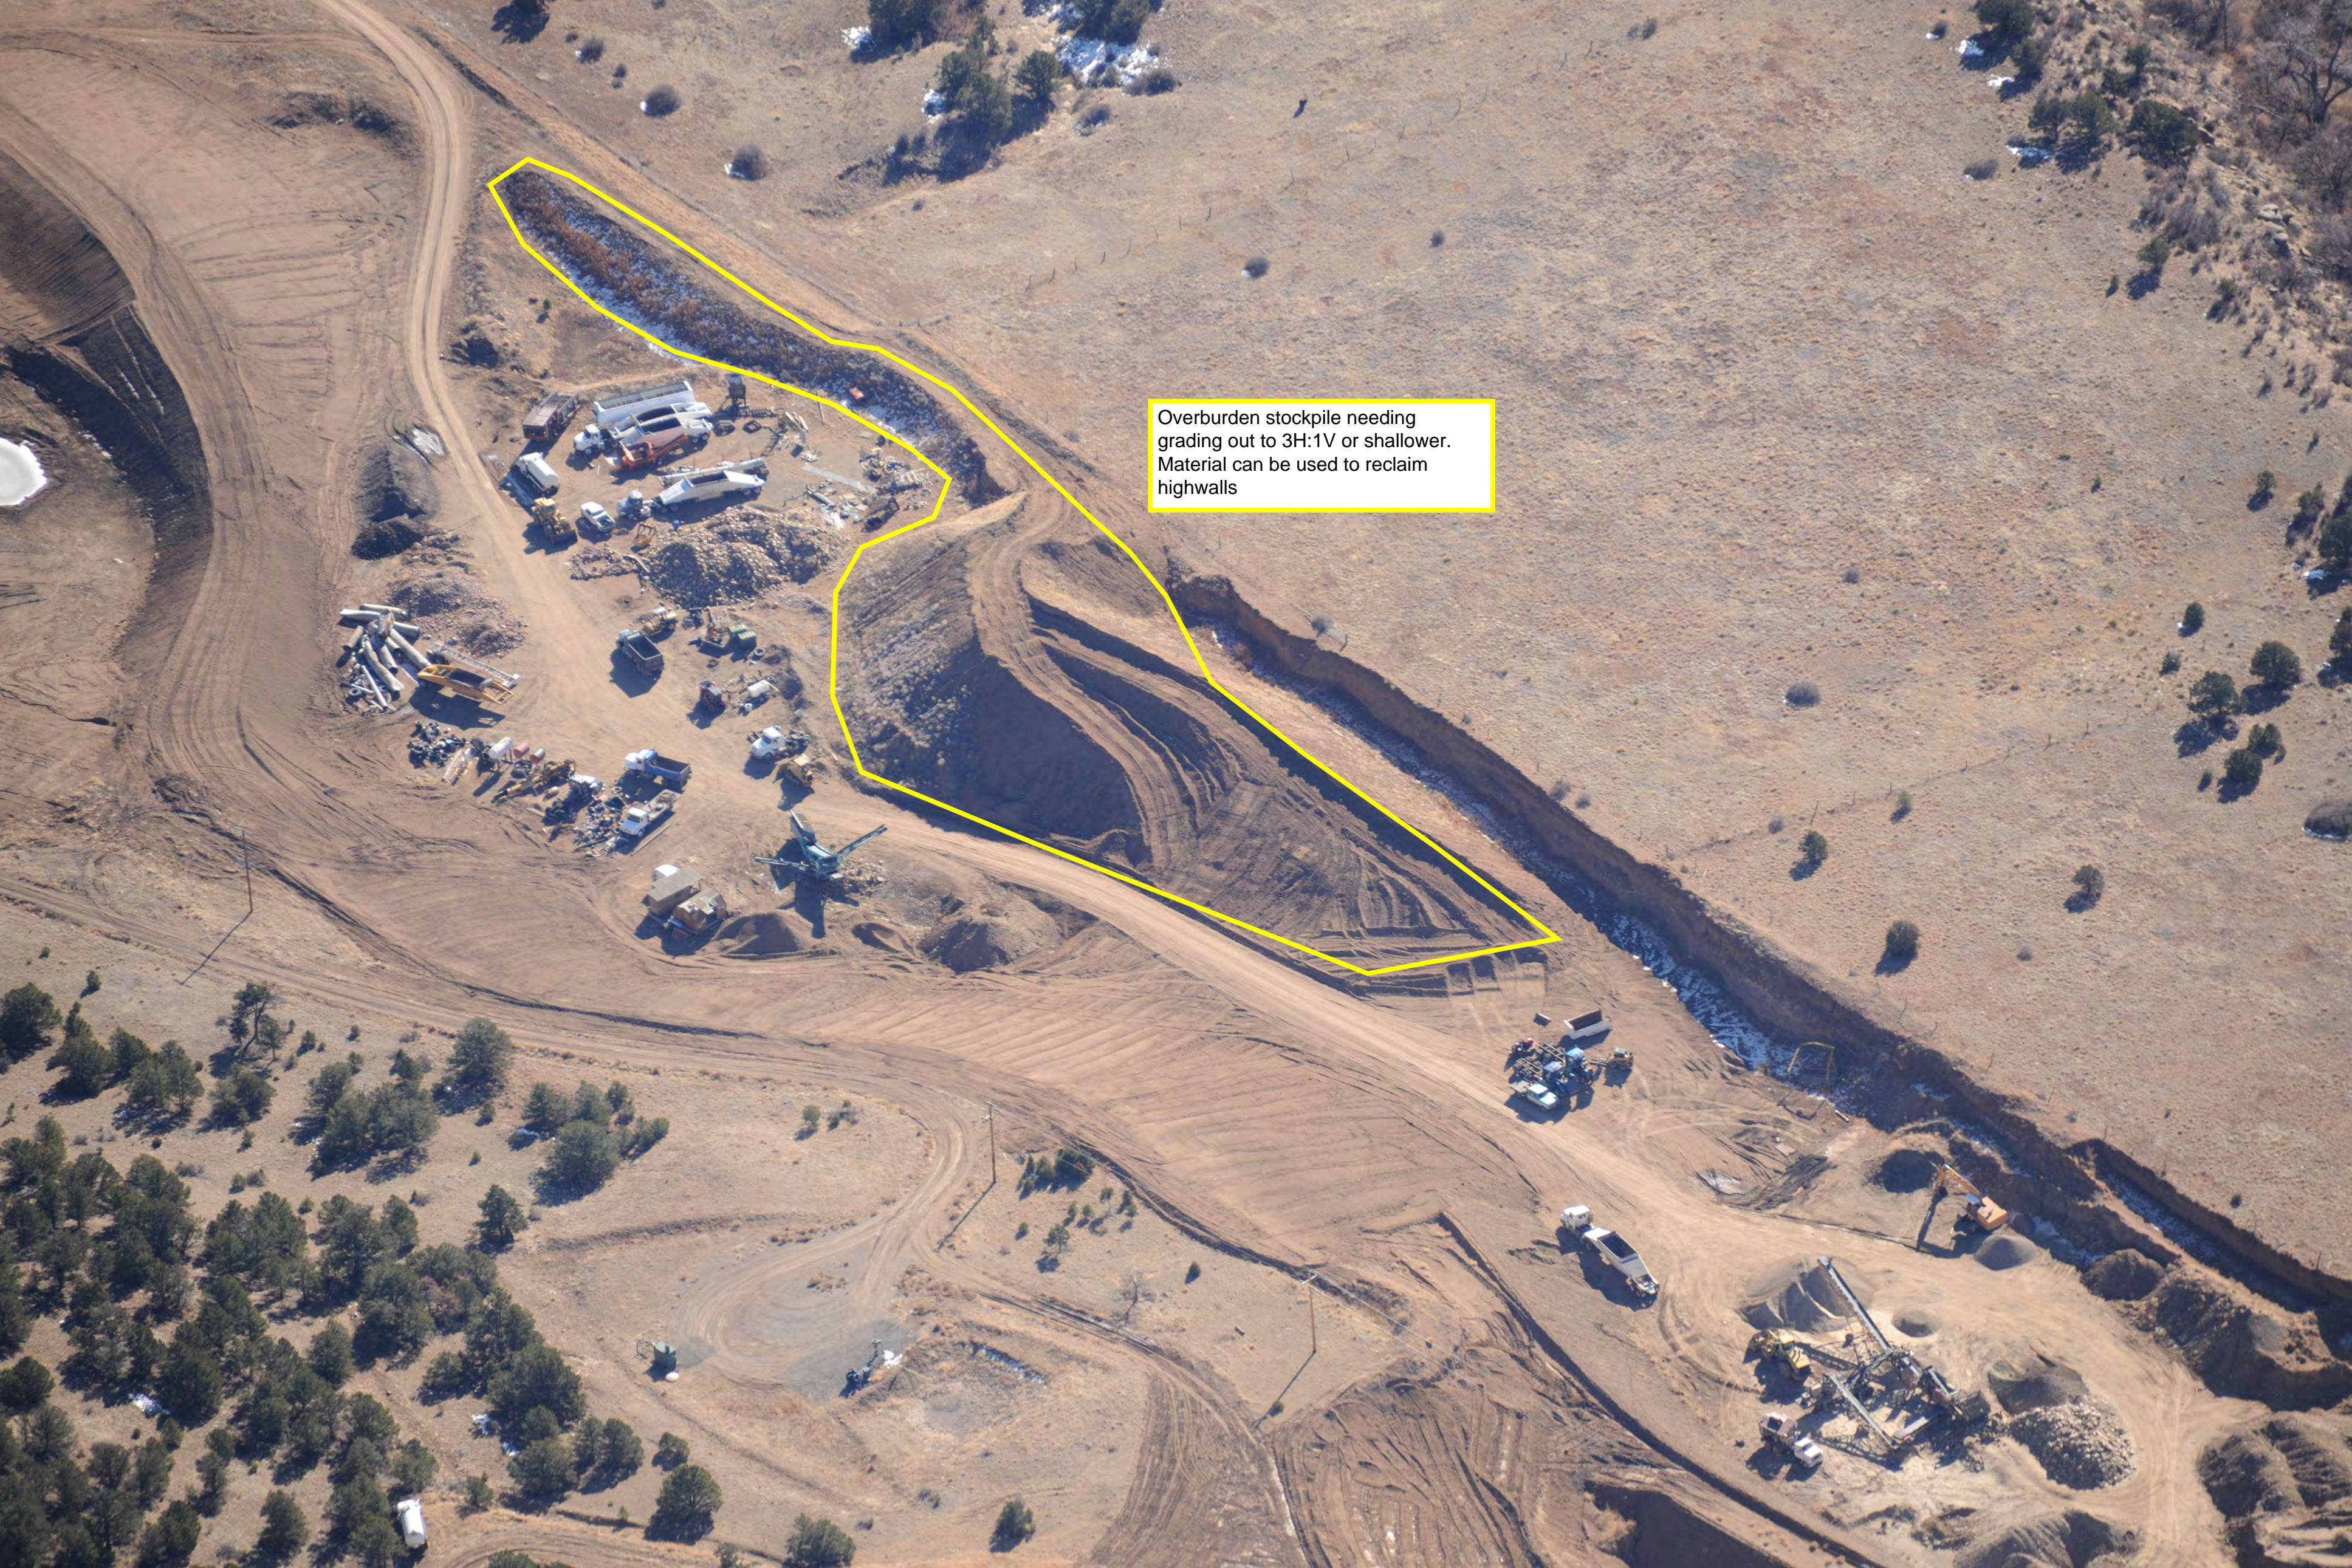
Overburden stockpile needing  
grading out to 3H:1V or shallower.  
Material can be used to reclaim  
highwalls

Area that is impounding water that is not permitted to do so. Needs to be connected to the drainage downgradient. Side slopes require additional grading to achieve 3H:1V slope

Downgradient drainage

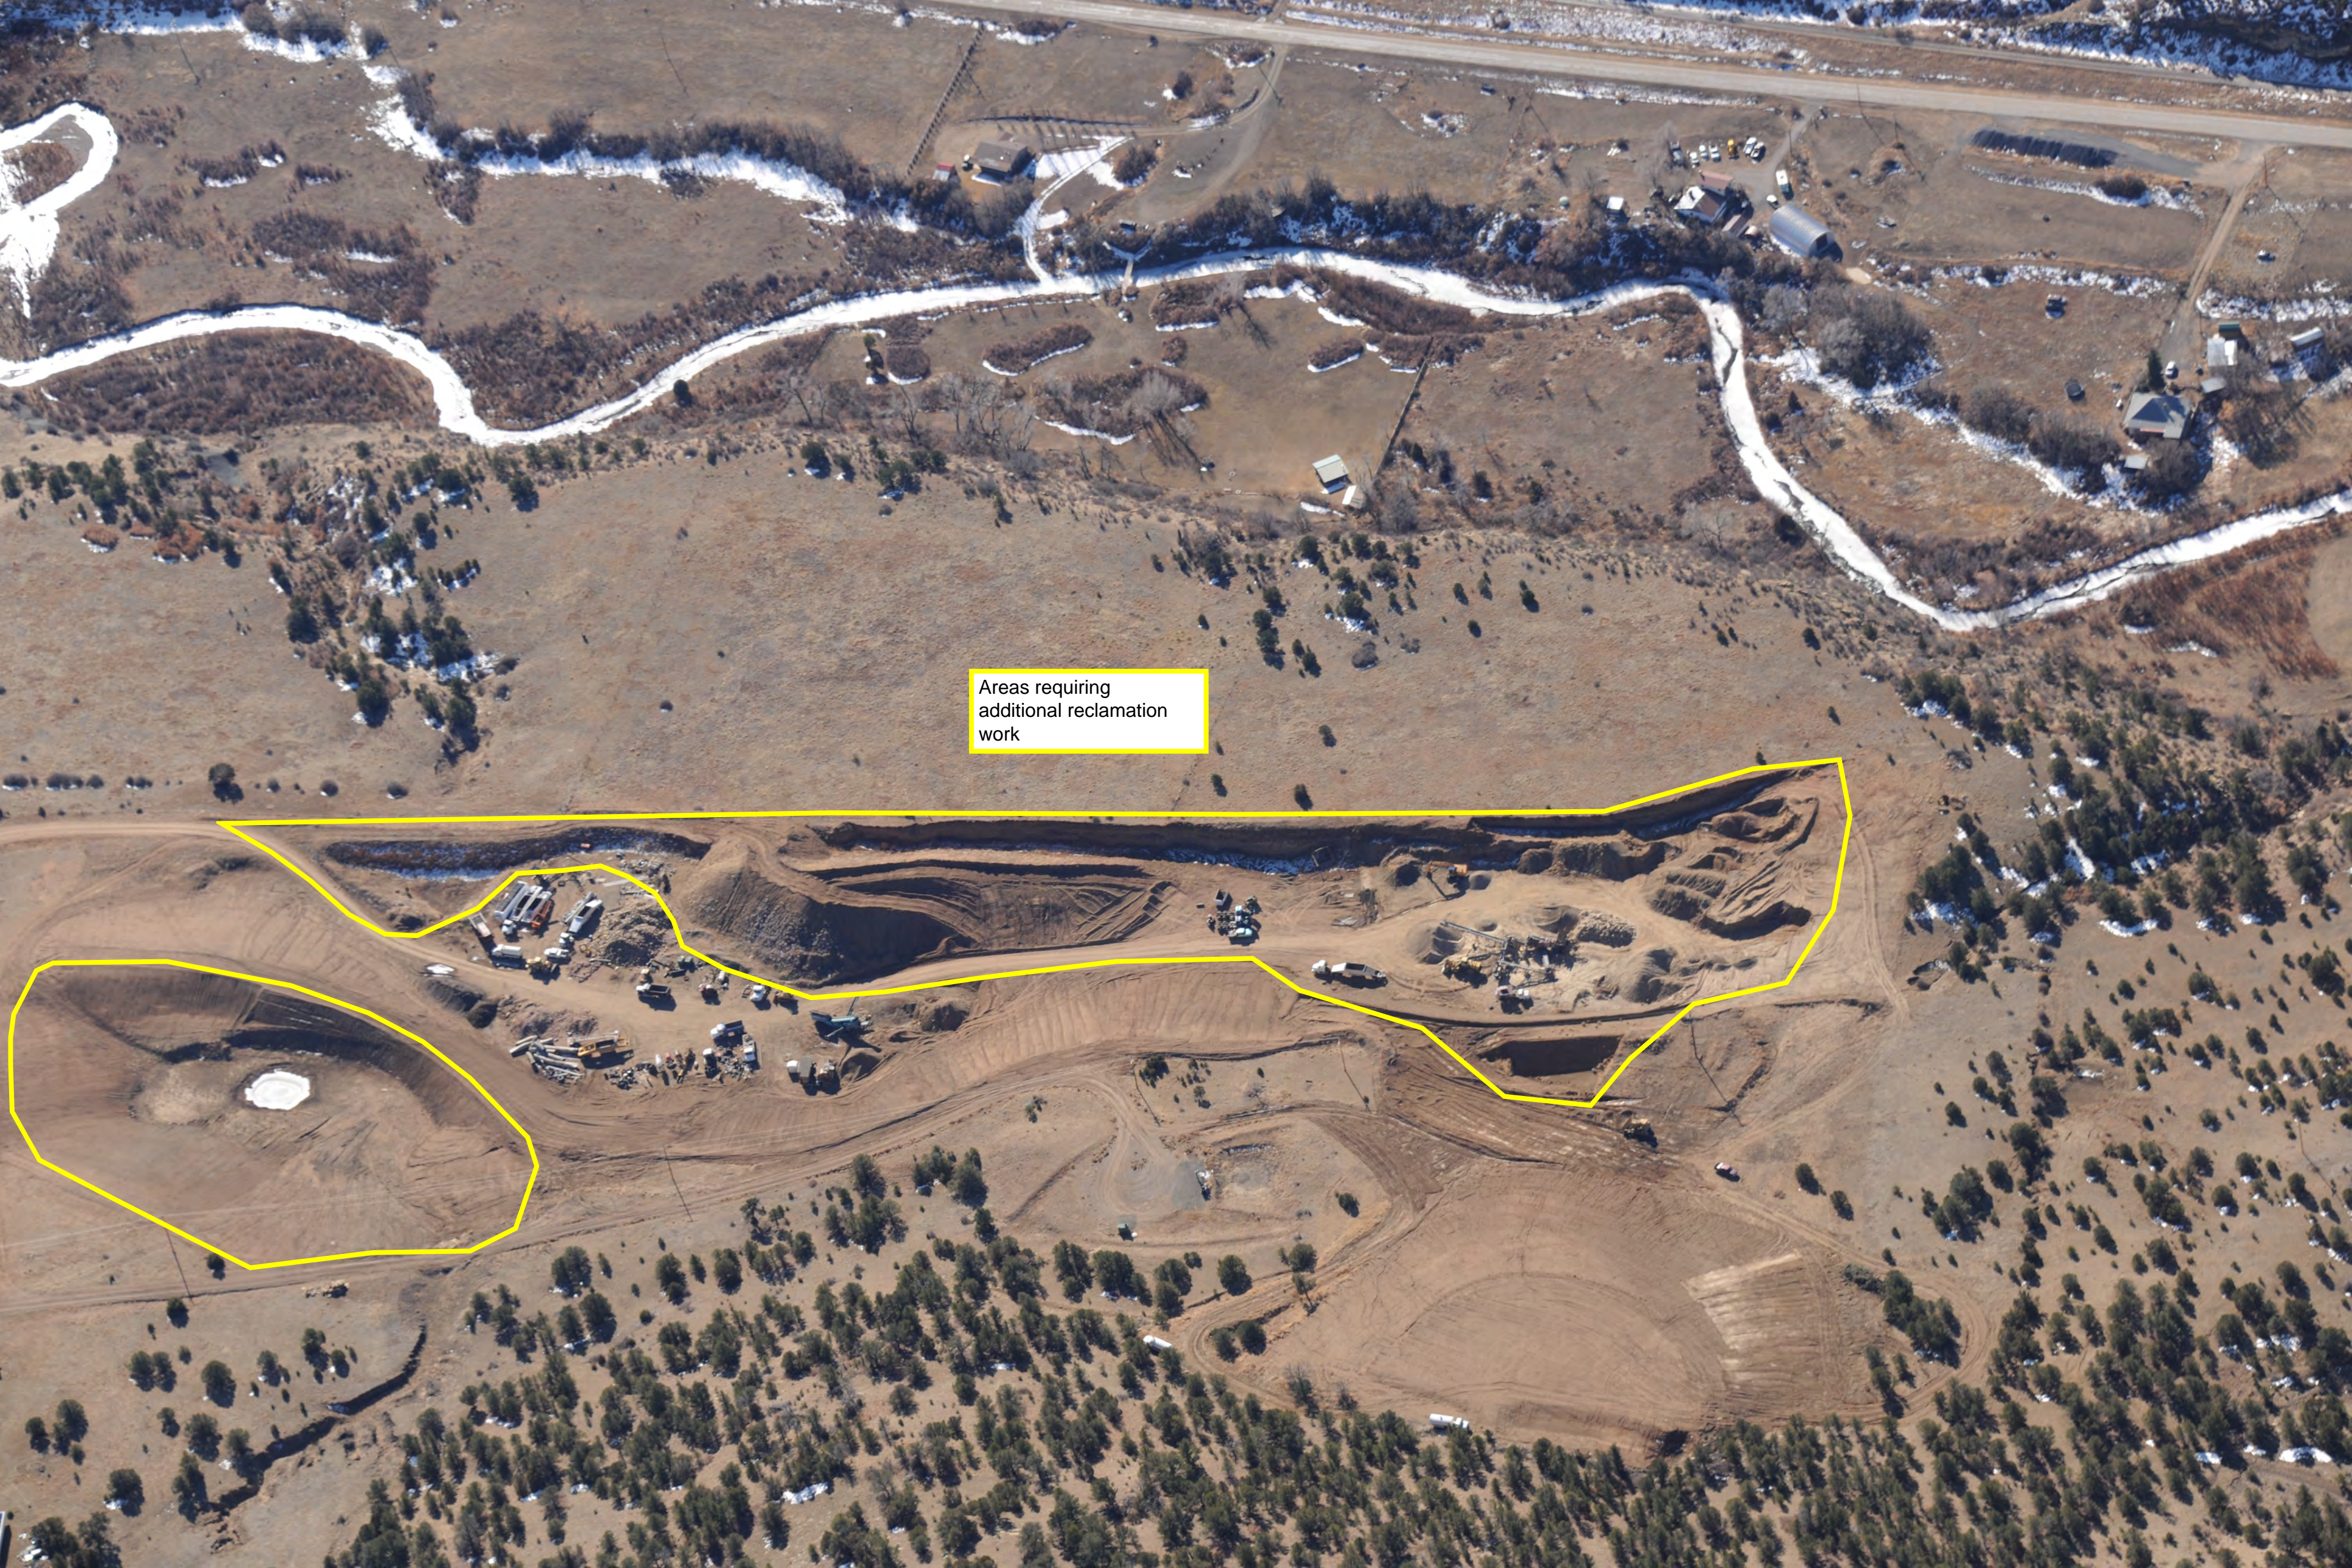
Areas requiring  
additional reclamation  
work

Based on the Division's estimate, the Operator will need to continue to work on reclamation efforts to complete the majority of the required earthwork at the site (backfilling, grading and topsoiling) to reduce the reclamation liability at the site sufficiently for the current \$52,815.00 bond to be adequate.
