COLORADO
Division of Reclamation,
Mining and Safety
Department of Natural Resources

Permit Number: C-1981-019 Mine Name: Colowyo Coal Mine Operator: Colowyo Coal Company L.P. Operator Address: Mr Tony Tennyson 5731 State Highway 13 Meeker, CO 81641	County: Moffat, Rio Blanco Operation Type: Surface Permit Status: Active Ownership: Private
Operator Representative Present: Tony Tennyson and Tom Fry	
Operator Representative Signature: (Field Issuance Only)

Inspection Start Date: March 10, 2020 Inspection Start Time: 07:30 Inspection End Date: March 10, 2020 Inspection End Time: 13:00		Inspection Type: Coal Complete Inspection Inspection Reason: Normal I&E Program Weather: Snowing	
Joint Inspection Agency: None		Joint Inspection Contacts: None	
Post Inspection Agency: None		Post Inspection Contacts: None	
Inspector(s): Zach Trujillo Robin Reilley, GISP	Inspector's Signature:

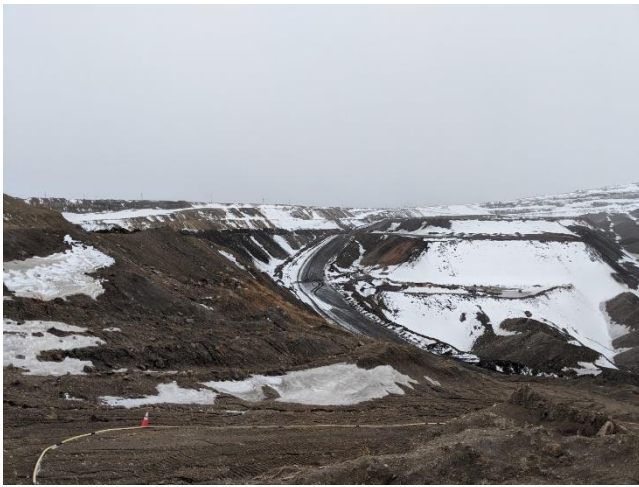
Backfilling operations during the winter months is being conducted within the South Taylor Pit. As the pit progresses to the west, spoil is being moved to the east of the active mining area by dragline and truck and shovel operations.

South Taylor Pit – east end.

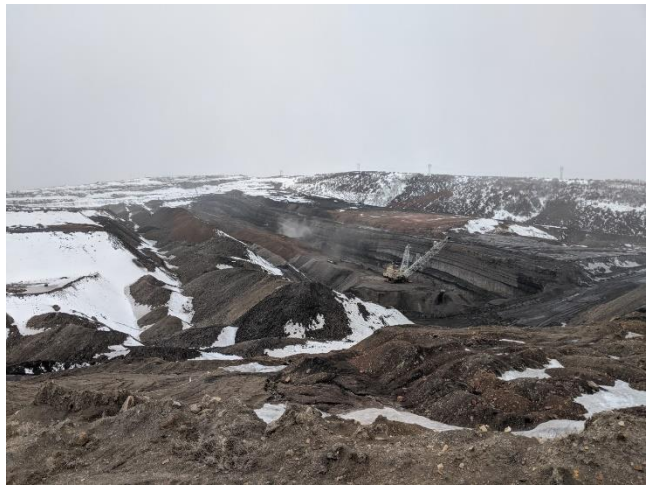
South Taylor Pit – west end.

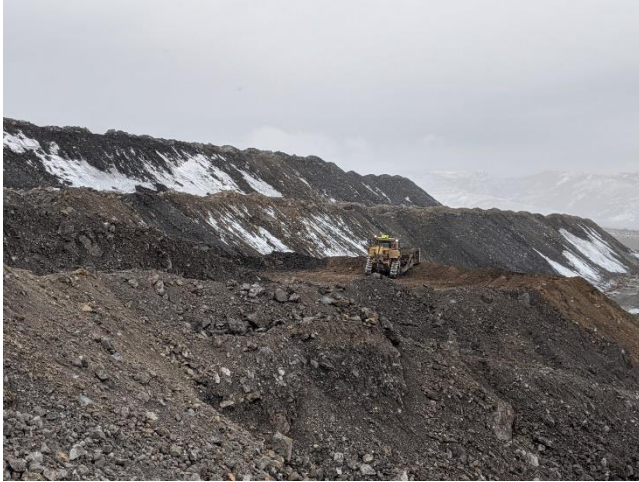
Spoil placement continues along the Collom Temporary Spoil Pile. Spoil is being staged by dozing operations where it is then being loaded and transported by dump truck from the active mining sections of the Collom Pit, south of the excess spoil pile.

Collom Temporary Spoil Pile.

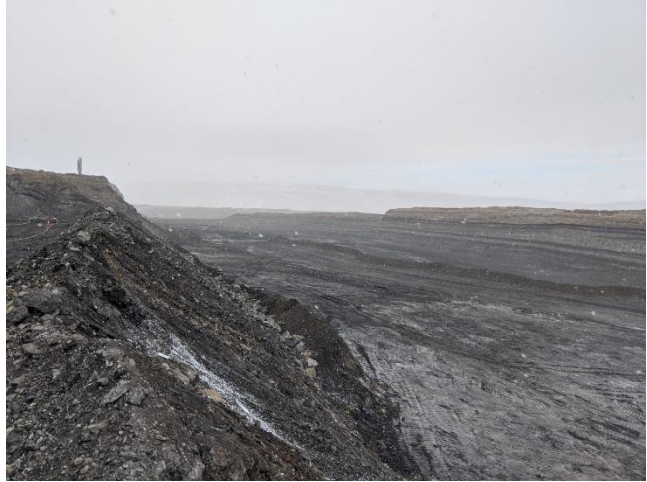
Collom Pit.

Drilling operations for a future blast was occurring at the Collom Pit. No blast occurred during the Division's inspection.

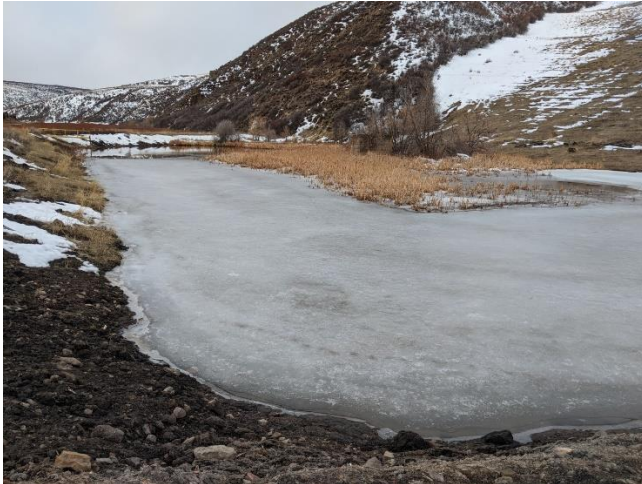
The Streeter Pond and Prospect bonds both held water. The Streeter Pond was discharging and had a discharge flow of 0.2 on the flume measurement. The Prospect Pond was not discharging at the time of the inspection. Both ponds were stable and no issues were observed.

Streeter Pond.

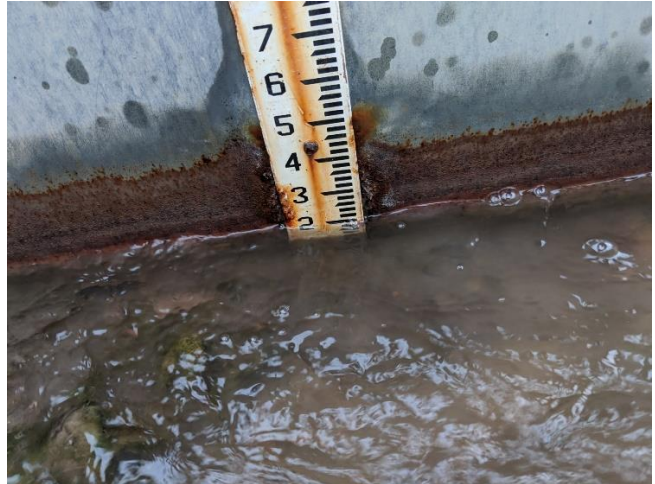
Streeter Pond flume measurement.

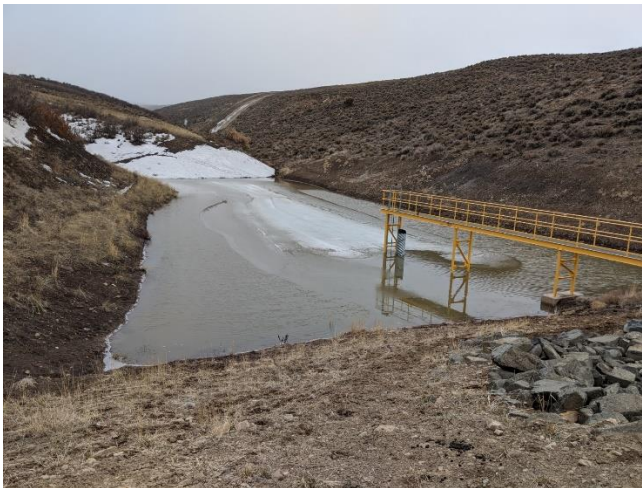
The Section 36, Middle, and Section 25 Ponds run in series and the disturbance from the facilities and pit area report to. Each pond held water and was discharging at the time of the inspection. The ponds were stable and functional.

Section 25 Pond.

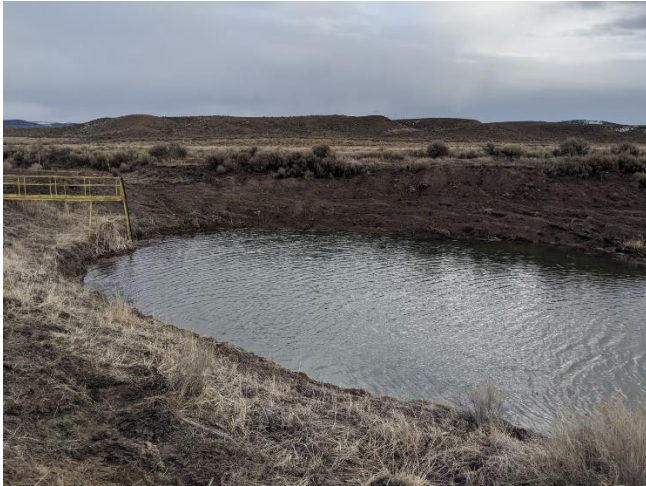
The Stoker Pond was discharging at the time of the inspection. Maintenance cleaning was conducted in the fall of 2019 however additional maintenance is scheduled for 2020 when weather permits. The pond remains functional with no issues observed. The temporary access road to the pond remains open and functional as well.

Stoker Pond.

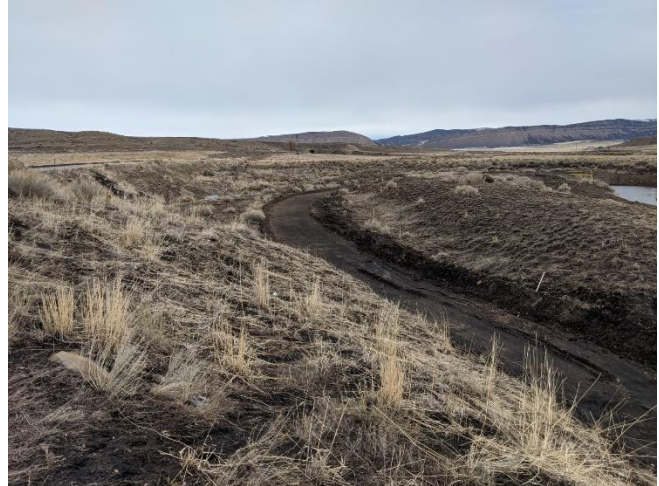
Stoker temporary maintenance road.

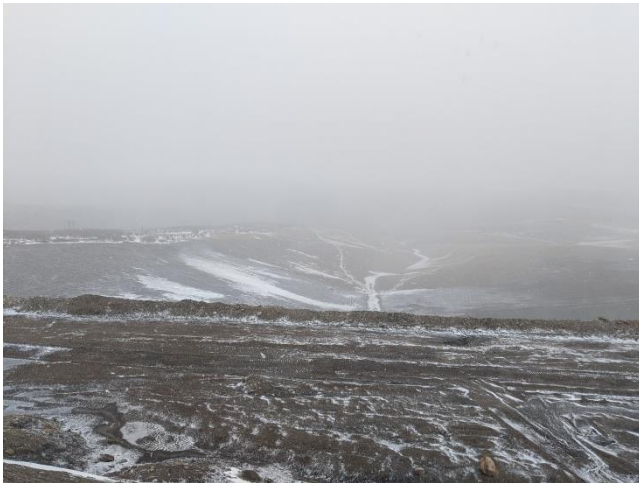
The regrade and reclaimed slopes of the East and West Pit remain stable.

West Pit Reclamation.

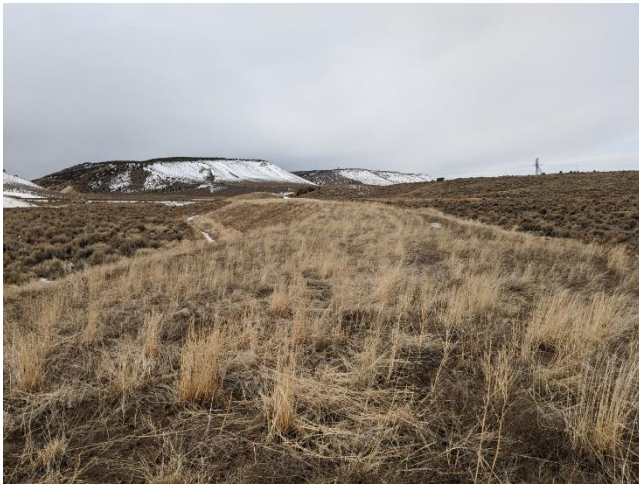
All topsoil piles inspected were stable and well vegetated. Each pile was marked with a sign for designation.

Topsoil Pile 21D.
