**RE: Colowyo Coal Company L.P.  
Permit No. C-1981-019  
2020 Annual Rill and Gully Report**

2020 Rill and Gully Report

# COLOWYO COAL COMPANY

MAP 1  
RILL AND GULLY AREAS

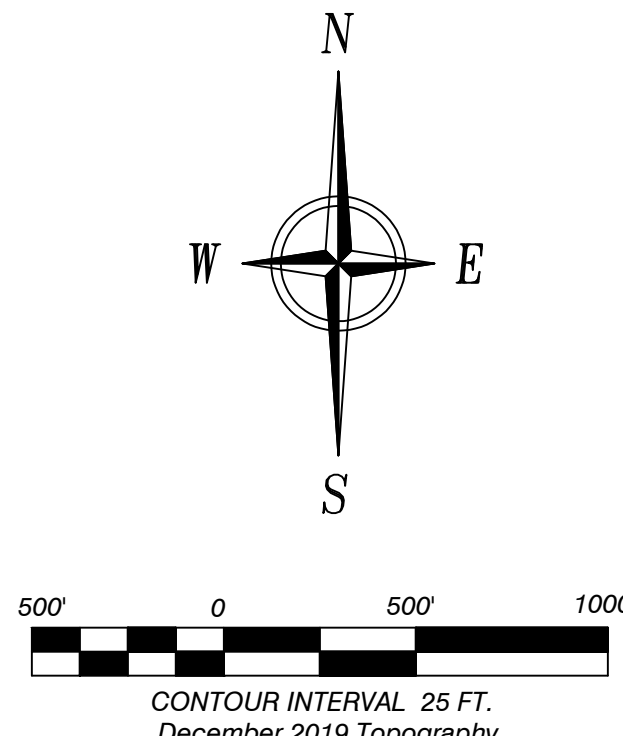
In 2020, three areas have been identified for the repair of rilling and/or gullies. Please see Map 1 for location of identified rills and gullies. Actual locations are not shown due to the small size of the identified rills and gullies.

Area 1 is located in reclamation block WP031 on the west side of the Taylor Tributary Ditch. The rilling area identified was repaired with a backhoe in May of the year.

Area 2 is on a cut slope above the Collom Haul Road to the south of the Wilson Storage Pond within N ½ of T4N, R93W, Section 21. The rill will be repaired with a dozer or backhoe.

Area 3 is on the outslope of the Collom Haul Road in NE ¼ of T4N, R93W, Section 30. The area will be repaired with a dozer or a trackhoe and reseeded accordingly.

As noted in Volume 1, Section 4.14.6 in Permit No. C-1981-019, all areas will be repaired within three months of being identified. As noted above the rills in Area 1 have already been repaired. The remaining two areas will be repaired by August 31, 2020.
