SL-2 OSMRE Inspection Report

Elk Creek SL-2 OSMRE Inspection Report 7-7-2020 signed.pdf

Mine Site Inspection

Inspection Type: SL-2 Phase I & II Bond Release Inspection

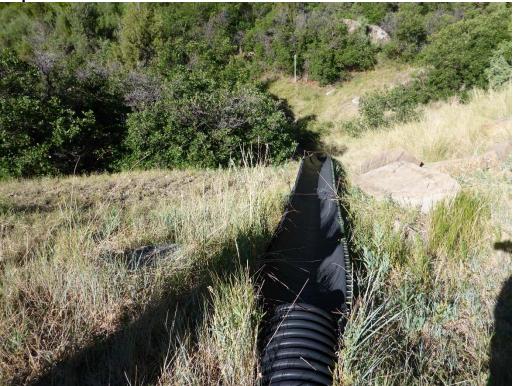
The Hubbard Creek Fan pad drop outlet has a plastic liner which is approved to remain, per page 2.05-65 of the PAP, and Map 2.05-M6 (sheet 6 of 7). Pad area is well vegetated.

Photo 1: Ditch liner on reclaimed Hubbard Creek Fan pad.

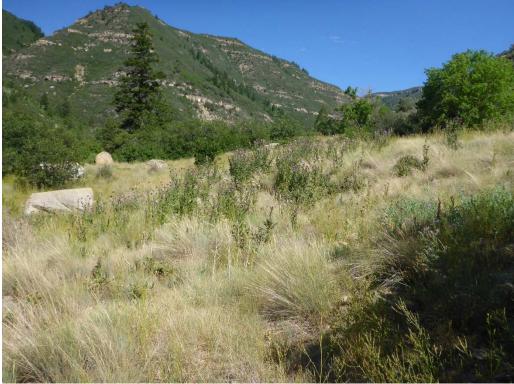
Photo 2: Typical thistle patch, weed control necessary in multiple locations.

- Weed control (primarily thistle) required at multiple reclaimed GVB pad and road locations.
- The principal and emergency spillways in Ponds F and E should be removed, and the embankments breached to preclude water retention after DRMS approval under Rules 4.05.6(7) and 4.05.2(2).

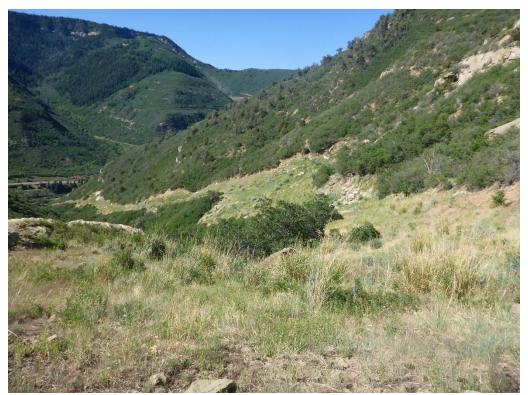
Photo 3: Steep slope reclamation stable and well-vegetated.

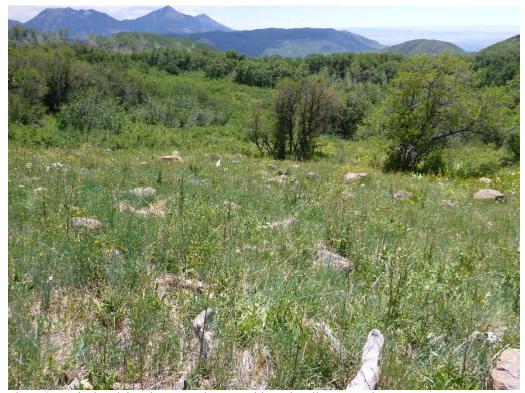
Photo 4: Typical reclaimed GVB pad area, stable and well-vegetated.

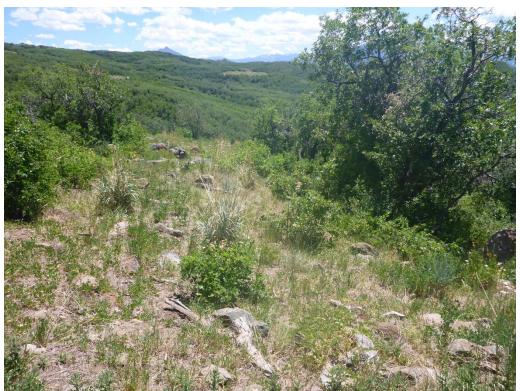
All observed areas were reclaimed according to plan. Roads are reclaimed or retained consistently with approved maps indicating landowner requests. Reclaimed roads were frequently littered with rocks or felled trees to discourage public vehicle (car, truck, or ATV) access and to help stabilize the ground surface. Reclaimed gob vent borehole (GVB) pads are stable and well-vegetated. Generally, more recently reclaimed pads were dominated by grass species while older reclamation exhibited greater diversity of grasses, forbs, and woody perennial species. This is typical of reclamation revegetation patterns. Prominently noted

Photo 5: Typical reclaimed road corridor, stable and well-vegetated.
