Subject: Summary of Instrumentation Monitoring
2nd Quarter 2020
Bowie Coal Waste Disposal Area No. 3
Paonia, Colorado

**SUBJECT: Summary Report, 2nd Quarter 2020, Vibrating Wire Piezometers
April – June 2020, Bowie Mine #2
Coal Waste Disposal Area (CWDA) #3**

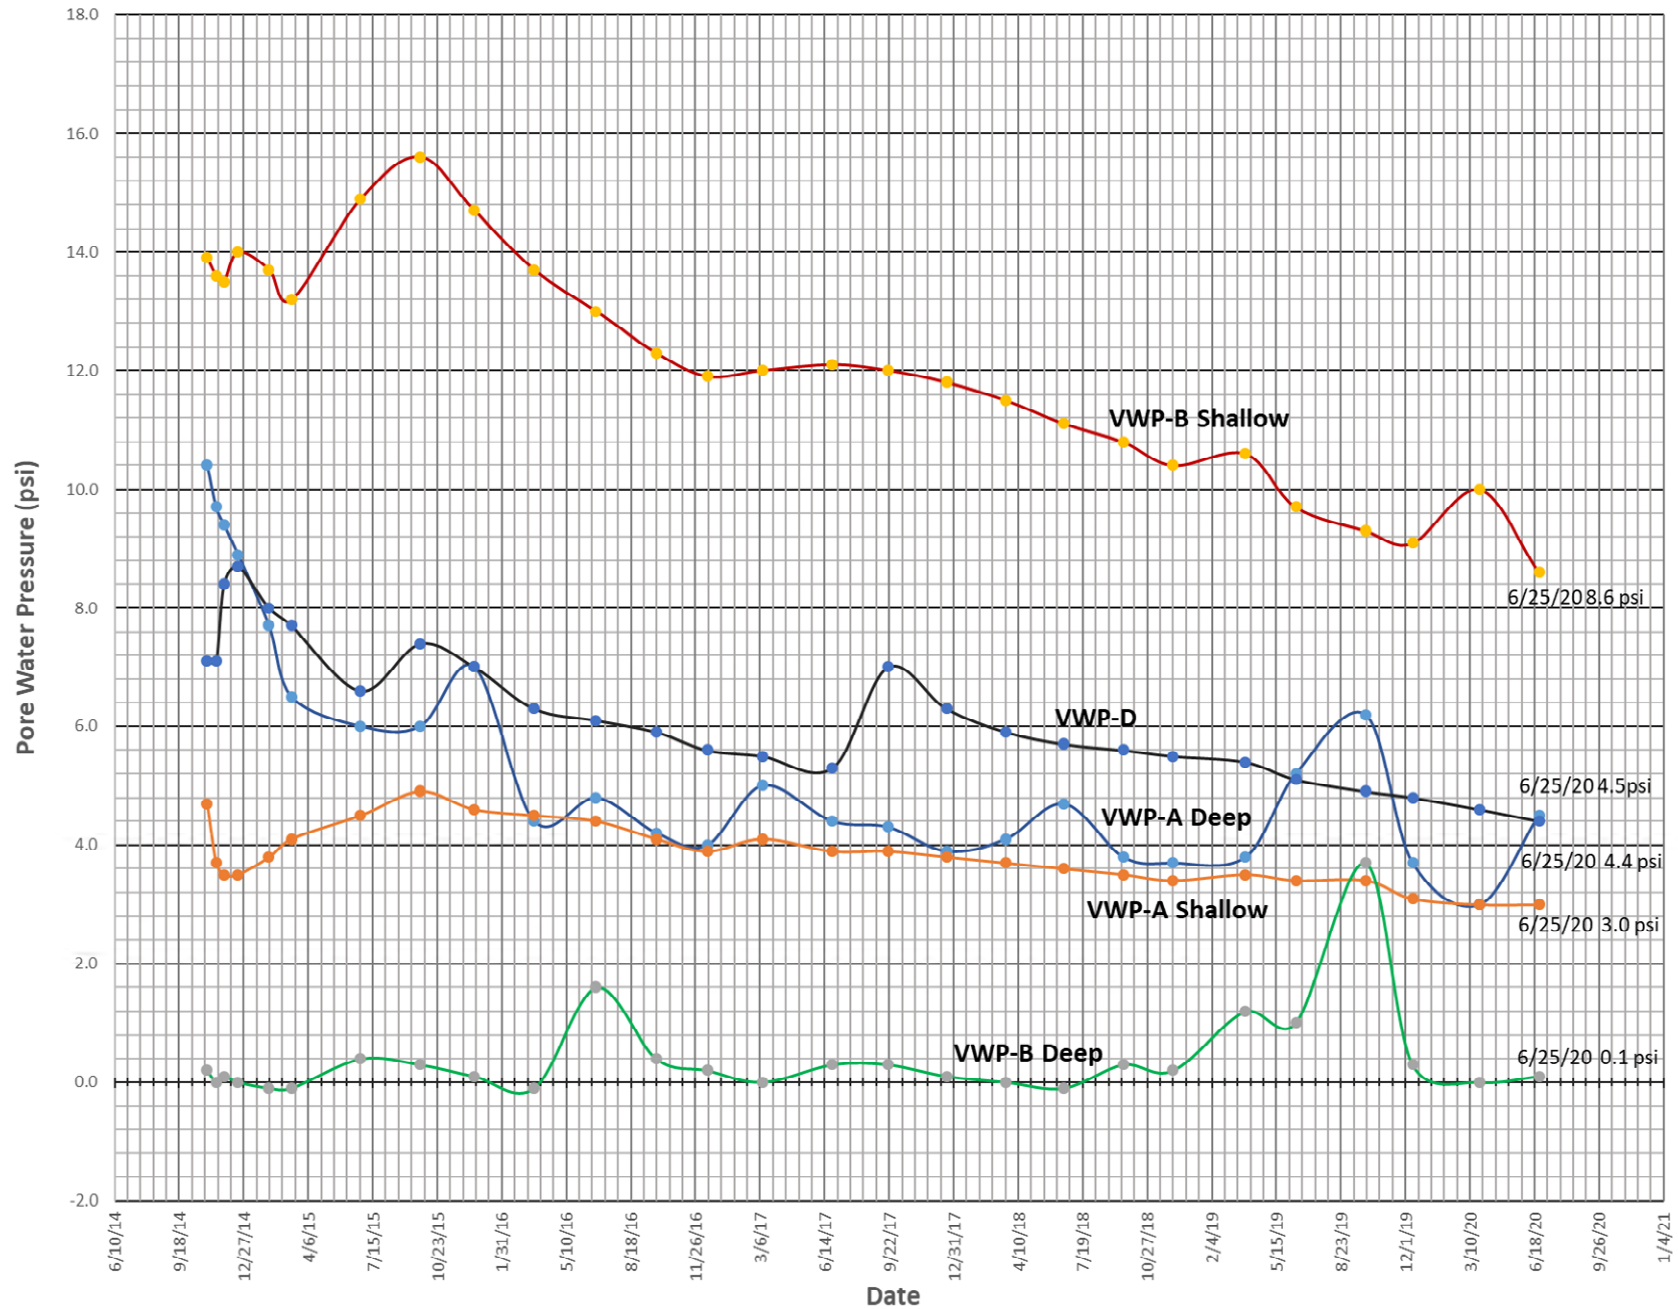
Figure 1 - Bowie Mine #2 - CWDA #3
Vibrating Wire Piezometer Data

As seen on Figure 1, when compared with the previous quarter, three of the pore pressure readings had very little change, while one (VWP-B Shallow) had a slightly sharper decline and one (VWP-A Deep) had an increase. The 2nd quarter readings appear to be nearly in-line with the typical stabilized trend for 3 of the 5 WVPs. However, two of the piezometers (VWP-A Deep and VWP-B Shallow) have more recent erratic behavior. All of the piezometers have had a decrease in pore pressure since last year (a wetter year) and since installation.

We present a graph of measured pore pressures on the attached Figure 1 and numerically in Table 1 below. Table 1 is a summary of the initial, prior and current readings. In addition, we present the difference between the current pore pressures and those at the time of installation, the previous quarter, and previous year.
