PERMIT INFORMATION

Permit Number: C-1982-056 Mine Name: Foidel Creek Mine Operator: Twentymile Coal, LLC Operator Address: Ms Miranda Kawcak 29515 Routt County Road No. 27 Oak Creek, CO 80467 County: Routt Operation Type: Underground Permit Status: Active Ownership: Private

INSPECTION INFORMATION

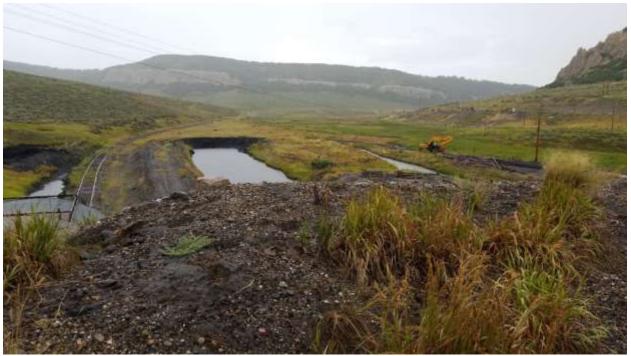
Long arm at Pond B

Culverts cleaning is ongoing, long arm used to clean ponds. Pond D is clean, B in process, E is next.

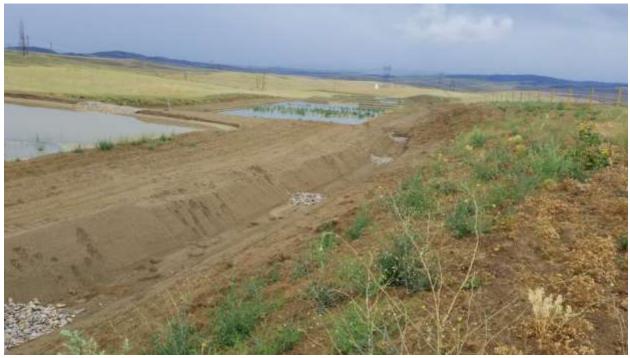
Passive treatment ponds
