**MINERALS PROGRAM INSPECTION REPORT**  
**PHONE: (303) 866-3567**

<b>MINE NAME:</b> Larson Pit	<b>MINE/PROSPECTING ID#:</b> M-2007-012	<b>MINERAL:</b> Gravel, sand and clay	<b>COUNTY:</b> Phillips
<b>INSPECTION TYPE:</b> Monitoring	<b>INSPECTOR(S):</b> Brock Bowles	<b>INSP. DATE:</b> July 15, 2020	<b>INSP. TIME:</b> 13:00
<b>OPERATOR:</b> Gregory Larson	<b>OPERATOR REPRESENTATIVE:</b> Greg Larson	<b>TYPE OF OPERATION:</b> 112c - Construction Regular Operation	
<b>REASON FOR INSPECTION:</b> Normal I&E Program	<b>BOND CALCULATION TYPE:</b>	<b>BOND AMOUNT:</b> \$28,889.00	
<b>DATE OF COMPLAINT:</b> NA	<b>POST INSP. CONTACTS:</b> None	<b>JOINT INSP. AGENCY:</b> None	
<b>WEATHER:</b> Clear	<b>INSPECTOR'S SIGNATURE:</b>

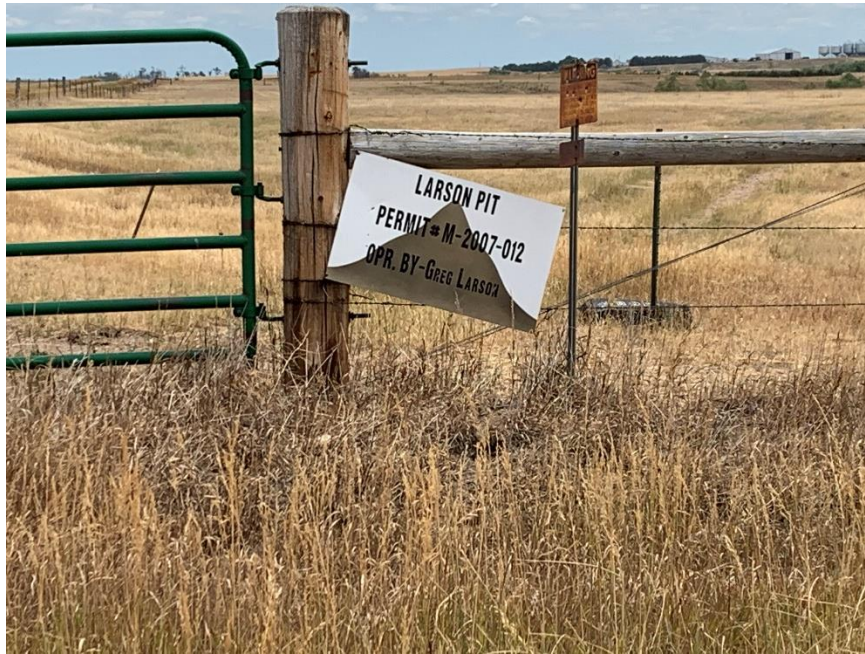
No mining activity was being conducted and no equipment was on site. The mine identification sign was in place and was legible. The permit boundary was marked with a fence on all sides. The gate was closed upon arrival and cattle were grazing in the permit area.

Mine entrance sign facing County Road 7

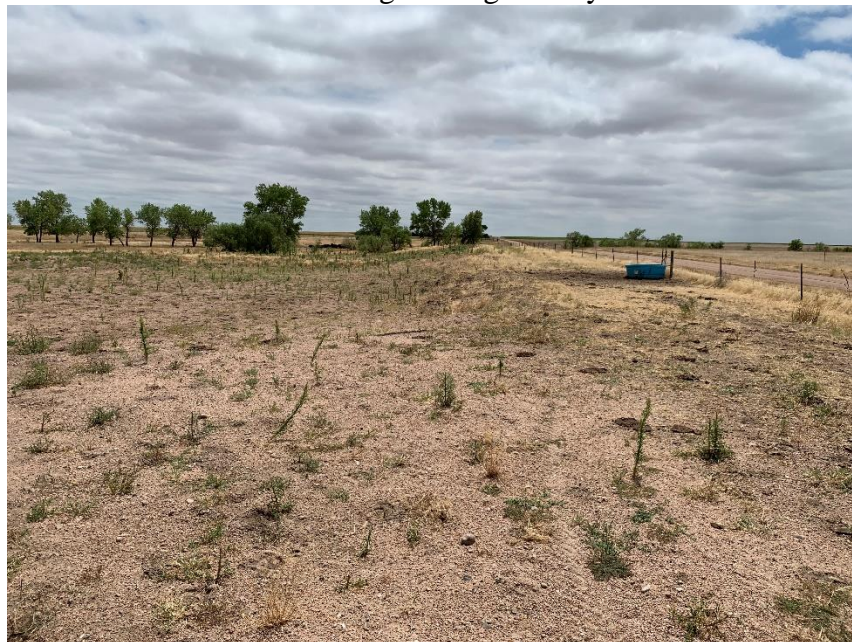
inspection report that mining had taken place in Area 1 and the bond had not been adjusted to cover the additional disturbance. An estimate was calculated for \$31,911 to cover the reclamation for the entire 33 acres of Area 1. When Mr. Larson was notified of the discrepancy he ceased mining in the area, backfilled and graded, and reseeded the area. The additional bond was not posted by the operator.

The size of the disturbance created in Area 1 is about 3.5 acres. The Division recognizes that the operator ceased mining Area 1, backfilled and graded the area and seeded it: however, this area was disturbed by mining activities and is not adequately bonded as required by Rule 4.2.1. Additional bond needs to be posted for \$1,867 to cover the cost of revegetation for the 3.5 acres or the operator needs to submit a technical revision, with the required \$216 revision fee, to update the current mine plan to reduce the overall liability of the mine's reclamation plan. The posting of the additional bond for the disturbance in Area 1 only covers the cost of revegetation for the 3.5 acres and should not be interpreted as permission to create additional disturbance in Area 1.

Mined area in Area 1 looking south

**CORRECTIVE ACTIONS:** The operator shall post additional bond of \$1,867 or submit a Technical Revision, with the required \$216 revision fee, to update and clarify the current approved mine plan to reflect existing and proposed activities by the corrective action date.

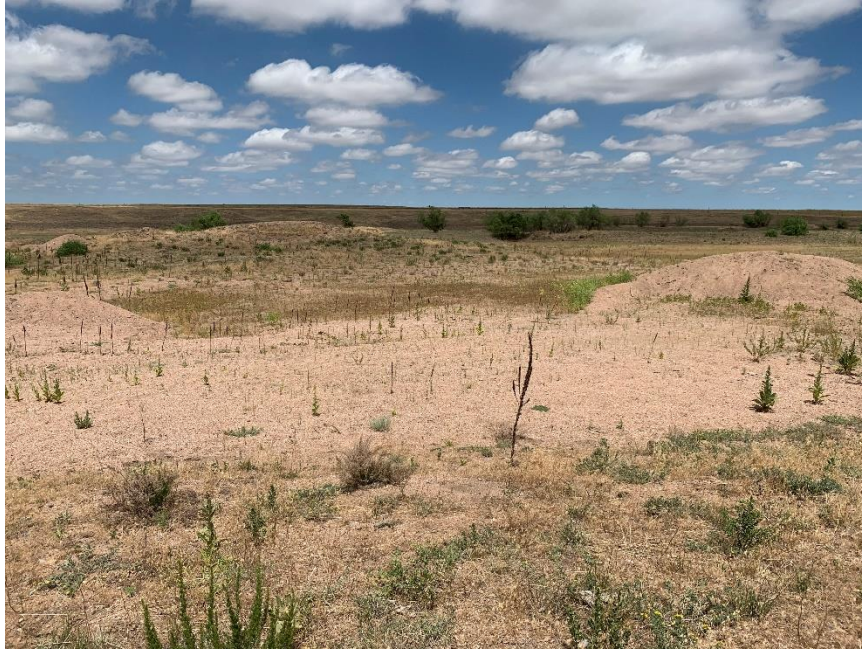
Mined area in Area 2 looking north

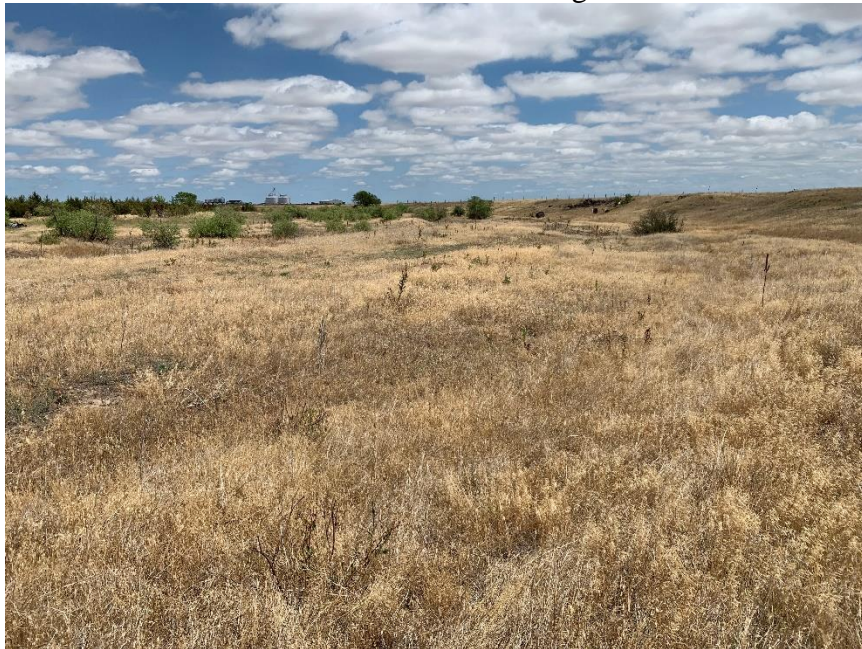
Area 3 looking east, no mining activity noted

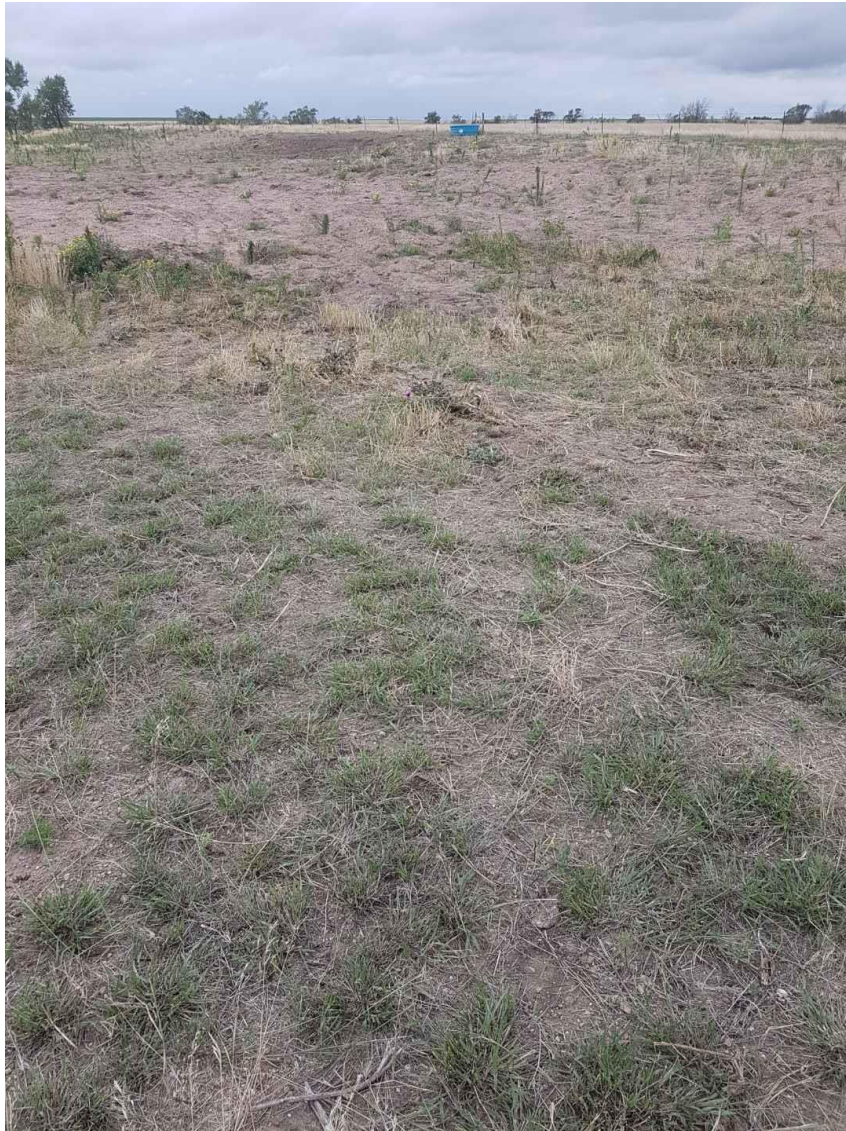
**PROBLEM/POSSIBLE VIOLATION:** Problem: There are state-listed noxious weeds present on site and there is not a weed control plan in the permit as required by Section 3.1.10 (6) of the Rules.

There are musk thistle plants in Area 1 that need to be treated. Musk thistle is a List B Colorado noxious weed and needs to be treated. The operator has submitted photos documenting that the musk thistles have been mowed since this inspection was conducted. The current mining permit does not have a weed control plan. The operator needs to submit a weed control plan through a technical revision for inclusion into the permit as required by Section 3.1.10 (6) of the Rules. A single technical revision can be submitted for both of the issues listed in this report.

Photo of area where musk thistle plants were mowed. Photo supplied by operator.

**CORRECTIVE ACTIONS:** The operator shall develop a weed control and management plan in accordance with Section 3.1.10 (6) of the Rule. This plan should be developed in consultation with the county extension agency, or weed control district office and should include specific control measures to be applied, a schedule for when control measures will be applied and a post-treatment monitoring plan. This weed control plan shall be submitted to the Division as a Technical Revision to the approved plan with the appropriate Technical Revision fee of \$216.00 by the corrective action date.
