# ESCO Sand and Gravel, LLC

## **RE: Inspection- Kattenberg Pit M-2004-017**

### **#1 INSPECTION TOPIC: Backfilling & Grading**

## **#2 INSPECTION TOPIC:** Signs & Markers

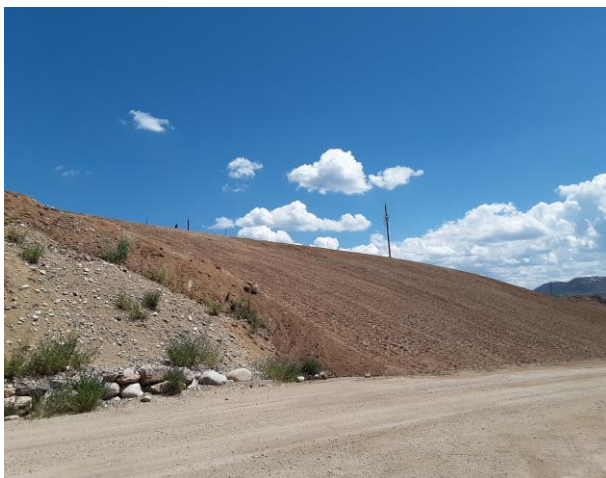
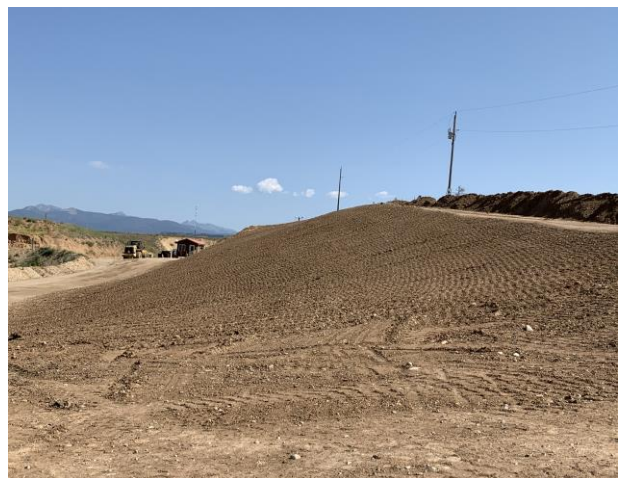
**PROBLEM:** The approved Mine Plan requires the Operator to maintain a 25-foot offset from the property line and mine the perimeter at the final 3H:1V slope. The northeastern highwall previously repaired by a former Operator has eroded to within 2 feet of the permit boundary and exceeds the approved perimeter mined slope of 3H:1V.

**CORRECTIVE ACTIONS:** The Division will require the Operator to backfill the highwall to establish the required

25-foot offset from the eastern boundary and the required 3H:1V slope and provide evidence within 30 days of the mailing date of this report.

**Corrected** 7/29/2020

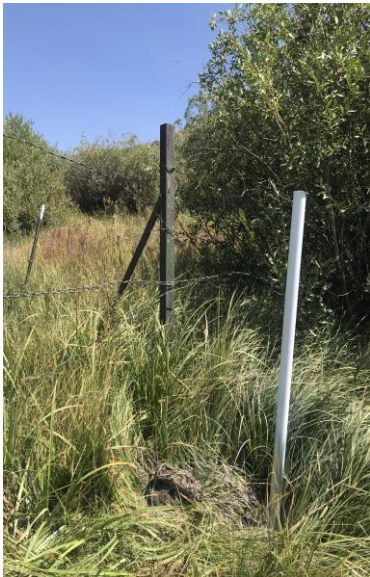
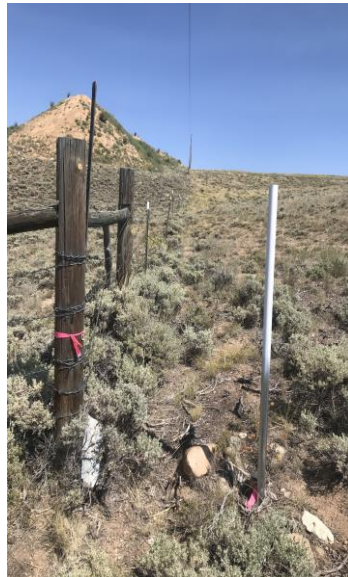
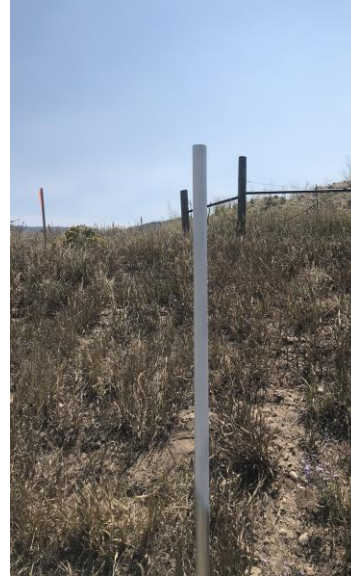
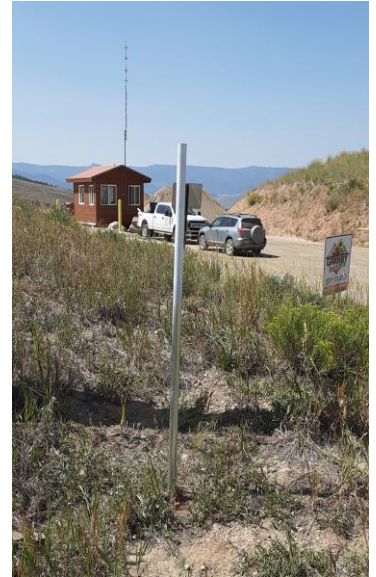
**We have completed Inspection Topic #2 on 8/13/2020 (Please See Reference Photos Below)**

**PROBLEM:** The affected area boundary markers are missing or incorrectly placed. This is a problem for failure

to maintain boundary markers around the affected area as required by Rule 3.1.12(2).

**CORRECTIVE ACTIONS:** The Operator shall conduct a survey and replace the boundary markers in the correct

location(s). The Operator shall provide proof to the Division that this has been done by the corrective action

date.

**Date Completed:** 8/13/2020
