**Re: Permit No. M-1980-244; Cripple Creek & Victor Gold Mining Company ("CC&V"); Cresson Project - Notification of Water Quality Analysis Parameter Exceedance October 6, 2020**

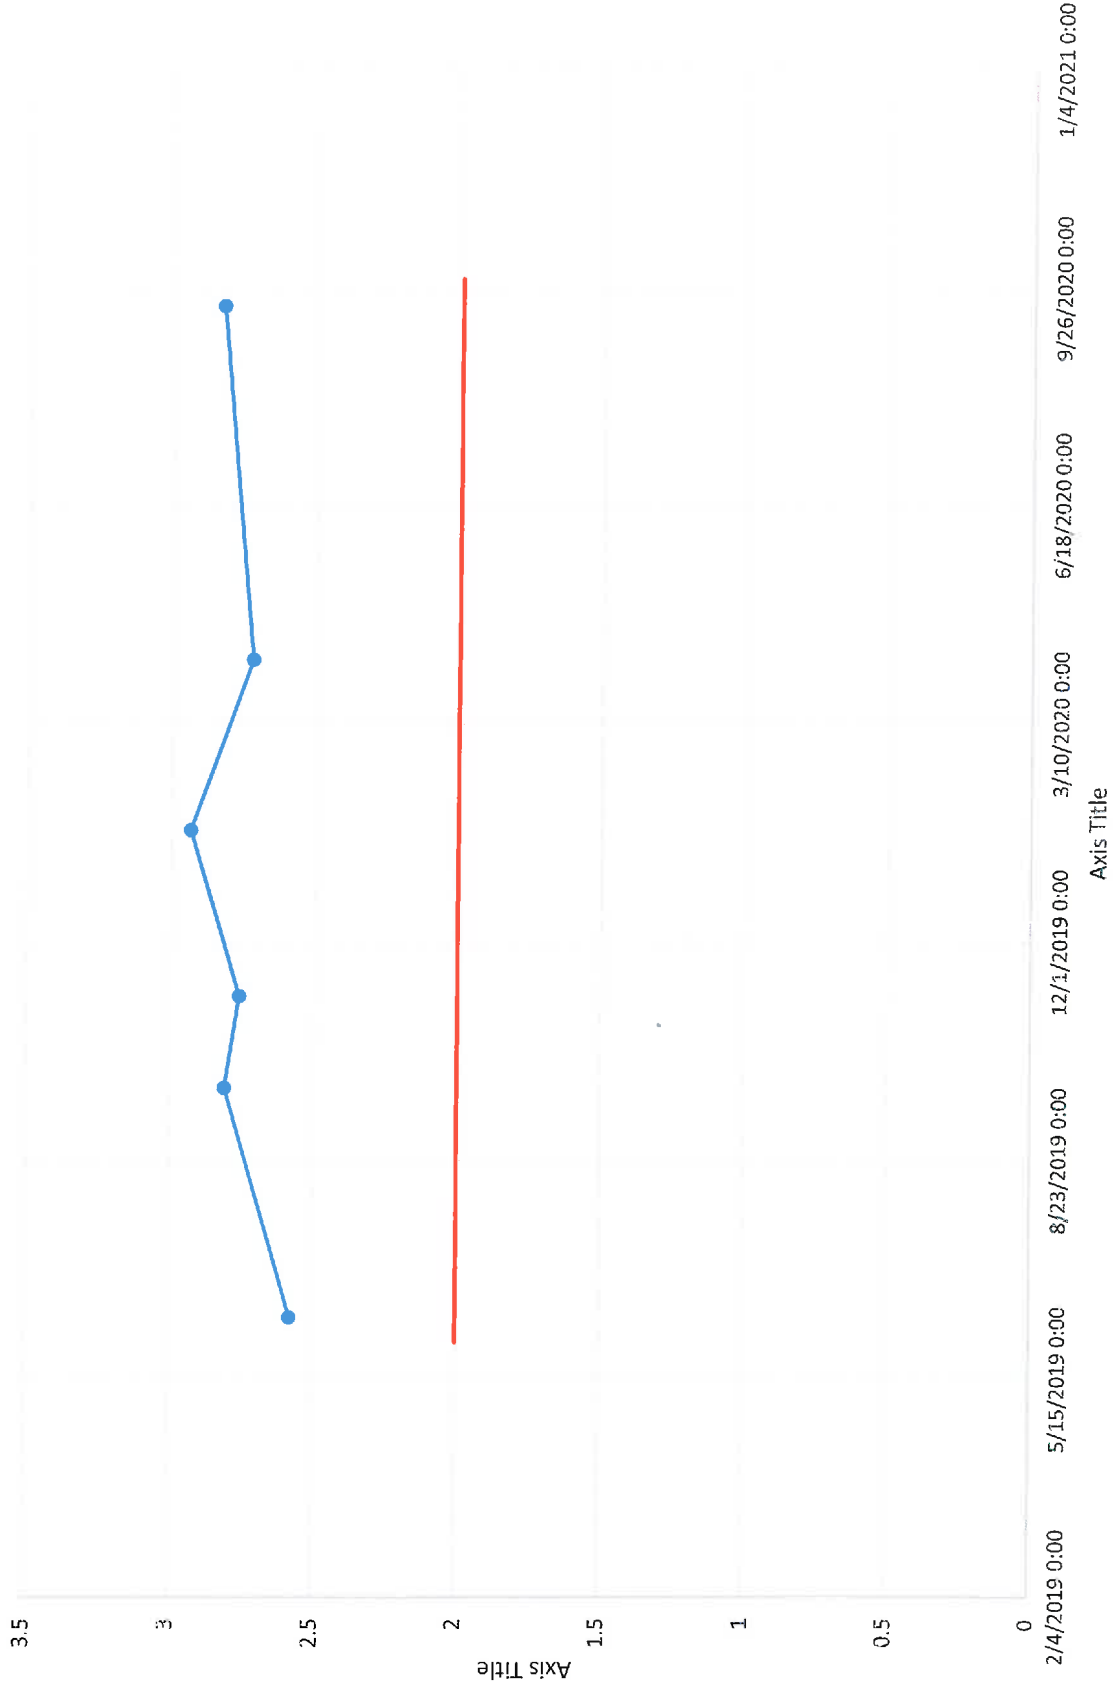
# CRMW\_5B

CC&V collected third quarter compliance groundwater samples from monitoring wells CRMW-5A and CRMW-5B on September 17, 2020. CC&V received the lab report for these analyses on September 29, 2020, and upon review, CC&V determined that CRMW-5A exceeded established numeric protection limits for uranium, and CRMW-5B exceeded established numeric protection limits for fluoride. The table below lists the exceedance for the location and the associated parameter and the attached graph demonstrates the parameter trend for collected data from Q2 2019 to present.

Fluoride — Fluoride - NPL / TVS

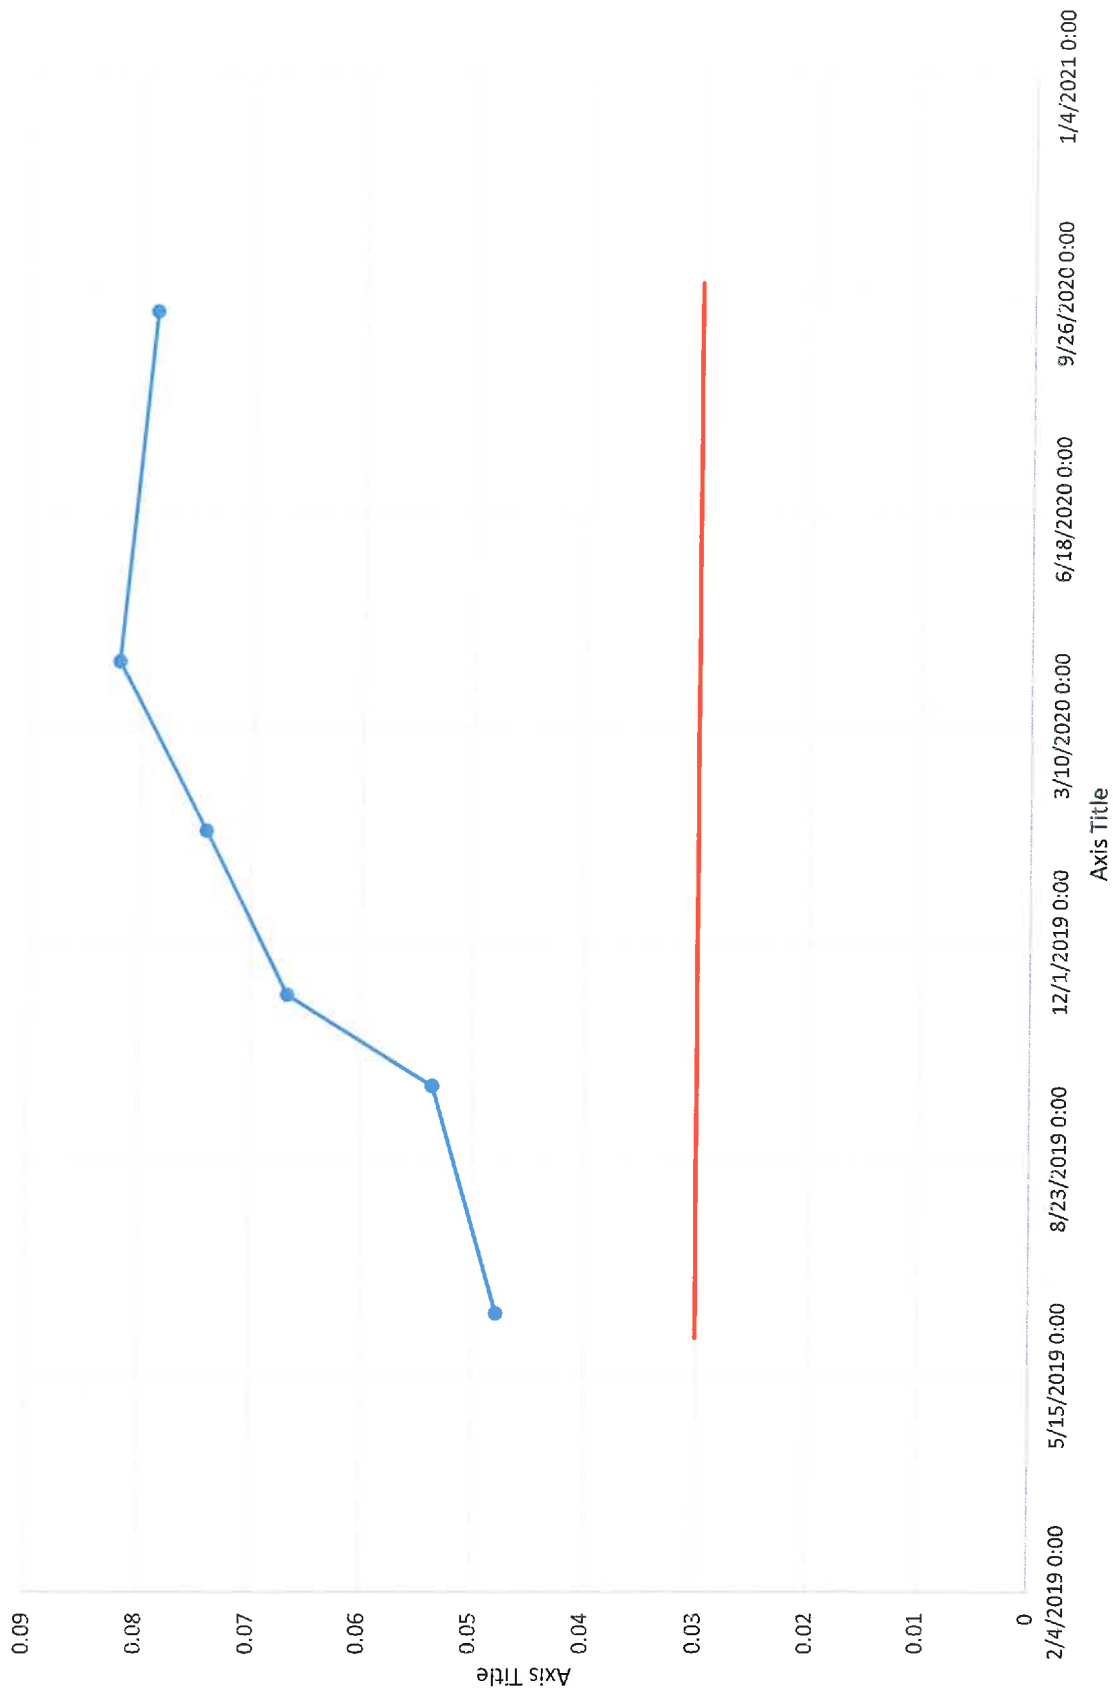
# CRMW-5A

—●— Uranium — Uranium - TVS
