MINERALS PROGRAM INSPECTION REPORT

MINE NAME: Sokol Pit	MINE/PROSPECTING ID#: M-1980-193	MINERAL: Sand and gravel	COUNTY: El Paso
INSPECTION TYPE: Monitoring	INSPECTOR(S): Robert Zuber, P.E.	INSP. DATE: October 29, 2020	INSP. TIME: 08:00
OPERATOR: Rocky Mountain Materials and Asphalt, Inc.	OPERATOR REPRESENTATIVE: David Bieber	TYPE OF OPERATION: 112c - Construction Regular Operation	
REASON FOR INSPECTION: Normal I&E Program	BOND CALCULATION TYPE: Complete Bond	BOND AMOUNT: \$113,757.00	
DATE OF COMPLAINT: NA	POST INSP. CONTACTS: None	JOINT INSP. AGENCY: None	
WEATHER: Clear	INSPECTOR'S SIGNATURE:

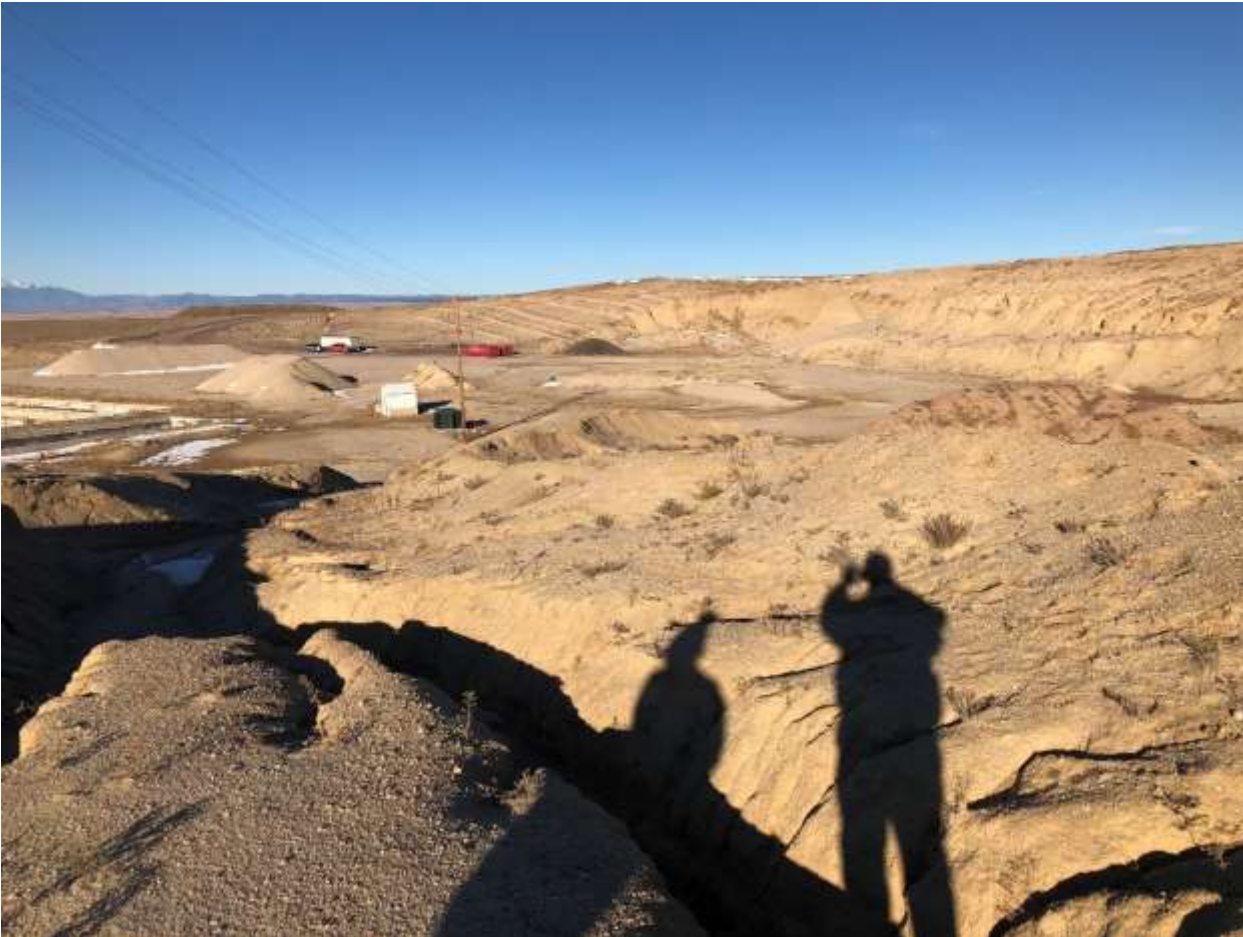
Looking northwest at highwall and process area

At the main area of the site, no reclamation has been performed. A large amount of highwall at the site requires backfill and grading. This highwall wraps around the middle of the site (where processing of material took place) on the north, east, and south sides. The area that requires backfilling and grading excludes the sediment pond (at the southwest corner of the site) and the concrete wash ponds (near the middle of the site).

The highwalls were measured at the north, east, and south directions with a laser rangefinder. The average height was found to be 28 feet.

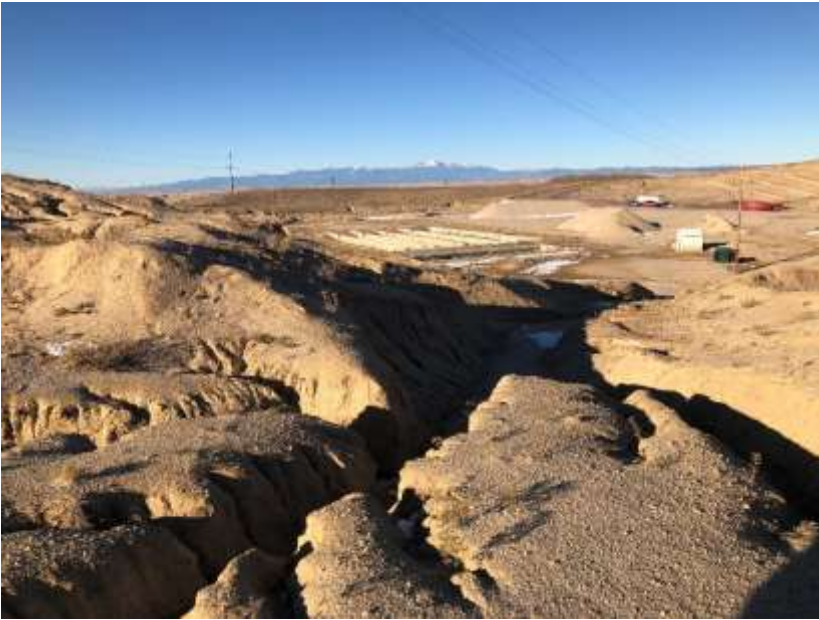
Looking west/southwest at site

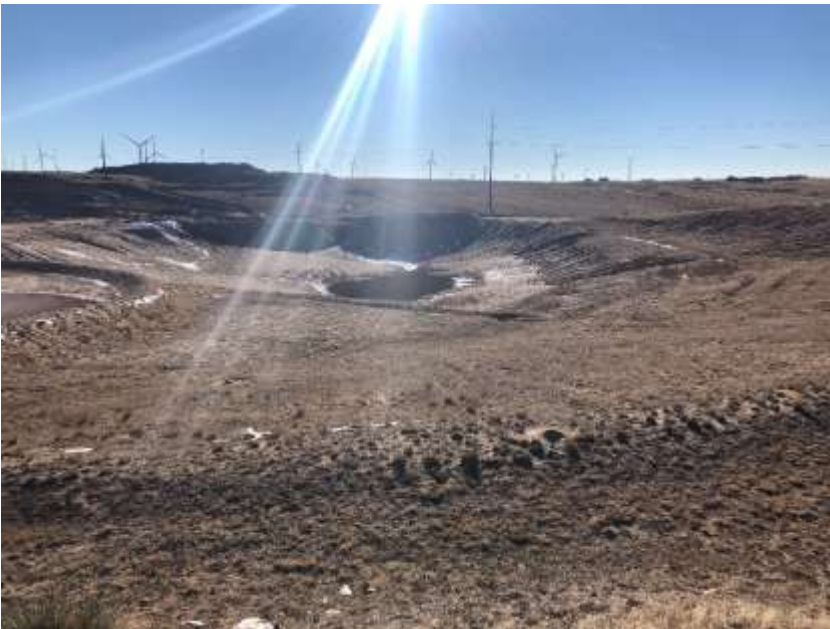
The pond was holding a small amount of water and far from discharging. It appeared to be large enough to collect runoff from the entire site, even after very large events, and the banks appeared stable.

Pond on west side of site

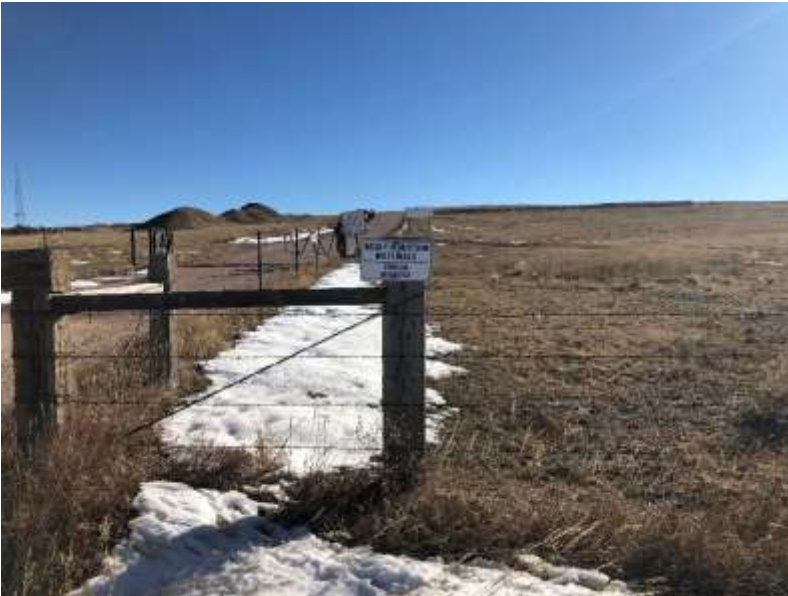
Sign with Permit Number M-1980-193

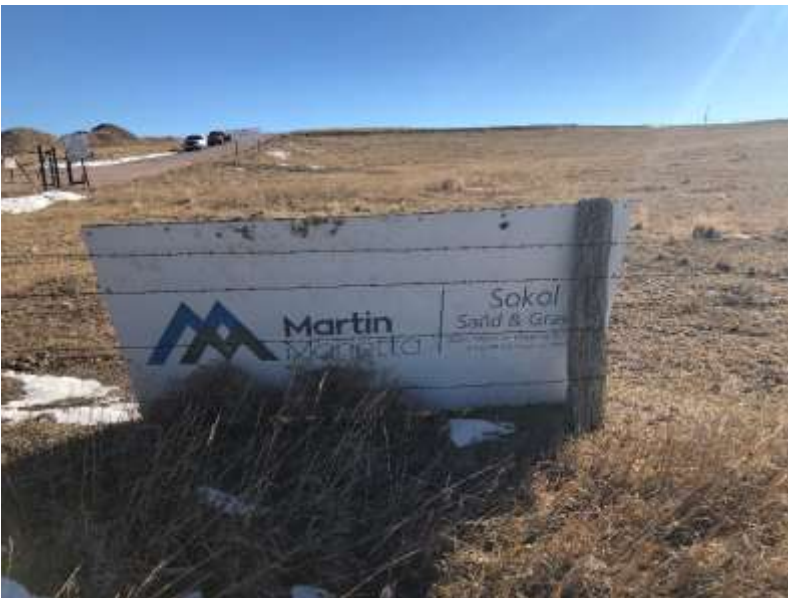
Sign with name of operator and pit – requires maintenance

The mine entrance signs contained the necessary information, although one of them had been knocked down and should be fixed.
