Re: Permit No. M-1980-244; Cripple Creek & Victor Gold Mine; Cresson Project; Written notification – HGM Process Water Spill, December 8, 2020

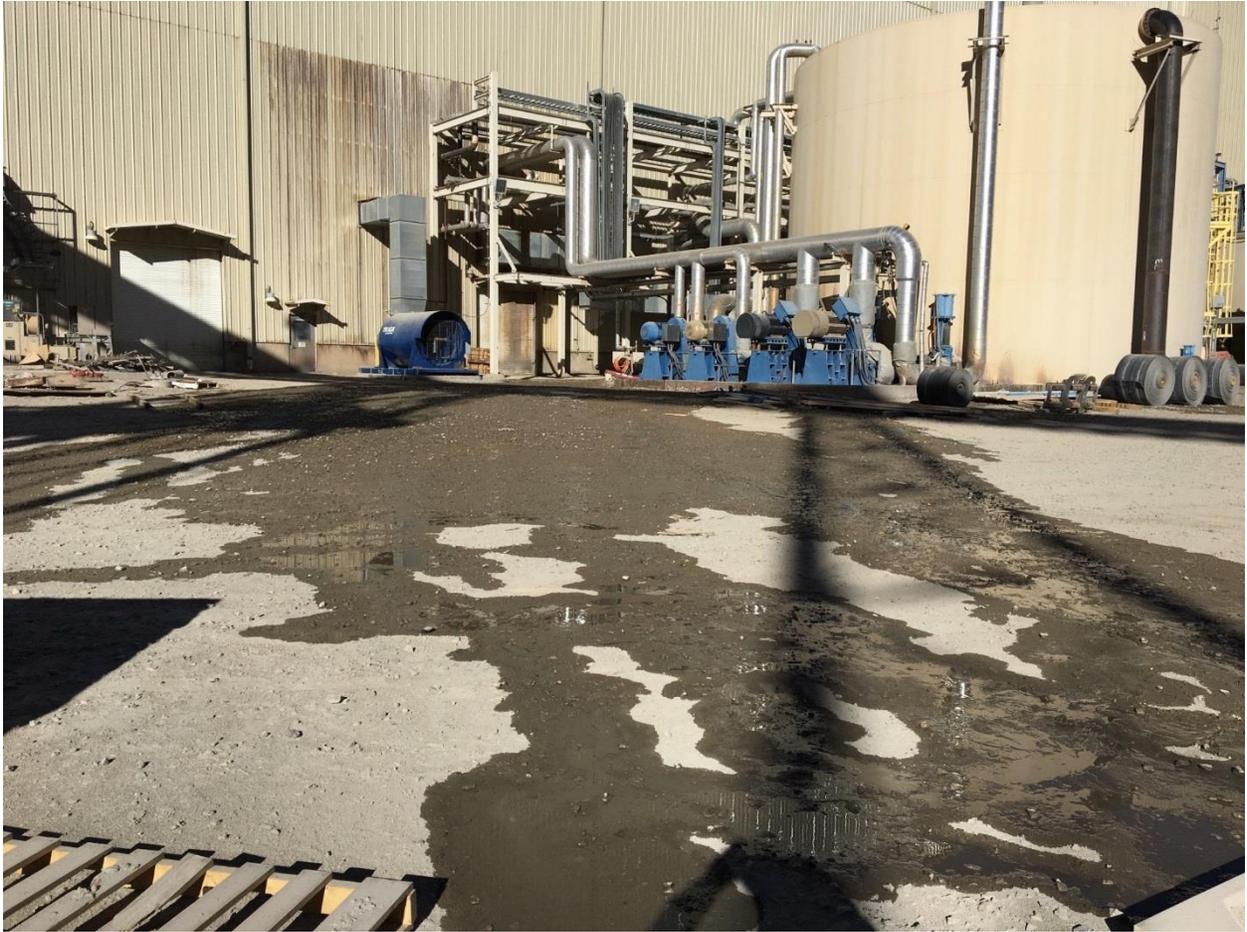
- Around 10:30 am on December 8, 2020, work was being performed on process water pumps at the HGM. Due to mechanical issues, backpressure was induced on water pumps, which resulted in overflow of containment of the HGM neutral water tank. Sump pumps were activated, but some solution overtopped containment along the east edge of the HGM facility. All solution remained on the mill liner.
- Once identified, CC&V personnel quickly addressed the problem and returned flow to normal operation.
- The impacted material was over-excavated and placed on the mill feed pile.

Photo 1. Area impacted by process solution, looking northwest (12/8/20)

After initial review of the incident, the cause of the spill can be attributed to a temporary power outage that resulted in the loss of communication between the plant operators and the solution management system.

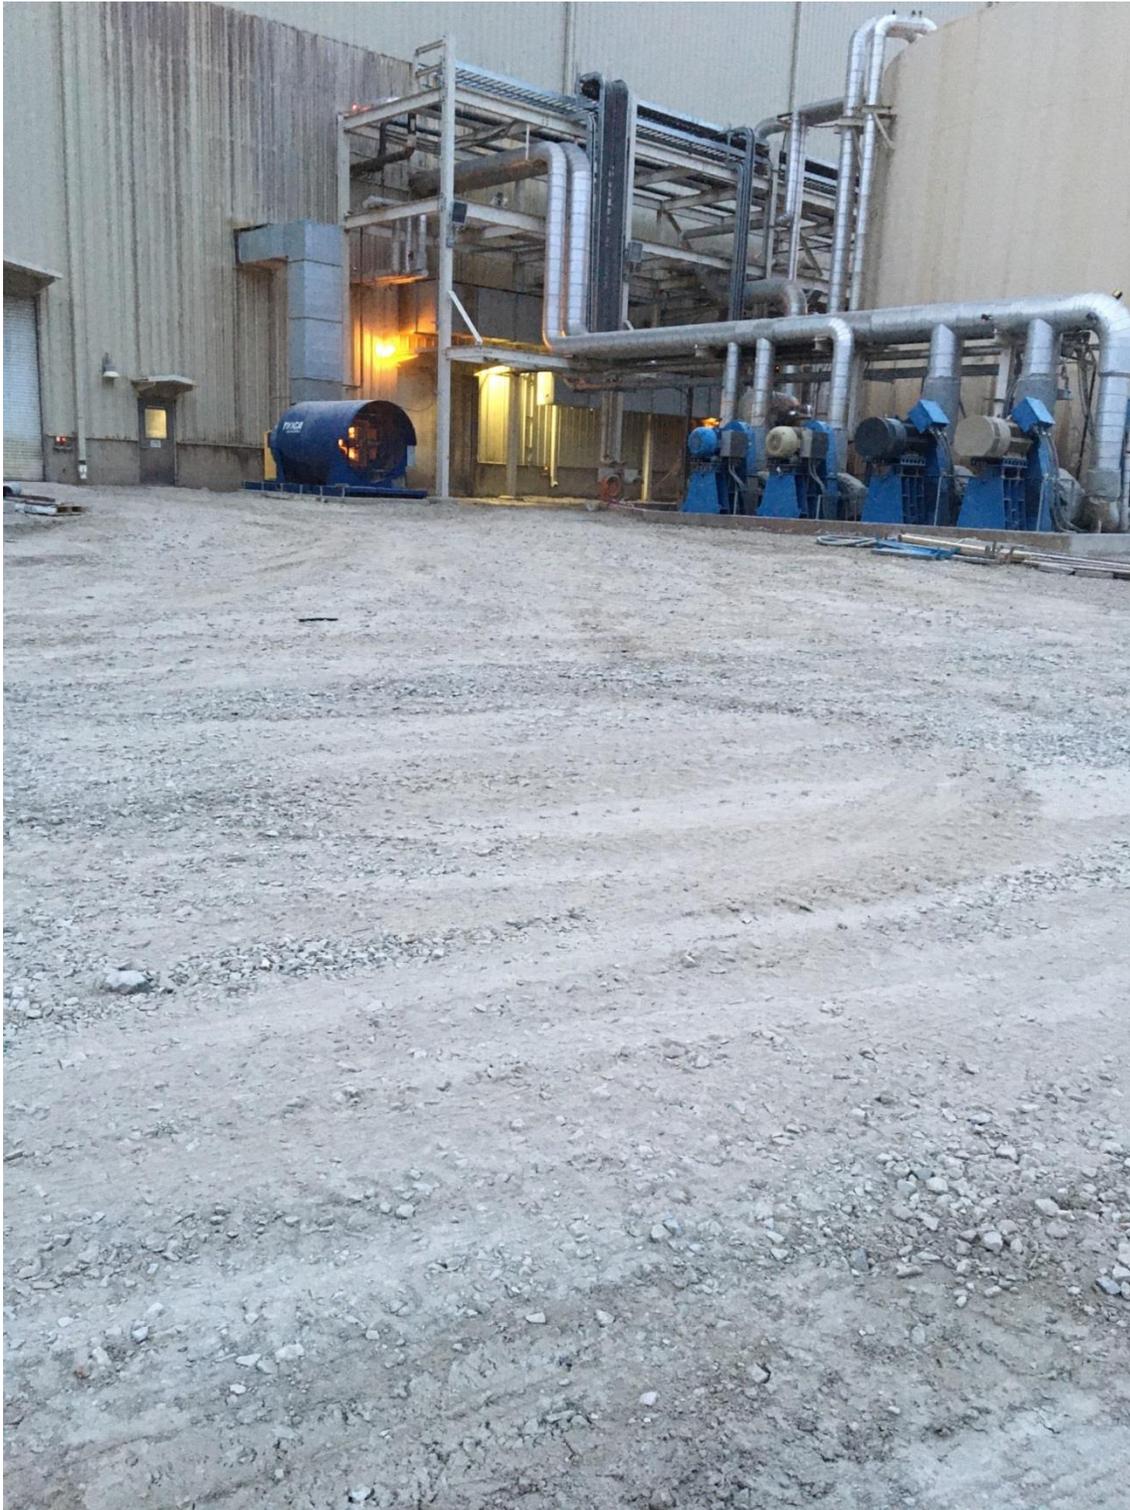
Photo 2. Area impacted by process solution – Post Cleanup, looking northwest (12/10/20)
