COLORADO
Division of Reclamation,
Mining and Safety
Department of Natural Resources

Permit Number: C-1981-037 Mine Name: GEC Strip Mine Operator: GEC Minerals, Inc. Operator Address: Dr W Corley 2605 Constellation Drive Colorado Springs, CO 80906	County: Fremont Operation Type: Surface Permit Status: Revoked Ownership: Private
Operator Representative Present:	
Operator Representative Signature: (Field Issuance Only)

Inspection Start Date: December 27, 2020 Inspection Start Time: 13:00 Inspection End Date: December 27, 2020 Inspection End Time: 13:10		Inspection Type: Coal Complete Inspection Inspection Reason: Normal I&E Program Weather: Clear	
Joint Inspection Agency: None		Joint Inspection Contacts:	
Post Inspection Agency: None		Post Inspection Contacts:	
Inspector(s): Zach Trujillo	Inspector's Signature:

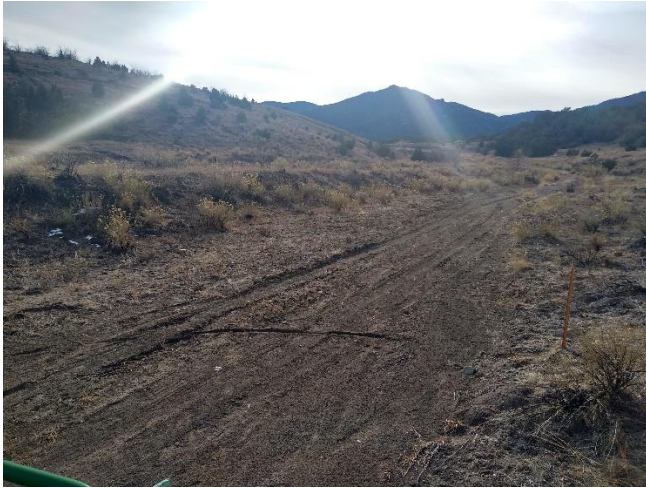
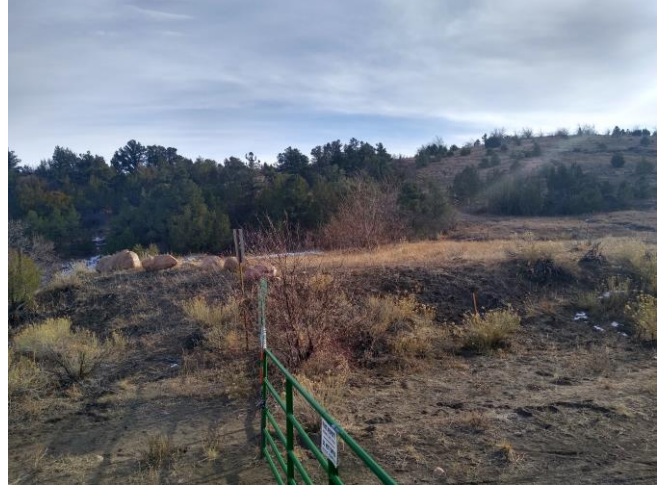
The inspection for the GEC Mine was done at the locked gate along the county road to the site. A portion of Chen's Hill was visible from this location. From that location, no rills or gullies could be observed due to the line of sight as well as snow cover. As documented in previous reports, the slope has multiple gullies. The embankment of the Pond A was inspected from the county road. The pond has been previously reported as filled with sediment.
