*OURAY SILVER MINES*

## **Revenue Virginius Mine Building Modifications & Bond Update**

**Technical Revision No. 13**  
**CDRMS Permit No. M-2012032**  
March 1, 2021

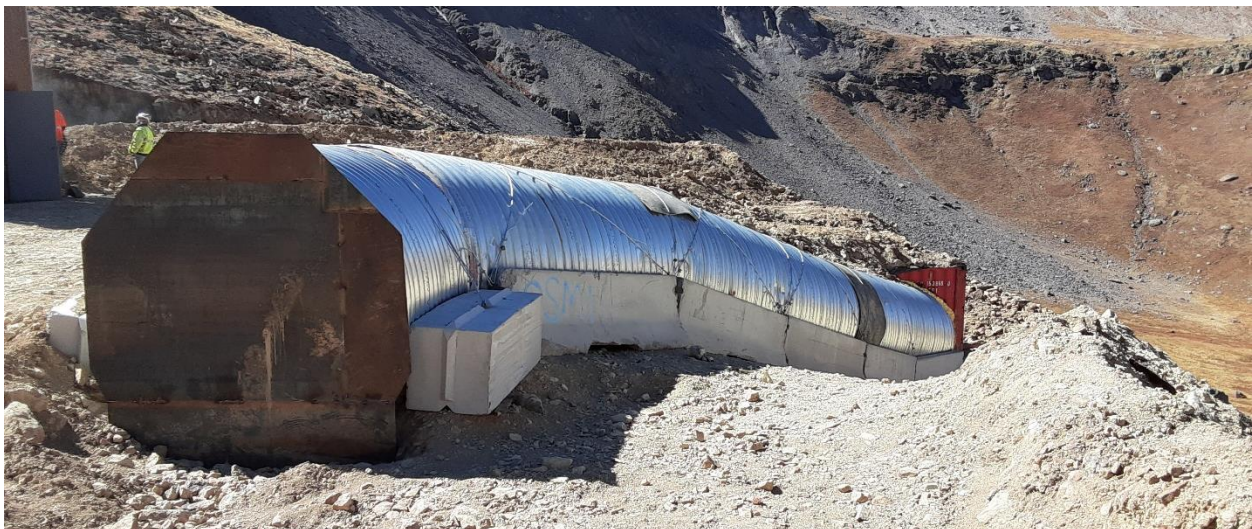
A door was cut into the side of the Connex where they daylight and a culvert was connected to allow access to the surface and to serve as a manway in or out of the refuge chamber (Figure 1). The manway was supported with concrete jersey barriers to protect it from avalanches. Work on the refuge chamber is expected to continue in 2021. As the raise is rehabilitated, a 20 ft drift will need to be created to connect the refuge chamber to the raise. An as built drawing of the refuge chamber and manway can be found in Appendix 2.

*Figure 1.- Image of manway connected to refuge chamber.*

Post mining, the structures that remain in Governor Basin will be removed during the timeframe that other mine structures are removed around the portal area. The headframe will be removed and placed down the Monogahela Shaft prior to capping and backfilling. The culvert to the surface that acts as a manway to the refuge will be cut, collapsed, and placed down the Monogahela Shaft along with the headframe. The Connex which serves as a refuge chamber will be cut, collapsed in place, and backfilled with surrounding waste rock to prevent collapse hazards. An updated reclamation cost can be found in updated Table L-2.
