May 3, 2021
Project#01349-0001

Subject: Summary of Instrumentation Monitoring
1st Quarter 2021
Bowie Coal Waste Disposal Area No. 3
Paonia, Colorado

**SUBJECT: Summary Report, 1st Quarter 2021, Vibrating Wire Piezometers
January – March 2021, Bowie Mine #2
Coal Waste Disposal Area (CWDA) #3**

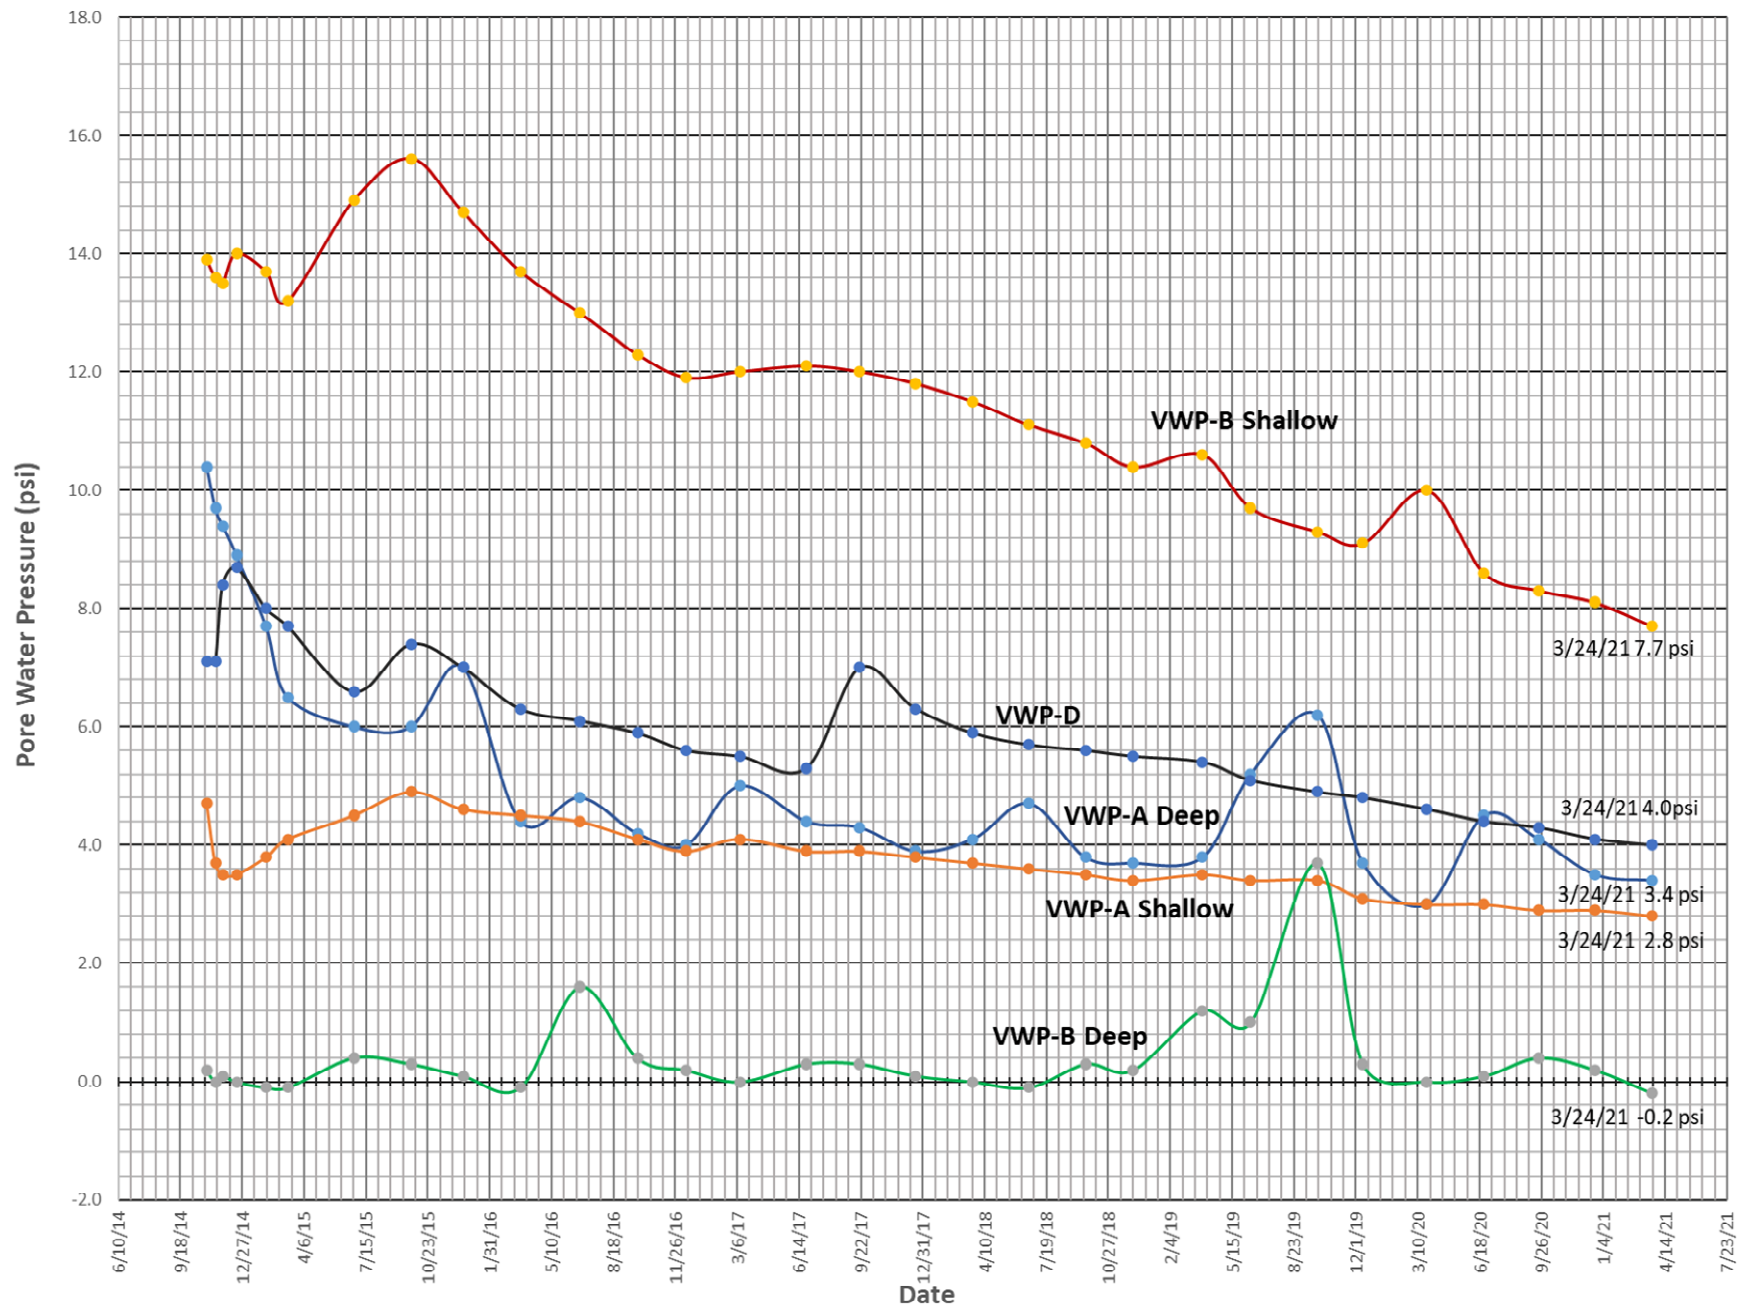
Figure 1 - Bowie Mine #2 - CWDA #3
Vibrating Wire Piezometer Data

We present a graph of measured pore pressures on the attached Figure 1 and numerically in Table 1 below. Table 1 is a summary of the initial, last year, last quarter and current readings. In addition, we present the difference between the current pore pressures and those at the time of installation, the previous quarter, and previous year.

As seen on Figure 1 and Table 1, all five VWP's either decreased in pore pressure when compared with the previous quarter; however, when compared with the 1st quarter of last year, 4 of the 5 VWP's decreased in pore pressure while one (VWP-A Deep) increased by 0.4 psi. All five VWP's have decreased in pore pressure since installation in 2014. Although there is a general trend of decreasing pore pressure over time, three of the piezometers (VWP-A Deep, VWP-B-Deep and VWP-B Shallow) have more recent erratic behavior since early 2019.

Based upon the results of the most recent VWP monitoring data, HBET does not believe that there is any reduction in the stability of CWDA No. 3.
