**MINERALS PROGRAM INSPECTION REPORT**  
**PHONE: (303) 866-3567**

<b>MINE NAME:</b> Rudibaugh Pit	<b>MINE/PROSPECTING ID#:</b> M-1995-057	<b>MINERAL:</b> Sand and gravel	<b>COUNTY:</b> Gunnison
<b>INSPECTION TYPE:</b> Monitoring	<b>INSPECTOR(S):</b> Dustin Czapla	<b>INSP. DATE:</b> May 24, 2021	<b>INSP. TIME:</b> 15:00
<b>OPERATOR:</b> Deb Rudibaugh	<b>OPERATOR REPRESENTATIVE:</b>	<b>TYPE OF OPERATION:</b> 110c - Construction Limited Impact

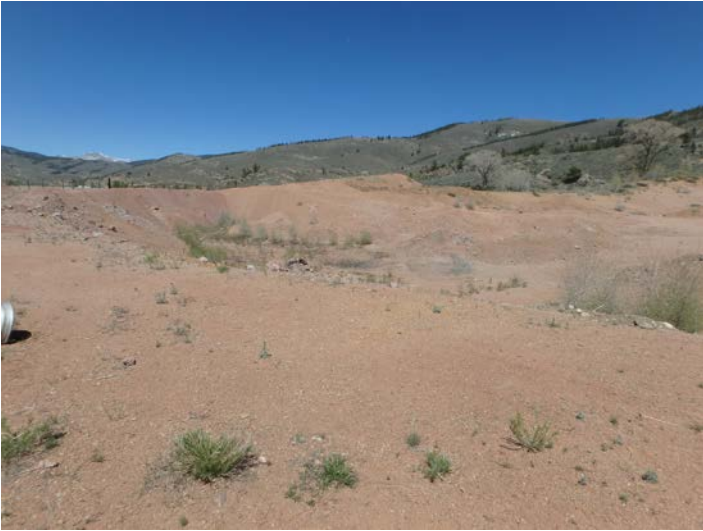
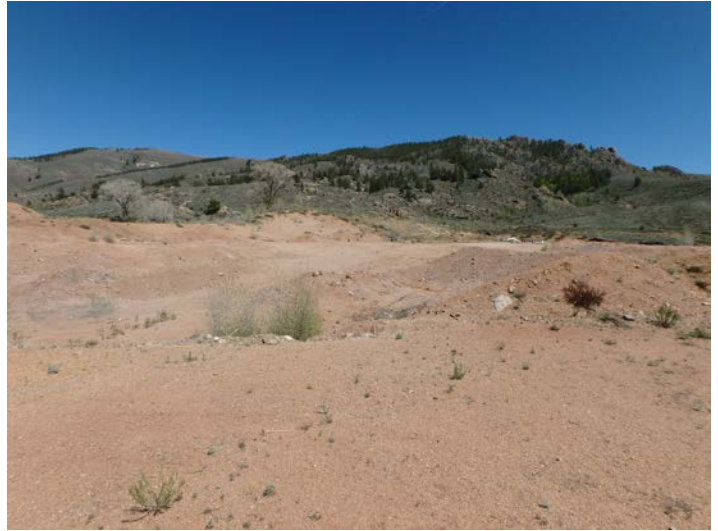
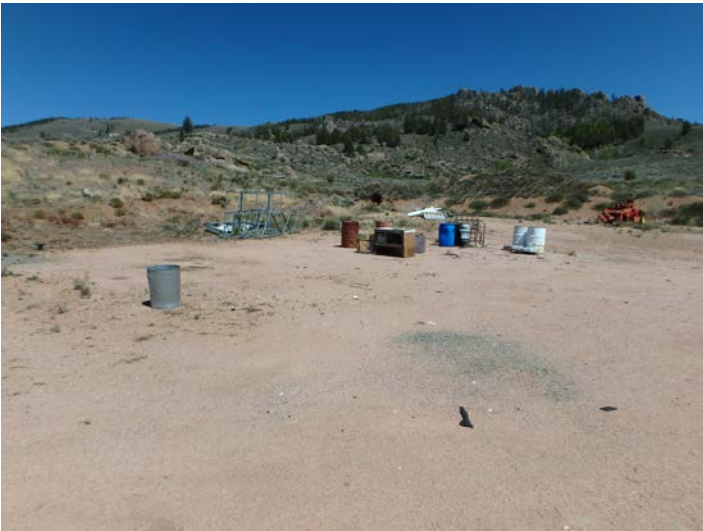
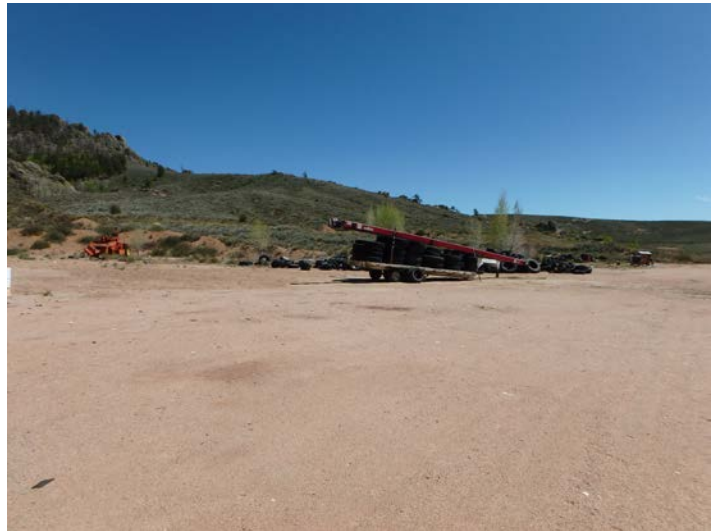
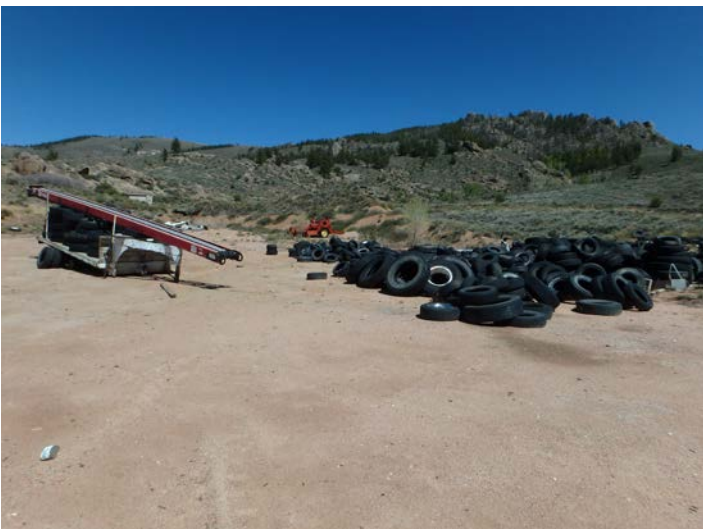
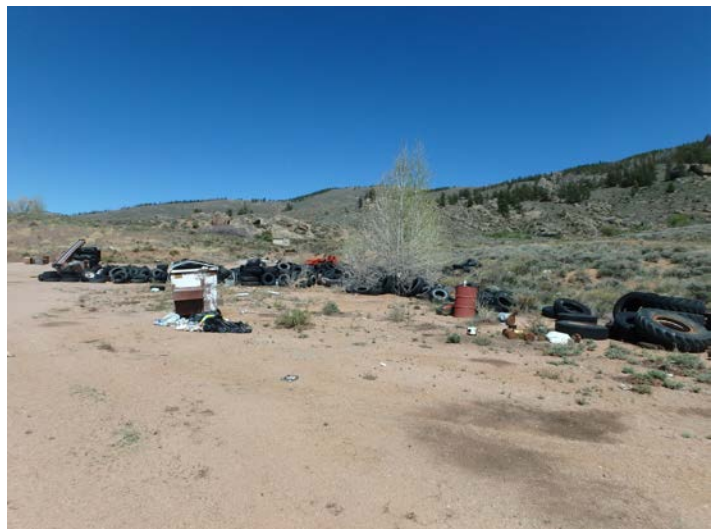
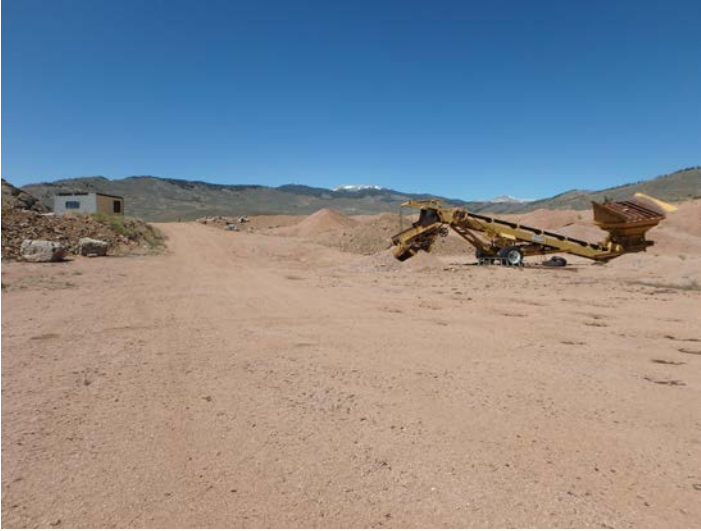
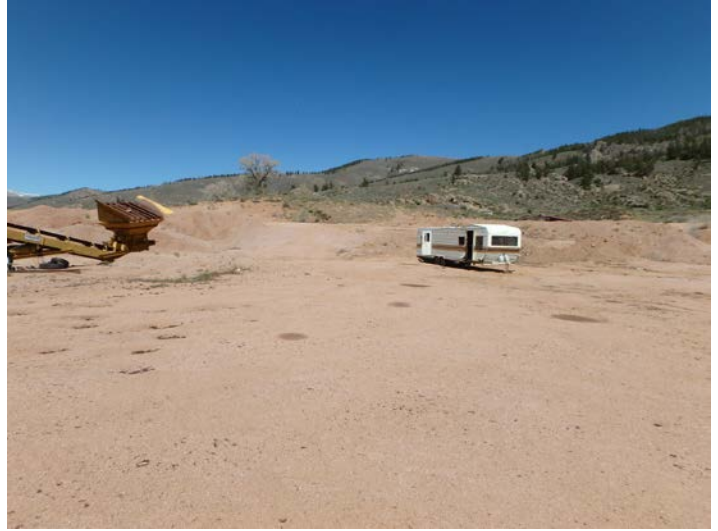
## PHOTOGRAPHS

**PROBLEM/POSSIBLE VIOLATION:** Problem: Trash and refuse was noticed within the permit area. The south portion of the permit area has been used as a junkyard. Junk vehicles/equipment and various refuse were stored in this area. On August 28, 2018 the Mined Land Reclamation Board issued an order finding the

Excessive trash and refuse were observed within the permit area. The south portion of the permit area has been used as a junkyard. Junk vehicles/equipment and various refuse were stored in this area. This issue was documented in previous inspection reports. On August 28, 2018 the Mined Land Reclamation Board issued an order finding the operator in violation for failing to control the unsightliness or deleterious effects of refuse and imposed a corrective action requiring the operator to remove all trash and scrap vehicles from the site by November 26, 2018. Although the operator made significant progress, cleanup of the site was not completed. Various trash/scrap piles, a large pile of old tires, and several pieces of dilapidated farm equipment remain on site.
