**MINERALS PROGRAM INSPECTION REPORT**  
**PHONE: (303) 866-3567**

<b>MINE NAME:</b> Bear Ranch Gravel Mine	<b>MINE/PROSPECTING ID#:</b> M-2013-002	<b>MINERAL:</b> Sand and gravel	<b>COUNTY:</b> Gunnison
<b>INSPECTION TYPE:</b> Monitoring	<b>INSPECTOR(S):</b> Dustin Czapla	<b>INSP. DATE:</b> June 6, 2021	<b>INSP. TIME:</b> 16:00
<b>OPERATOR:</b> Bear Ranch LLC	<b>OPERATOR REPRESENTATIVE:</b>	<b>TYPE OF OPERATION:</b> 110c - Construction Limited Impact	
<b>REASON FOR INSPECTION:</b> Normal I&E Program	<b>BOND CALCULATION TYPE:</b> Complete Bond	<b>BOND AMOUNT:</b> \$49,400.00	
<b>DATE OF COMPLAINT:</b> NA	<b>POST INSP. CONTACTS:</b> None	<b>JOINT INSP. AGENCY:</b> None	
<b>WEATHER:</b> Clear	<b>INSPECTOR'S SIGNATURE:</b>

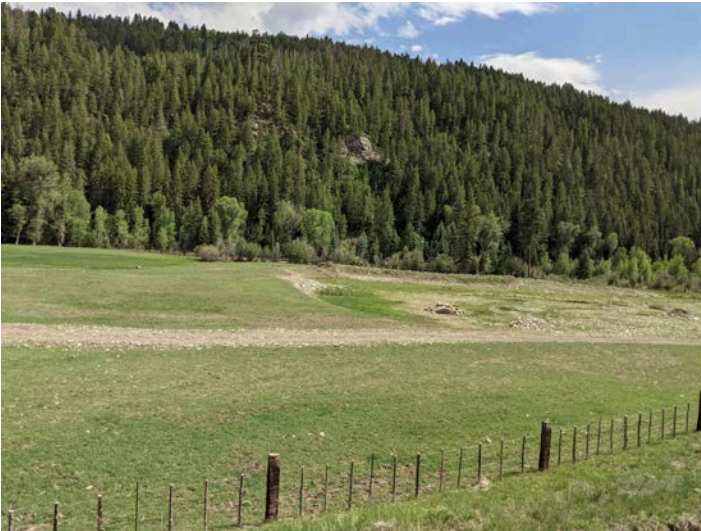
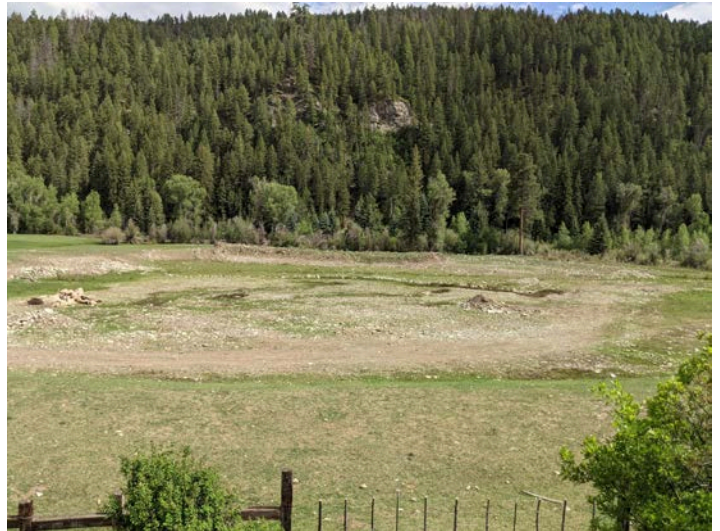
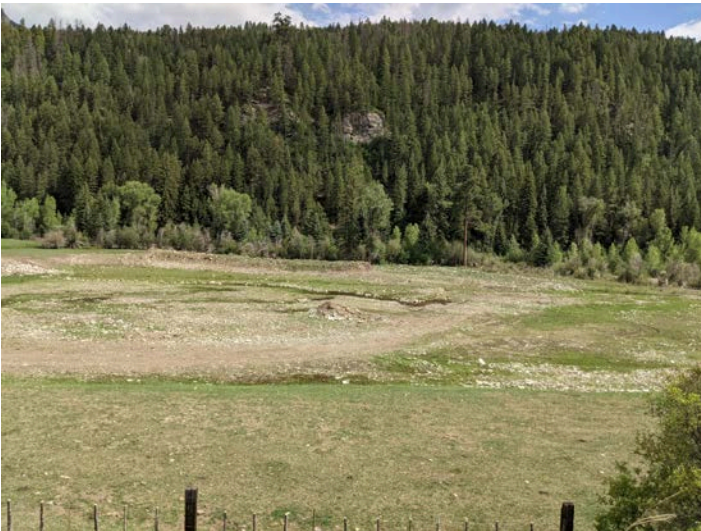
Adequate mine identification signage was noted at the entrance to the site.

The affected area was marked by fencing that was clearly visible and adequate to delineate the affected area boundary.

The current disturbance covers approximately three acres within the 9.9 acre permit area. The pit has been excavated to a depth of approximately three feet with side slopes 3H:1V or flatter. Topsoil has been pushed into a berm on the south side of the excavated pit. Mining equipment or fuels are not stored on site.
