**REQUEST FOR FULL OR PARTIAL RELEASE OF PERMIT AREA/SURETY REDUCTION**

File No.: M 2000-047

Site Name: Diamond Rock Pit

## **REQUEST FOR BOND REDUCTION**

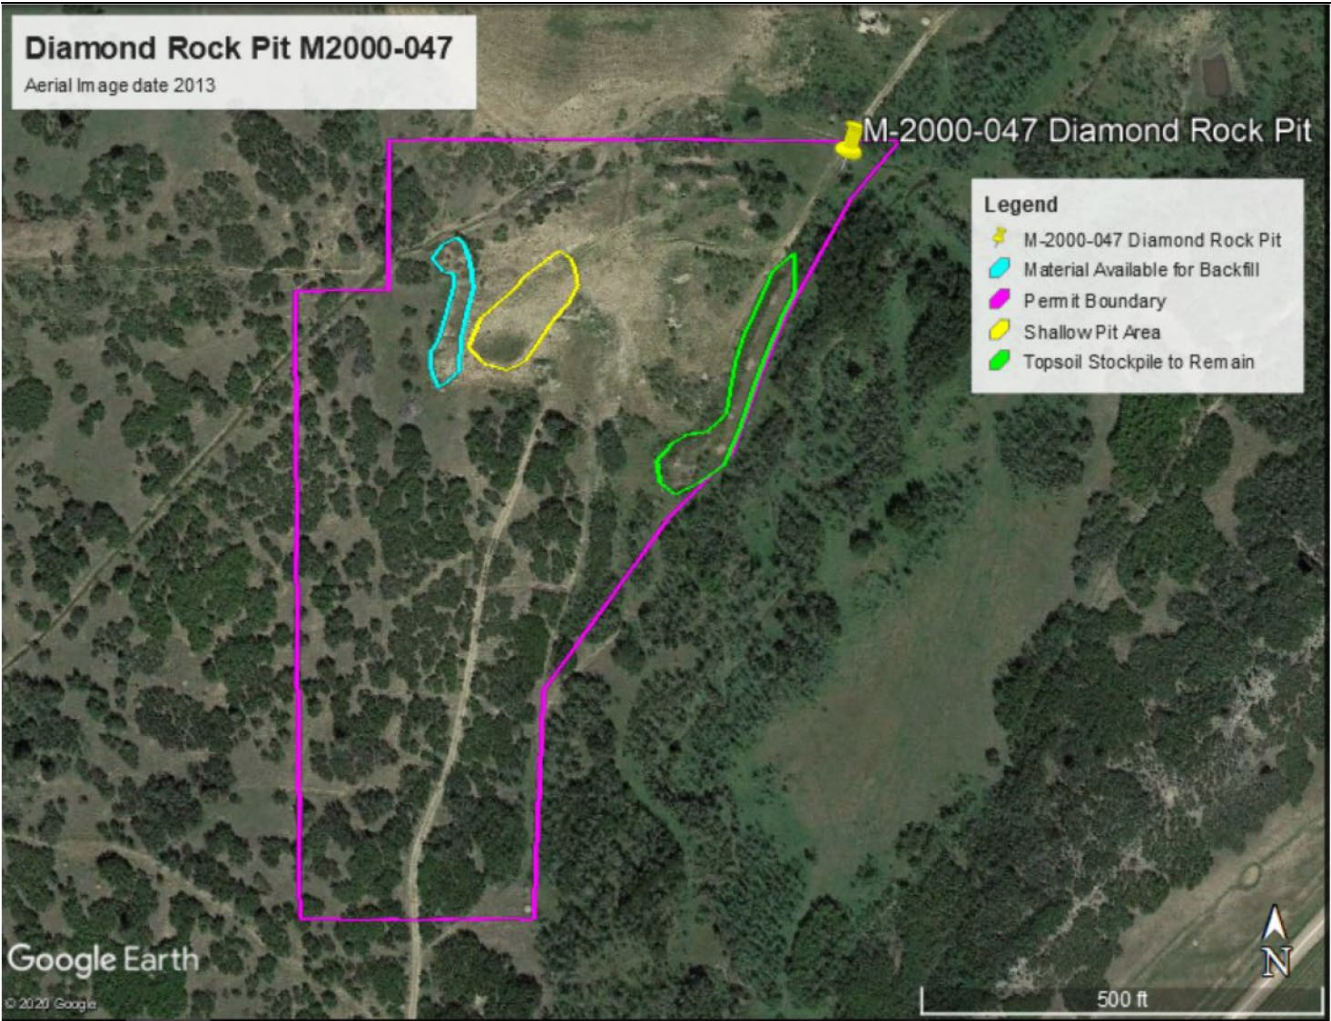
**PROBLEM:** Failure to follow approved reclamation plan, and failure to carry reclamation to completion in a reasonable timeframe pursuant to C.R.S. 34-32.5-116. The operator must follow approved reclamation plan or provide sufficient information to describe or identify how the operator intends to conduct reclamation.

**CORRECTIVE ACTIONS:** The operator shall begin reclamation activities within 60 days of the date on the inspection report. The operator shall submit a Technical Revision, with the required \$216 revision fee, to update and clarify the current approved reclamation plan to reflect existing conditions once reclamation has been completed.

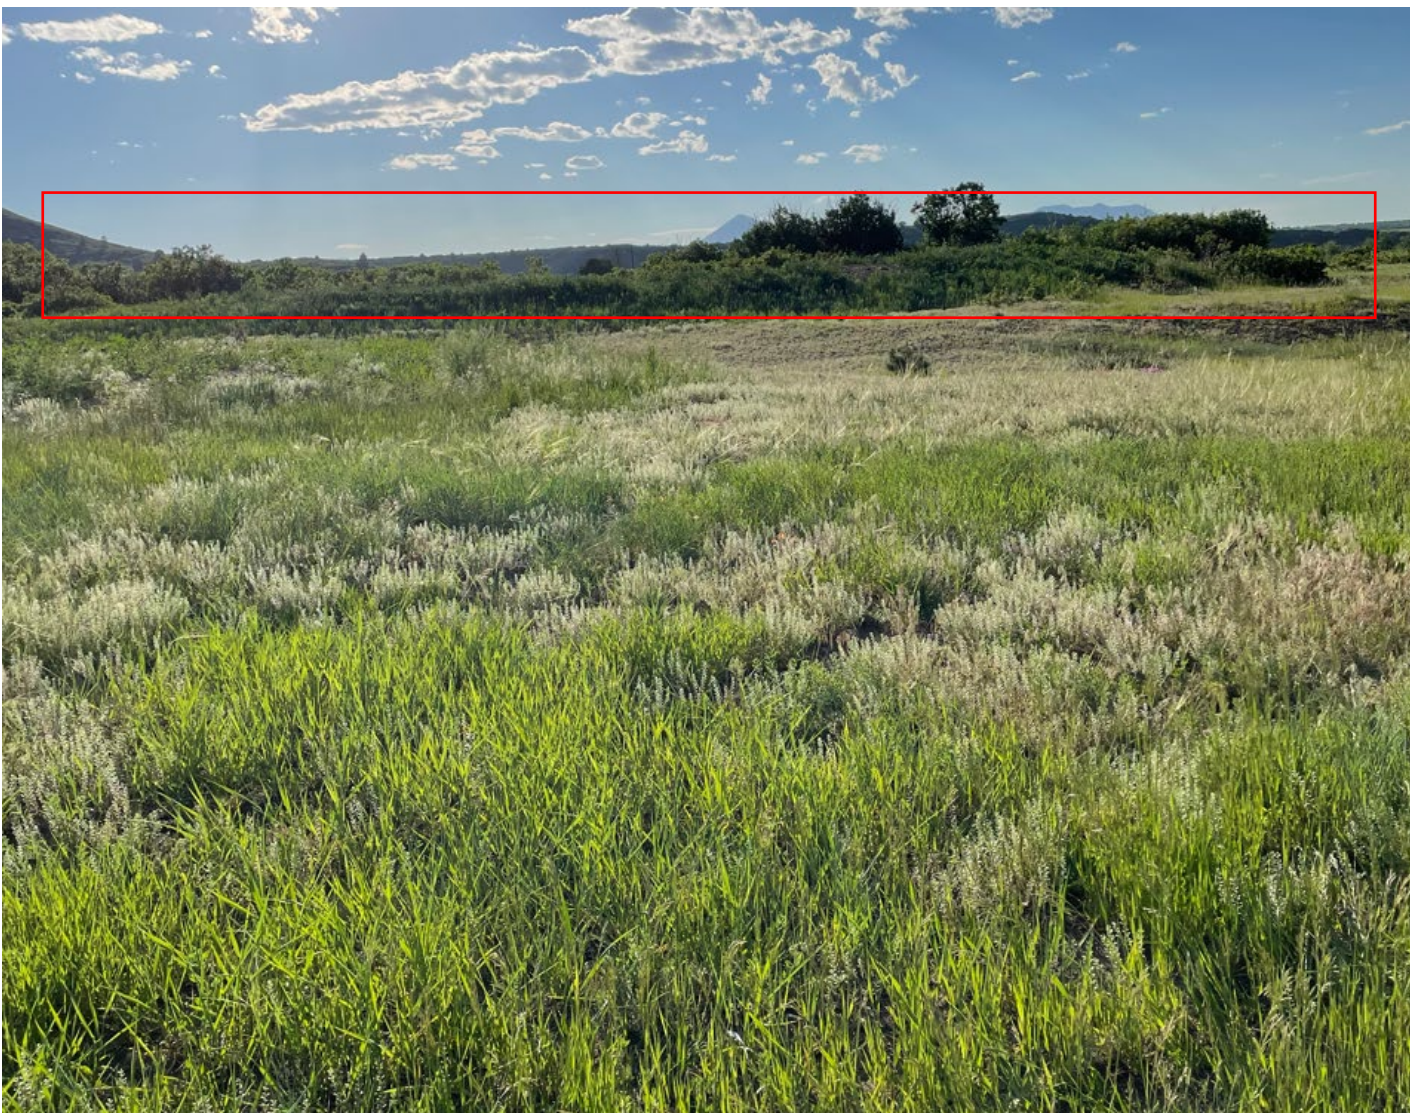
## **CORRECTIVE ACTION – “MATERIAL AVAILABLE FOR BACKFILL”**

To complete the correction action due, the “Material Available for Backfill” (identified as blue circle on the map) has been reshaped and graded to 3:1 slope and seeded with grass.

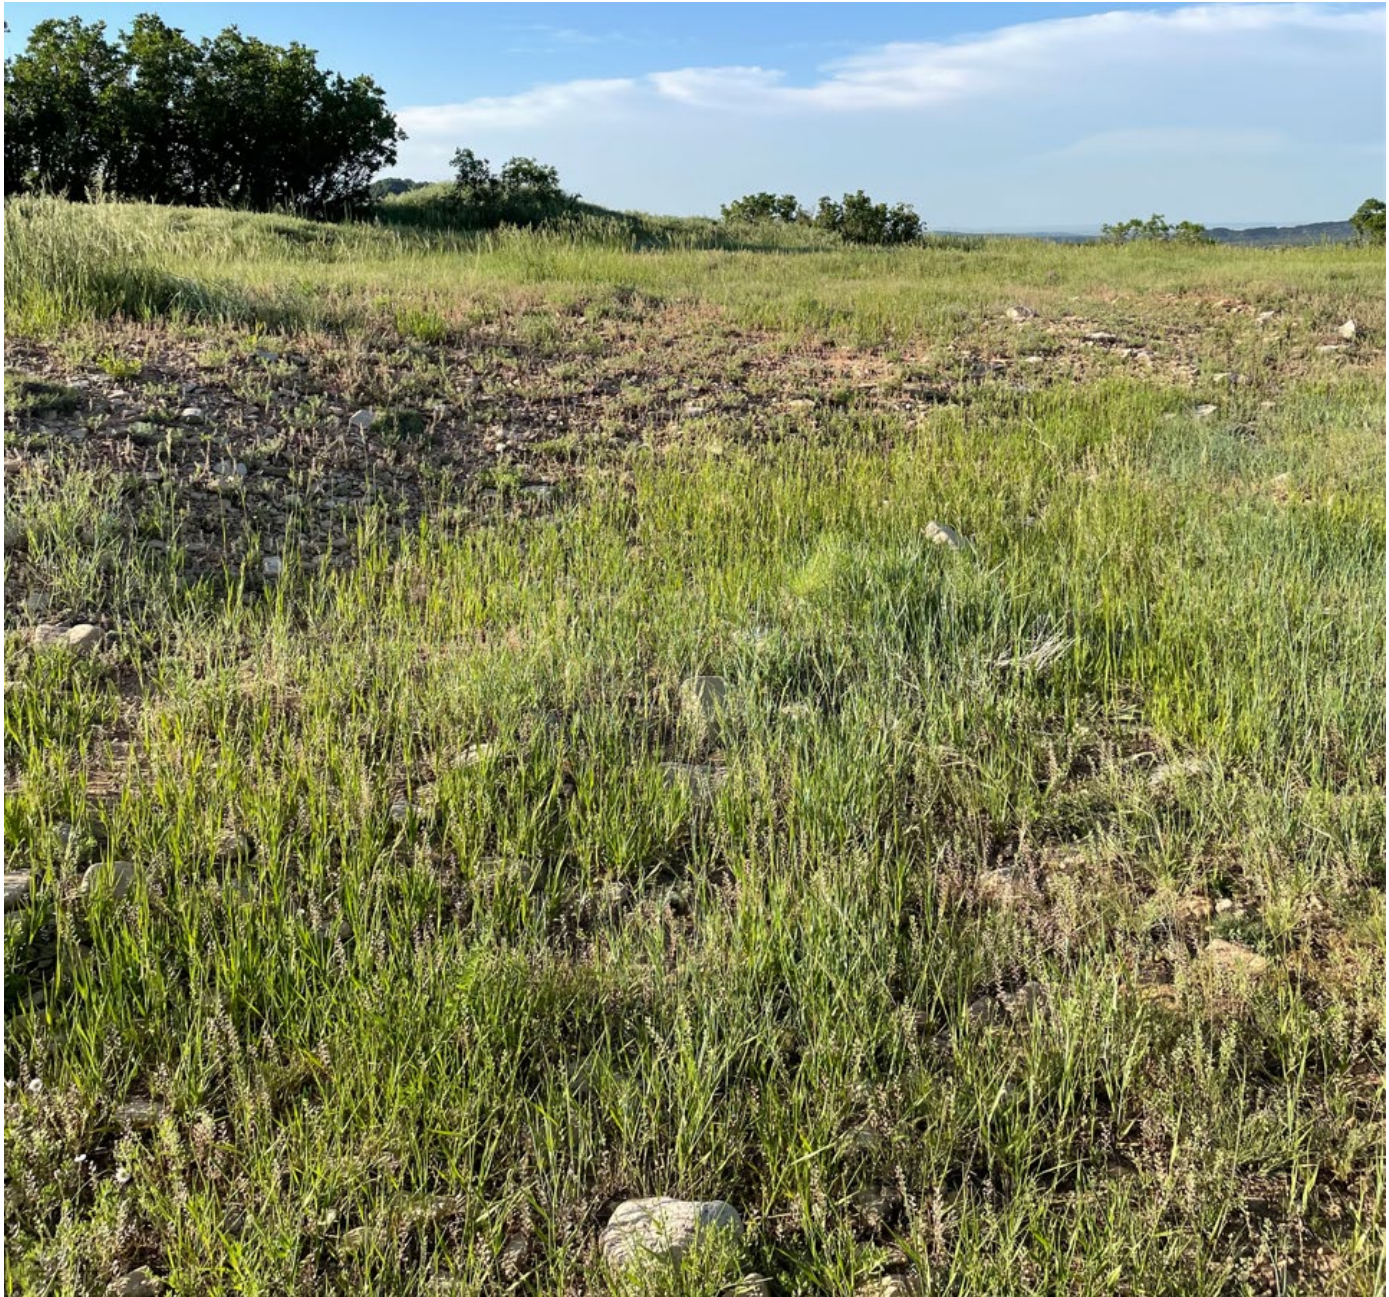
## **CORRECTIVE ACTION – “SHALLOW PIT AREA”**

The “Shallow Pit Area” (identified as the yellow circle on the map) has been reshaped and graded to >4:1 slope and seeded with grass.

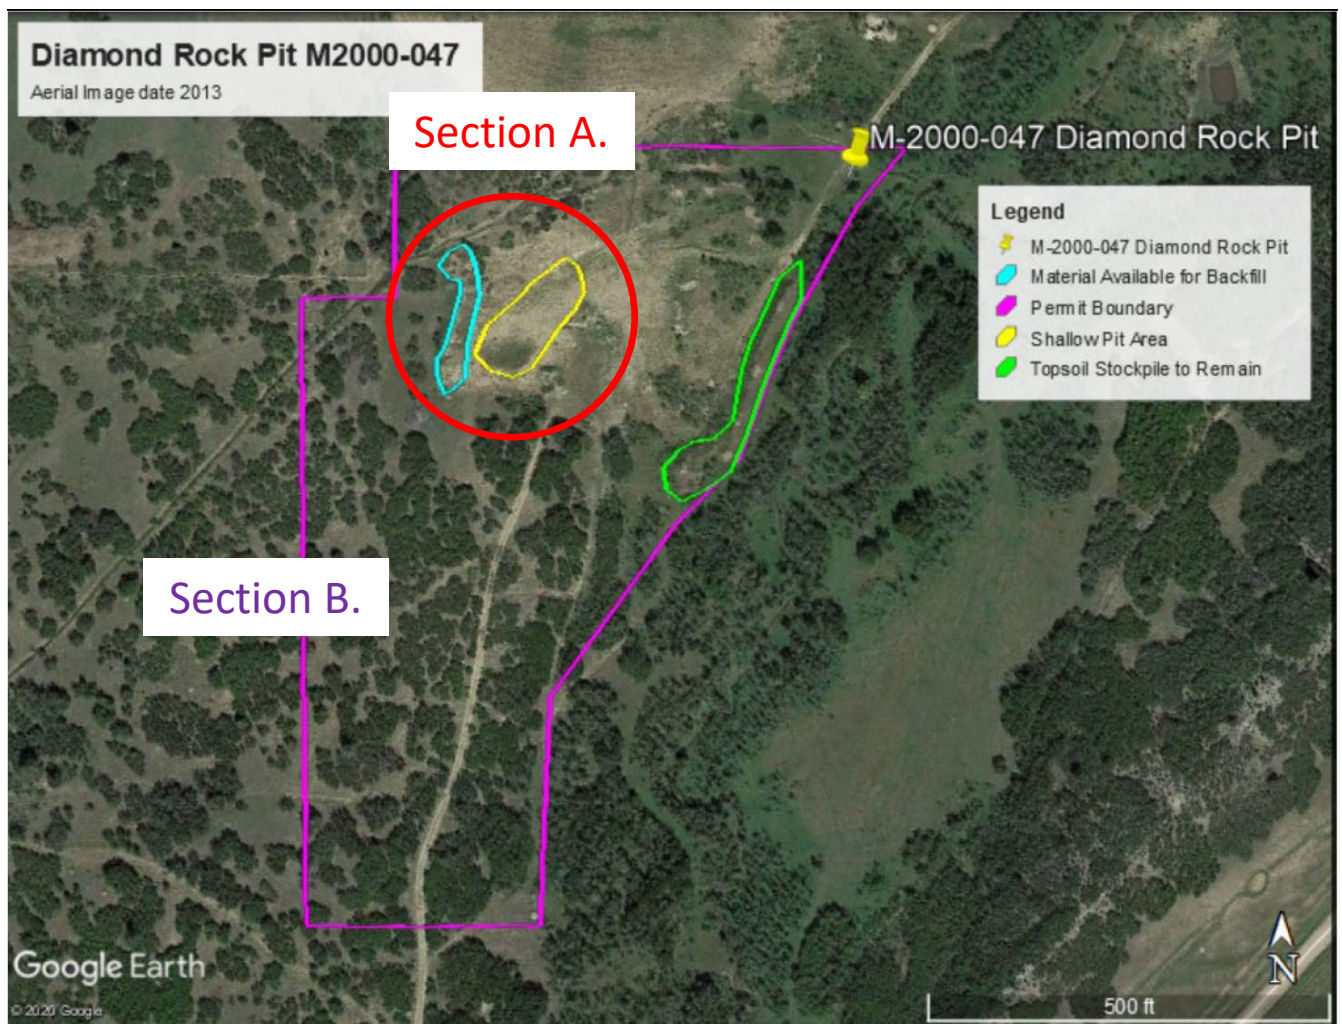
## RECLAMATION MAP OF AFFECTED AREA

**SECTION A:** Approximately 2.0 acres that has been reclaimed and seeded; area requested to be bonded

**SECTION B:** Approximately 7.9 acres to be released at this time
