MINERALS PROGRAM INSPECTION REPORT
PHONE: (303) 866-3567

MINE NAME: Whinnery Pit	MINE/PROSPECTING ID#: M-1998-055	MINERAL: Sand and gravel	COUNTY: Gunnison
INSPECTION TYPE: Monitoring	INSPECTOR(S): Dustin Czapla	INSP. DATE: August 19, 2021	INSP. TIME: 11:00
OPERATOR: Helen Whinnery	OPERATOR REPRESENTATIVE: None	TYPE OF OPERATION: 110c - Construction Limited Impact

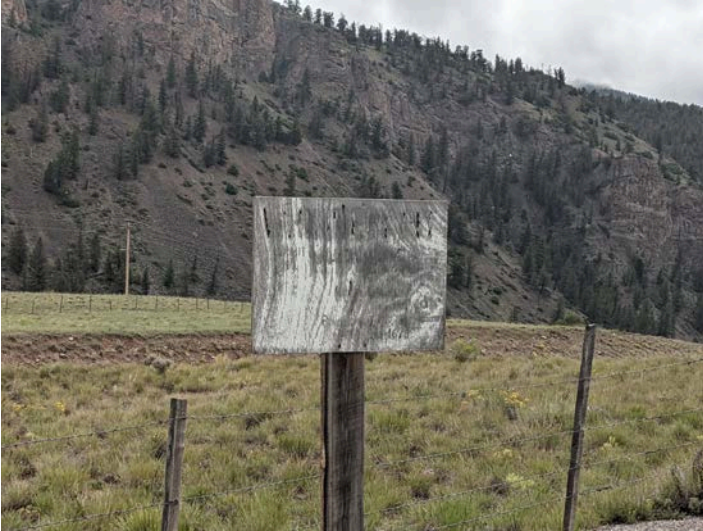
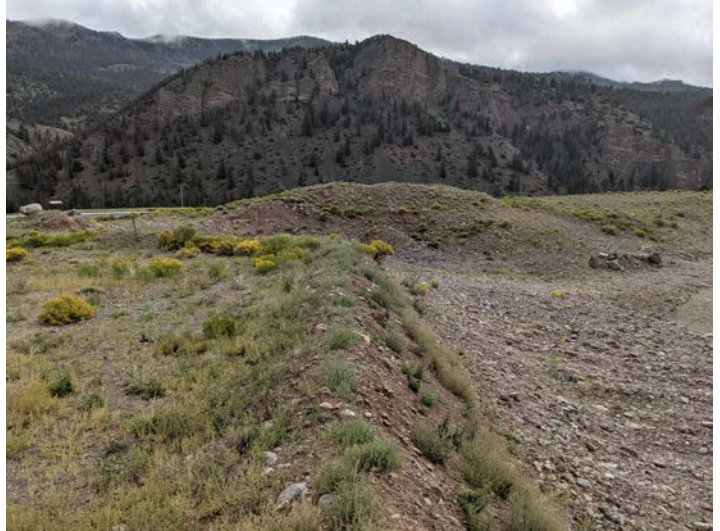
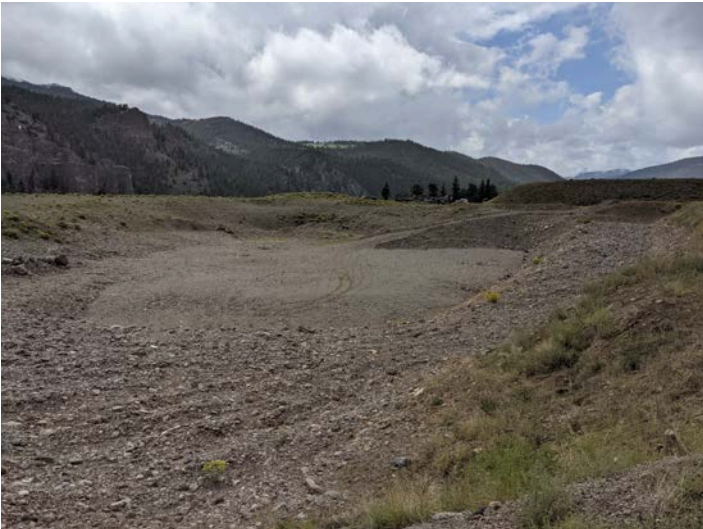
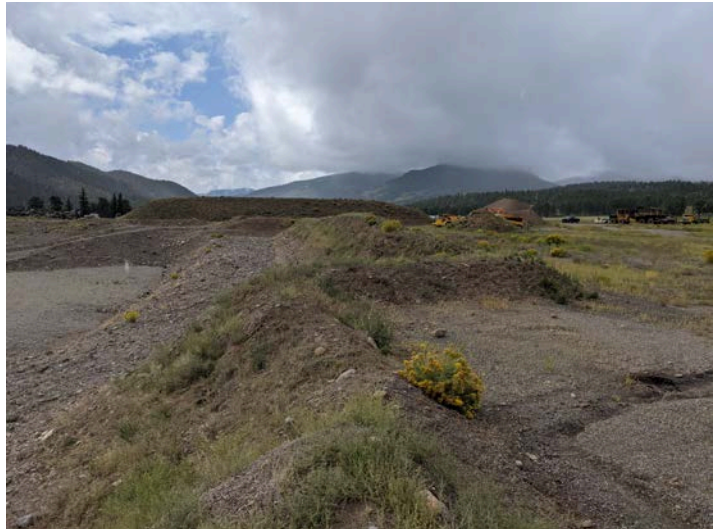
Adequate mine identification signage was not noted at the entrance to the site. The existing sign is weathered to the point that the lettering has become illegible. This has been noted as a problem.

The affected area was marked by posts and fencing that were clearly visible and adequate to delineate the affected area boundary.

Mining was not occurring during this inspection. Sand and gravel stockpiles are located on the south and west side of the pit. Mining equipment is parked near the stockpiles. The pit currently includes around four acres and is approximately twenty feet deep. Slopes around the pit range from 2-3H:1V. No stability or erosion concerns were noted. Topsoil is stockpiled on the south end of the pit. Overall, the site appears to be well maintained.

CORRECTIVE ACTIONS: The Operator shall, at the entrance of the mine site post a sign, which shall be clearly visible from the access road, with a minimum size equaling one hundred and eighty-seven (187) square inches, such as eleven (11) inches in height and seventeen (17) inches in width, with appropriate font size, with the following: the name of the Operator, a statement that a reclamation permit for the operation has been issued by the Colorado Mined Land Reclamation Board; and the permit number. The operator shall submit photo documentation that a proper sign has been posted by the corrective action date.
