PERMIT INFORMATION

| Permit Number: C-2009-087 Mine Name: Peabody Sage Creek Mine Operator: Peabody Sage Creek Mining, LLC Operator Address: Ms Mirdanda Kawcak 29515 Routt County Road 27 Oak Creek, CO 80467 | County: Routt Operation Type: Underground Permit Status: Temporary Cessation Ownership: Private |

INSPECTION INFORMATION

| Inspection Start Date: September 9, 2021 Inspection Start Time: 09:00 Inspection End Date: September 10, 2021 Inspection End Time: 12:00 | | Inspection Type: Coal Complete Inspection Inspection Reason: Normal I&E Program Weather: Clear | |

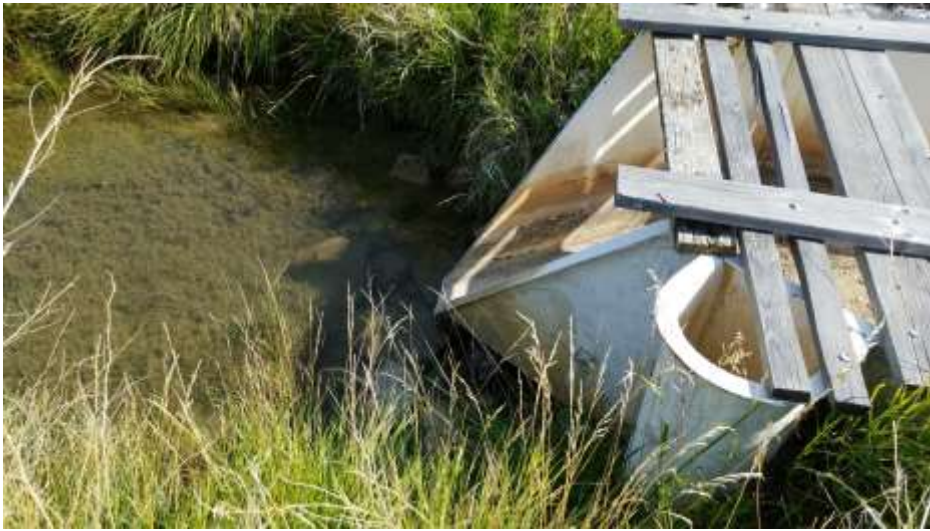
The upper sump, lower sump, pond 2, and Pecoco pond were observed and holding water and flowing from discharge points. Pond 3 was holding water and not discharging, Pond 4 was not observed as it was release with SL4. NPDES #7, which is at a ditch near the office that was not discharging.. There was some water present at the lower portal entrance. Springs on site were dry. **Erosional features were noted on the roads going down into the portal. Portal perimeter ditch will need to be cleared before spring. Flume pictured below was being undercut and water is no longer going through the flume, this requires repair. Vegetation debris needs to be cleared from the Upper sump outfall. Pipes are still dripping coming out of the bottom of pond 2, just east of the shop pad. This should be repaired before winter so another break does not occur.**

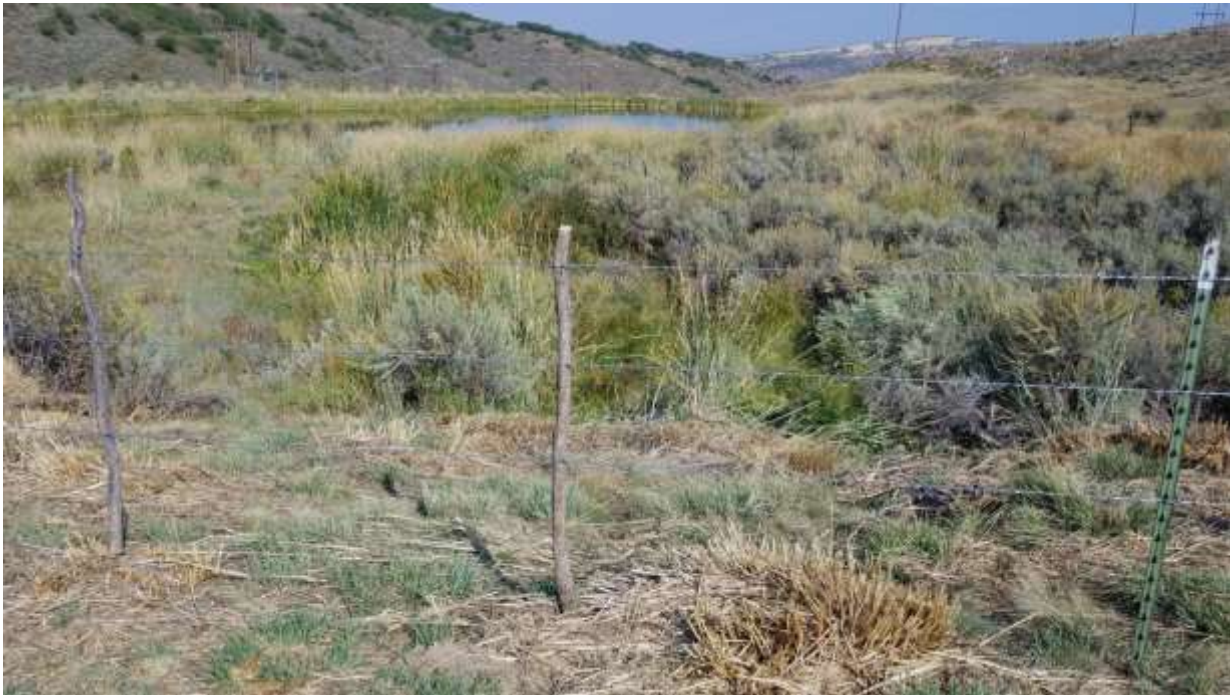
Some non-coal waste needs to be cleaned up around the pads. Weeds on site need to be sprayed. Disturbance boundary markers are down or absent and should be reestablished. A new cattle fence is present just downstream of the Pecoco pond, shown below.
