## Lorencito Canyon Mine, C-1996-084, Inspection Report

**PERMIT INFORMATION**

**INSPECTION INFORMATION**

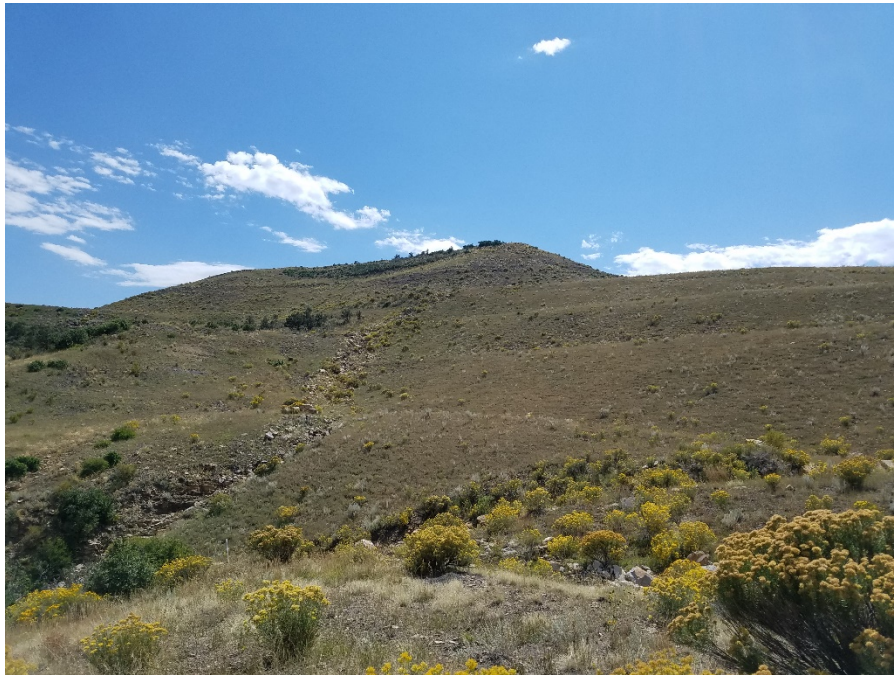
*Figure 1. Fill 8*

Fills 7, 8, and 9 were observed. The face of these fills are vegetated and stable. The adjacent rock lined ditches were clear and functional.

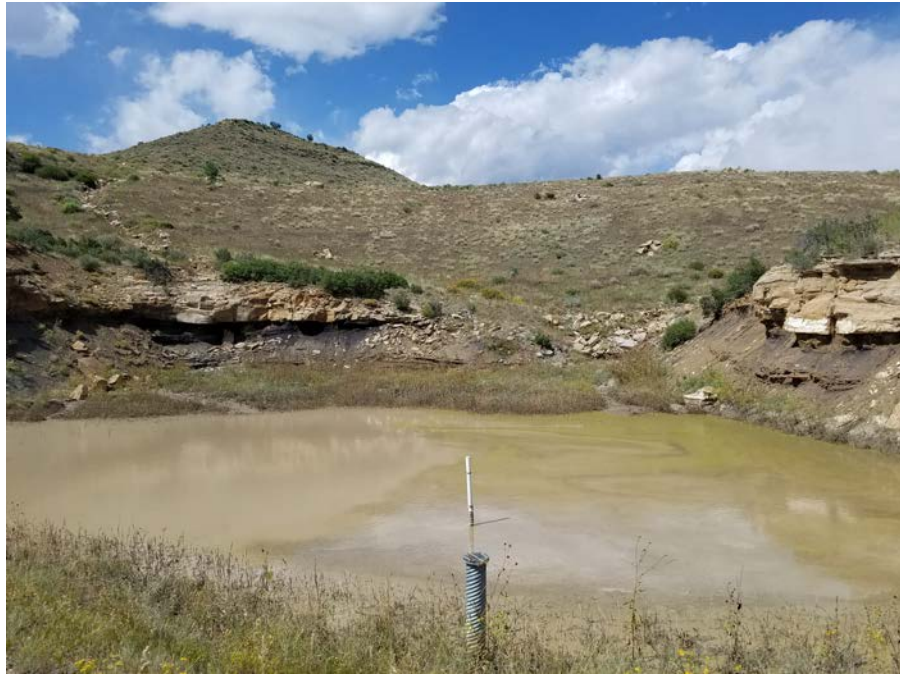
*Figure 3. Pond 009a, and Fill 9*

Pond 009a was holding water but not discharging. The embankment was stable and vegetated. The standpipe was clear and functional.
