COLORADO
Division of Reclamation,
Mining and Safety
Department of Natural Resources

Permit Number: C-1992-081 Mine Name: Hayden Gulch Loadout Operator: Hayden Gulch Terminal, LLC Operator Address: Ms Miranda Kawcak P.O. Box 670 Hayden, CO 81639	County: Routt Operation Type: Loadout Permit Status: Active Ownership: Private Operator Representative Present: None
Operator Representative Signature: (Field Issuance Only)

Inspection Start Date: October 20, 2021 Inspection Start Time: 12:00 Inspection End Date: October 20, 2021 Inspection End Time: 15:00		Inspection Type: Coal Complete Inspection Inspection Reason: Normal I&E Program Weather: Clear	
Joint Inspection Agency: None		Joint Inspection Contacts: 	
Post Inspection Agency: None		Post Inspection Contacts: 	
Inspector(s): Tabetha Lynch	Inspector's Signature:

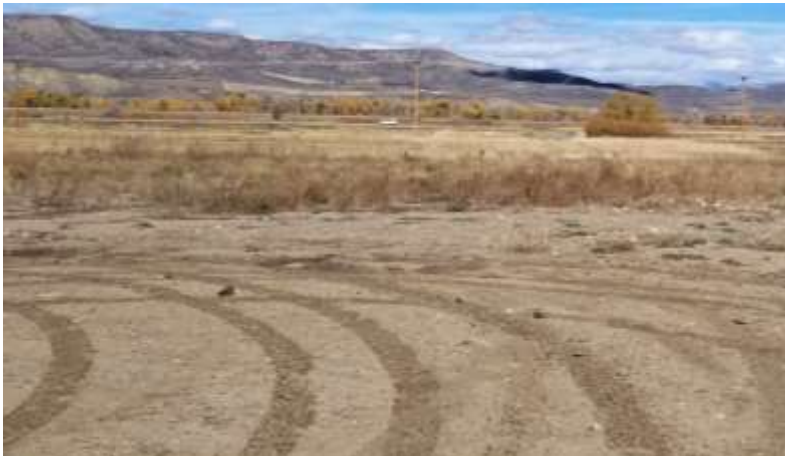
All railroad tracks have been removed. Area to the north of Hwy 40 is being reclaimed back to an agricultural field and progress appears to be going well.

Image above is from parking lot looking North across Hwy40
