## Inspection report

| <b>Permit Number:</b> C-1981-028<br><b>Mine Name:</b> Keenesburg Strip Mine<br><b>Operator:</b> Coors Energy Company<br><b>Operator Address:</b><br>Mr. Ben Moline<br>PO Box 4030<br>Golden, CO 80402 | <b>County:</b> Weld<br><b>Operation Type:</b> Surface<br><b>Permit Status:</b> Permanent Cessation<br><b>Ownership:</b> Private |

| <b>Inspection Start Date:</b> October 29, 2021<br><b>Inspection Start Time:</b> 12:40<br><b>Inspection End Date:</b> October 29, 2021<br><b>Inspection End Time:</b> 14:00 | <b>Inspection Type:</b> Coal Complete Inspection<br><b>Inspection Reason:</b> Normal I&E Program<br><b>Weather:</b> Clear |

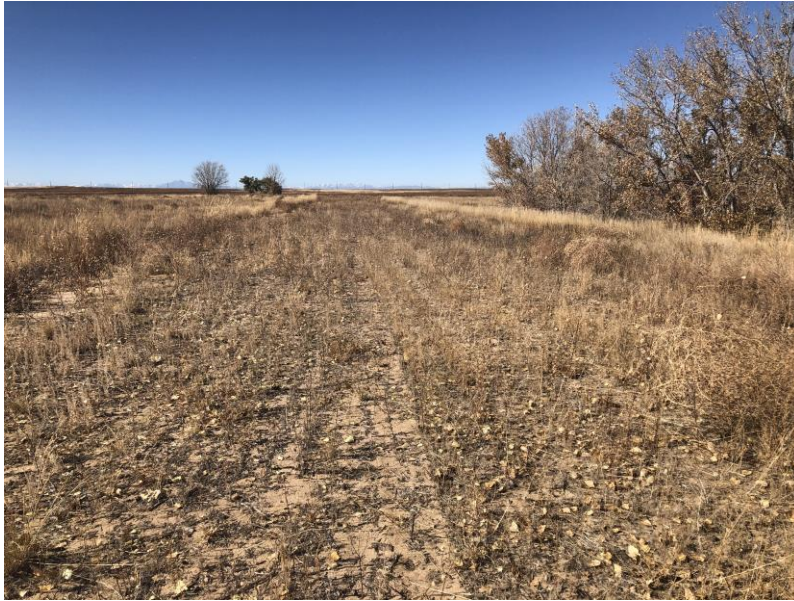
Sunflowers and undesirable species (cheat grass, kochia, and Russian thistle) are the predominant species in most of the newly reclaimed areas. These include the reclaimed road adjacent to Sediment Pond 2, Area 42, reclaimed topsand piles, and the eastern part of the Long Term Spoil Area. Grasses were sparse at many newly reclaimed areas.

**Road next to Sediment Pond 2**

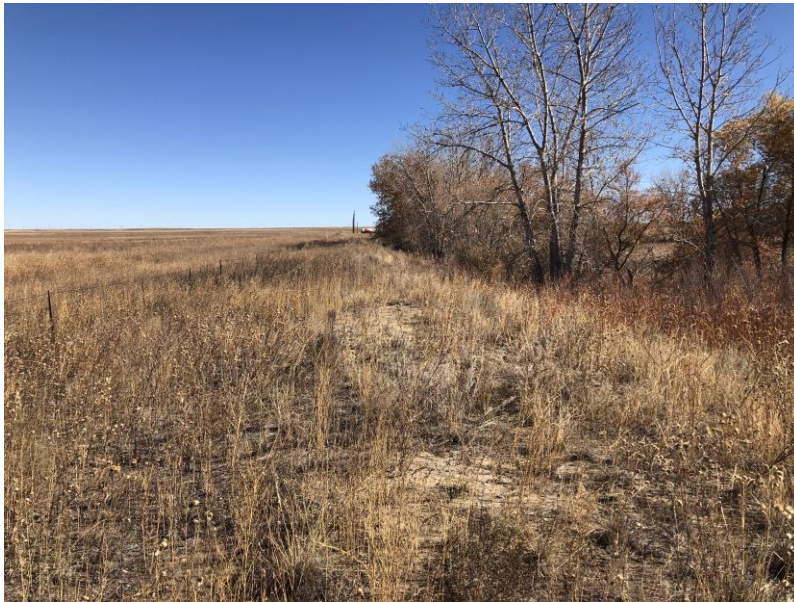
Sediment Pond 2 and the Dugout Pond contained little to no water (thick vegetation obscures the bottoms). Neither pond was discharging during the inspection. There were no signs that they had discharged recently. No problems were observed with the two ponds.

**Sediment Pond 2 embankment**

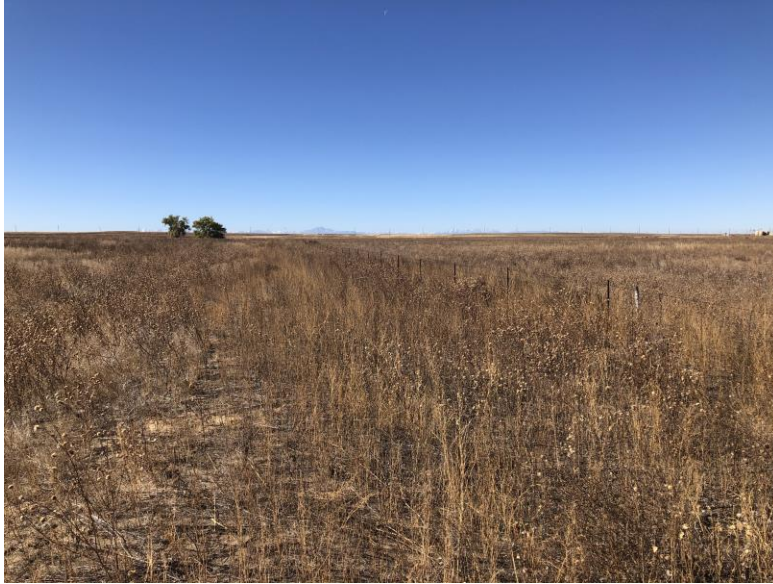
The eastern portion of the northern boundary of the site (including the ditch to Sediment Pond 2) was observed, and no signs of pollutant loading from the mine site, or any other problems, were seen.

**Northern side of mine**

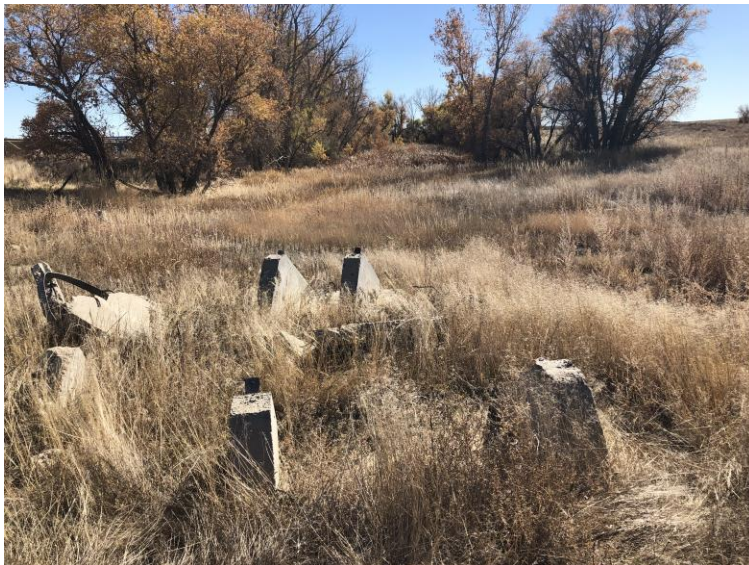
**Dugout Pond spillway**
