**PERMIT INFORMATION**

<b>Permit Number:</b> C-1982-056 <b>Mine Name:</b> Foidel Creek Mine <b>Operator:</b> Twentymile Coal, LLC <b>Operator Address:</b> Ms Miranda Kawcak 29515 Routt County Road No. 27 Oak Creek, CO 80467	<b>County:</b> Routt <b>Operation Type:</b> Underground <b>Permit Status:</b> Active <b>Ownership:</b> Private
	<b>Operator Representative Present:</b>  Kevin Copeland
<b>Operator Representative Signature: (Field Issuance Only)</b>

<b>Inspection Start Date:</b> December 13, 2021 <b>Inspection Start Time:</b> 10:00 <b>Inspection End Date:</b> <b>Inspection End Time:</b>	<b>Inspection Type:</b> Coal Partial Inspection <b>Inspection Reason:</b> Normal I&E Program <b>Weather:</b> Clear
<b>Joint Inspection Agency:</b>  None	<b>Joint Inspection Contacts:</b>  
<b>Post Inspection Agency:</b>  None	<b>Post Inspection Contacts:</b>  
<b>Inspector(s):</b>  Tabetha Lynch	<b>Inspector's Signature:</b>

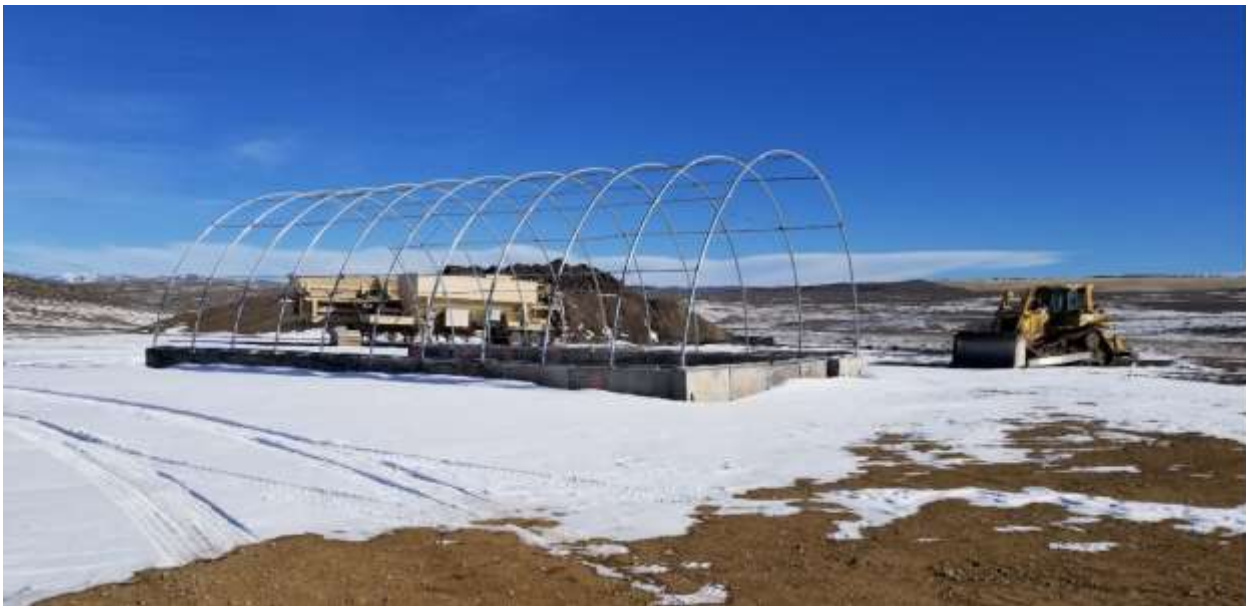
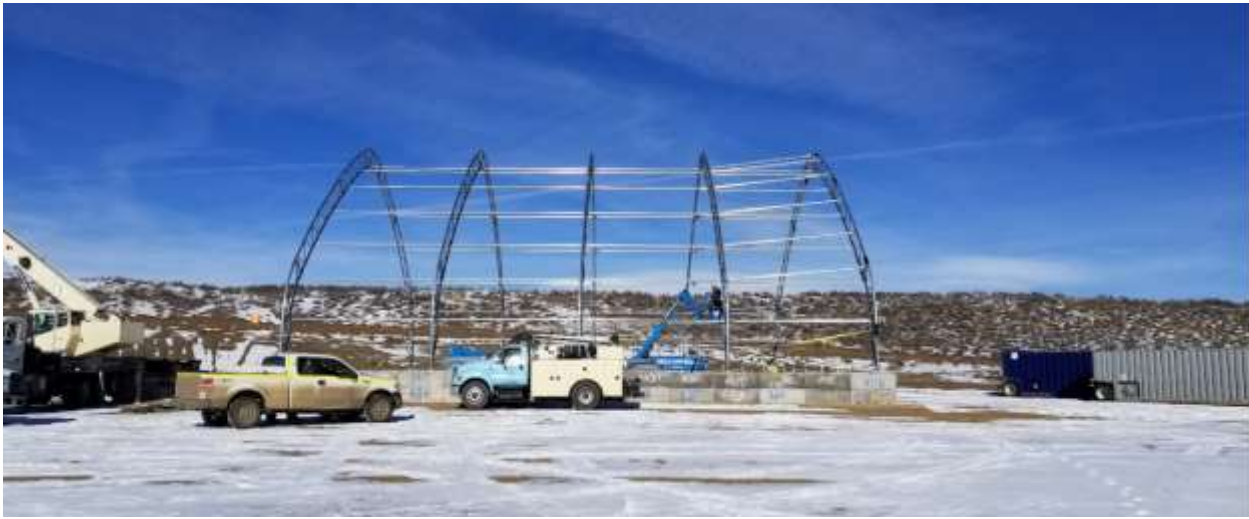
At the 7E, cement drop pad, permitted by the Division under TR97, multiple structures were noted by the Division at the time of inspection. Per the operator these are temporary structures owned by the contractor for the required cement work required. However these structures are not currently accounted for within the Divisions reclamation cost estimate. **Please provide the Division with an MR including these temporary structures in the reclamation cost estimate (RCE) or provide the Division a rational on why these structures have not been included in the RCE. Photos are below.**
