**RE: Permit No. M-1980-244; Cripple Creek & Victor Gold Mining Company; Cresson Project;
Schist Island Backfill Weekly Report**

FIELD WEEKLY PROGRESS REPORT

PROJECT: VALLEY LEACH FACILITY (VLF2) PHASE 3 CQA HIGH COMPACTION BACKFILL
SITE: CRIPPLE CREEK & VICTOR GOLD MINE (COLORADO)
CONTRACTOR: NEWMONT CC&V MINING OPERATIONS
WEEK ENDING: FRIDAY, JANUARY 7, 2022

REPORTING PERIOD: 01.01.2022 THROUGH 01.07.2022

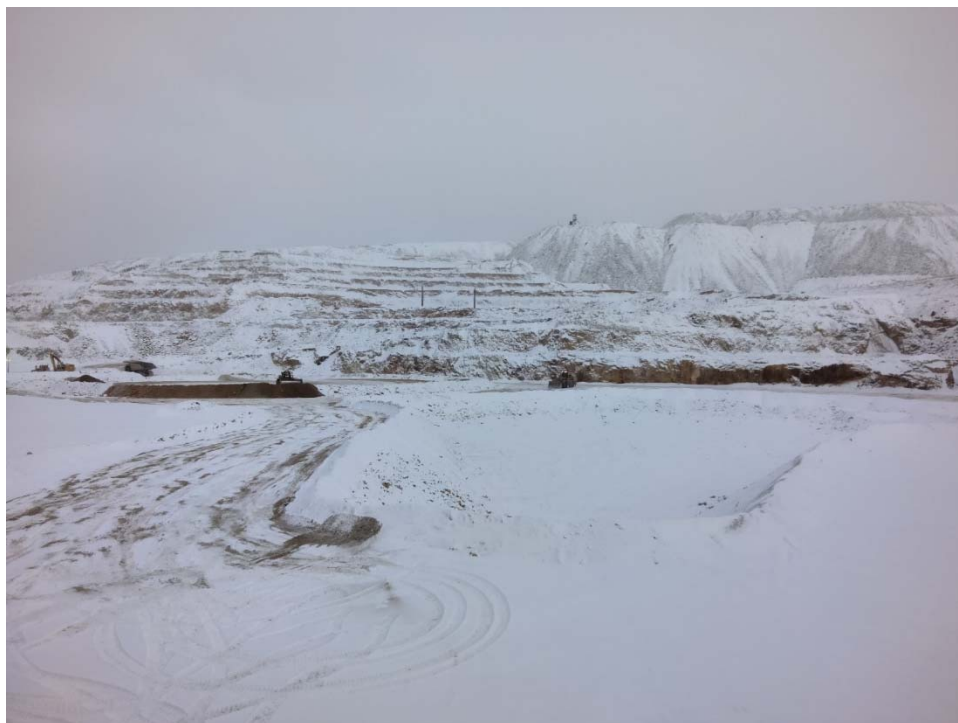
January 1, 2022 – High Compaction Backfill snow removal with loader (CC&V Supervisor)

- Newmont personnel removed accumulated snow from out in front of the leading edge of the 9970' lift on 1/1/2022.
- NewFields personnel completed the approval of the 9970' lifts. Visual inspection and the method compaction specification were utilized to approve the lift.
- A progress map provided by Newmont CC&V was utilized to create the attached figures showing high compaction backfill progress.

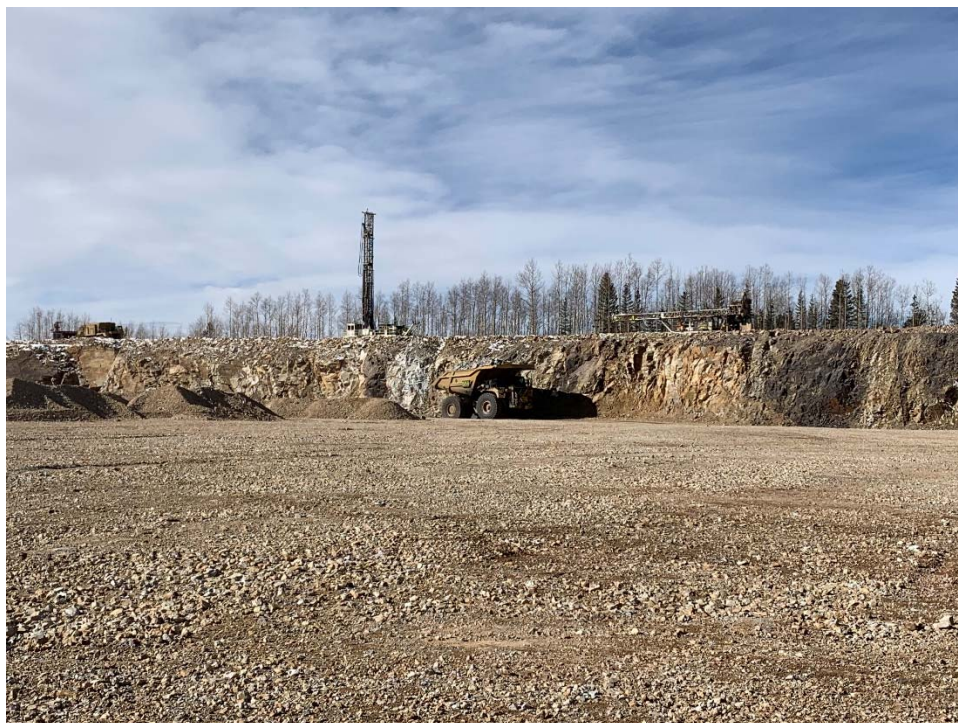
January 4, 2022 – High Compaction Backfill wheel rolling (TW)

CC&V completed the placement of the 9970' elevation high compaction backfill lift. CC&V began the placement of the 9975' elevation high compaction backfill lift. Run of Mine material was loaded from the Schist Island Pit and West/South Cresson Pit and hauled by 793 haul trucks to the high compaction backfill. A D10 dozer placed material in a 5 foot GPS controlled leading edge lift. The haulage traffic travelled over the entirety of the fill, splitting tracks with each loaded haul

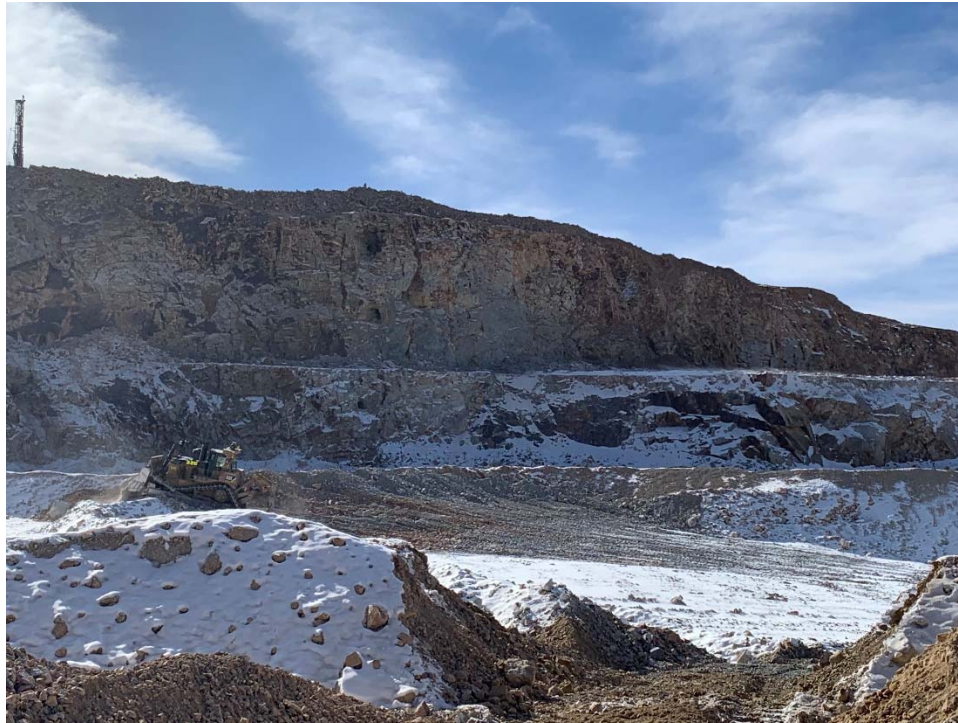
January 4, 2022 – Contour Grading of the PSSA floor (TW)

Contour grading continued in the floor of the PSSA. A D10 dozer graded overburden backfill material to the edges of the backfill placement for future removal from the bottom of the pond.
