January 25, 2022
Project#01349-0001

Subject: Summary of Instrumentation Monitoring
4th Quarter 2021
Bowie Coal Waste Disposal Area No. 3
Paonia, Colorado

**SUBJECT: Summary Report, 4th Quarter 2021, Vibrating Wire Piezometers
October – December 2021, Bowie Mine #2
Coal Waste Disposal Area (CWDA) #3**

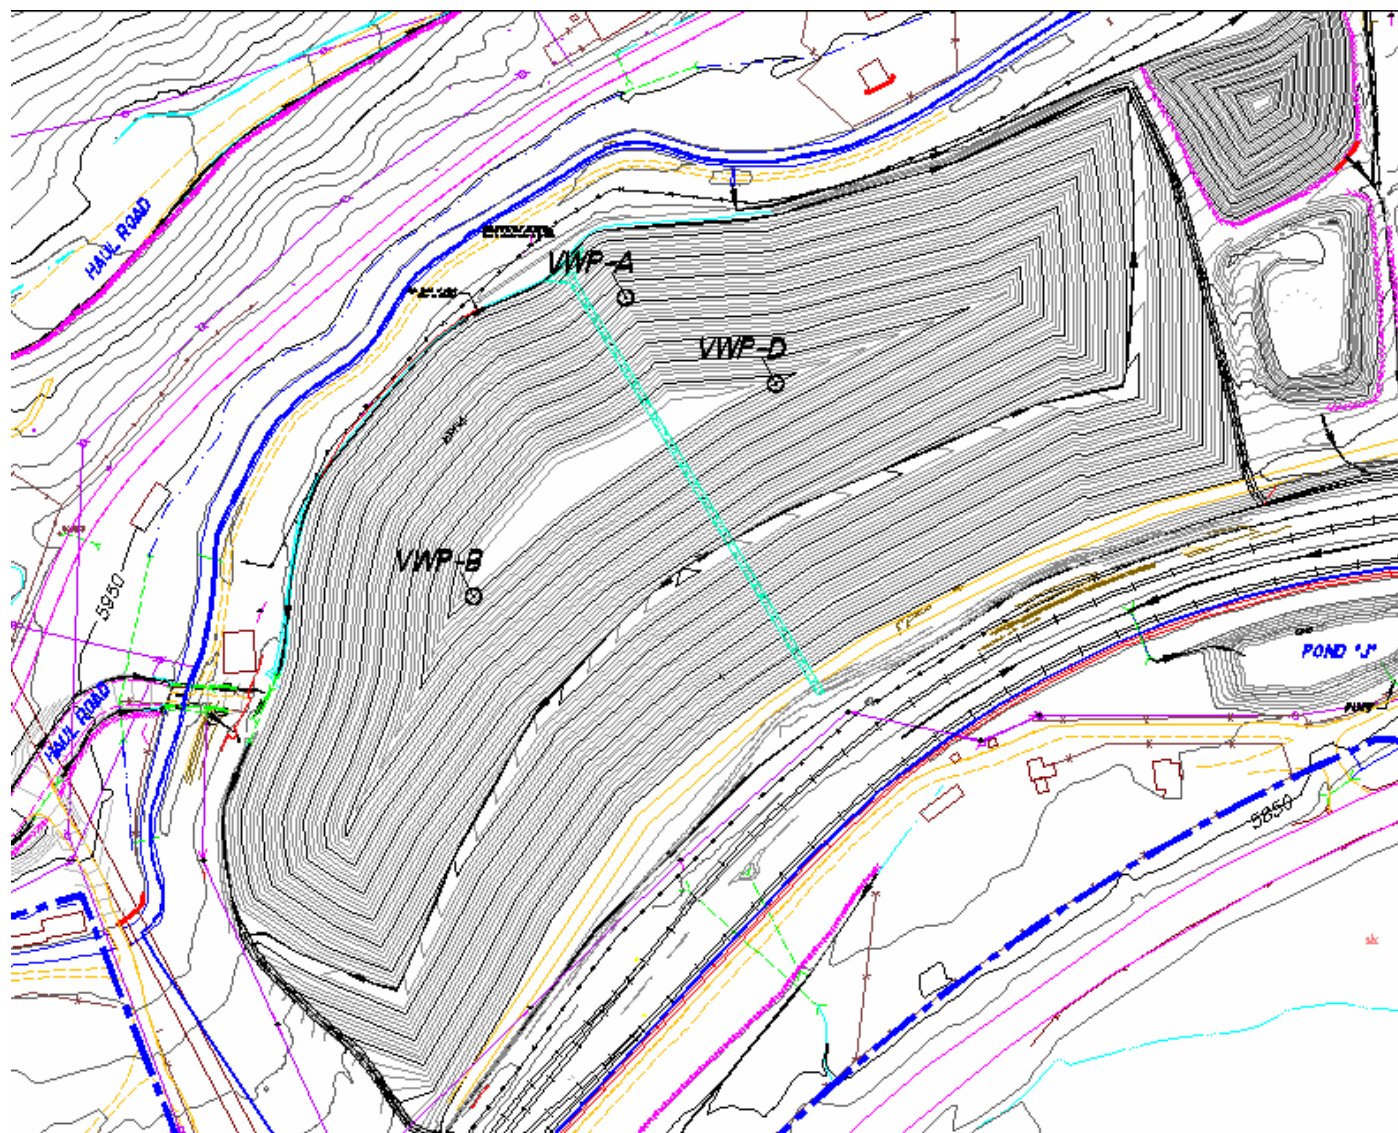
Five vibrating wire piezometers were installed in CWDA No. 3 in October 2014. The piezometers were installed at three locations within the footprint of the gob pile as shown on the attached figure. Monitoring of the functioning piezometers was completed by Buckhorn Engineering (Buckhorn) on December 27th, 2021. The attached monitoring report prepared by Buckhorn includes the piezometer monitoring data and the data is summarized in the following table.

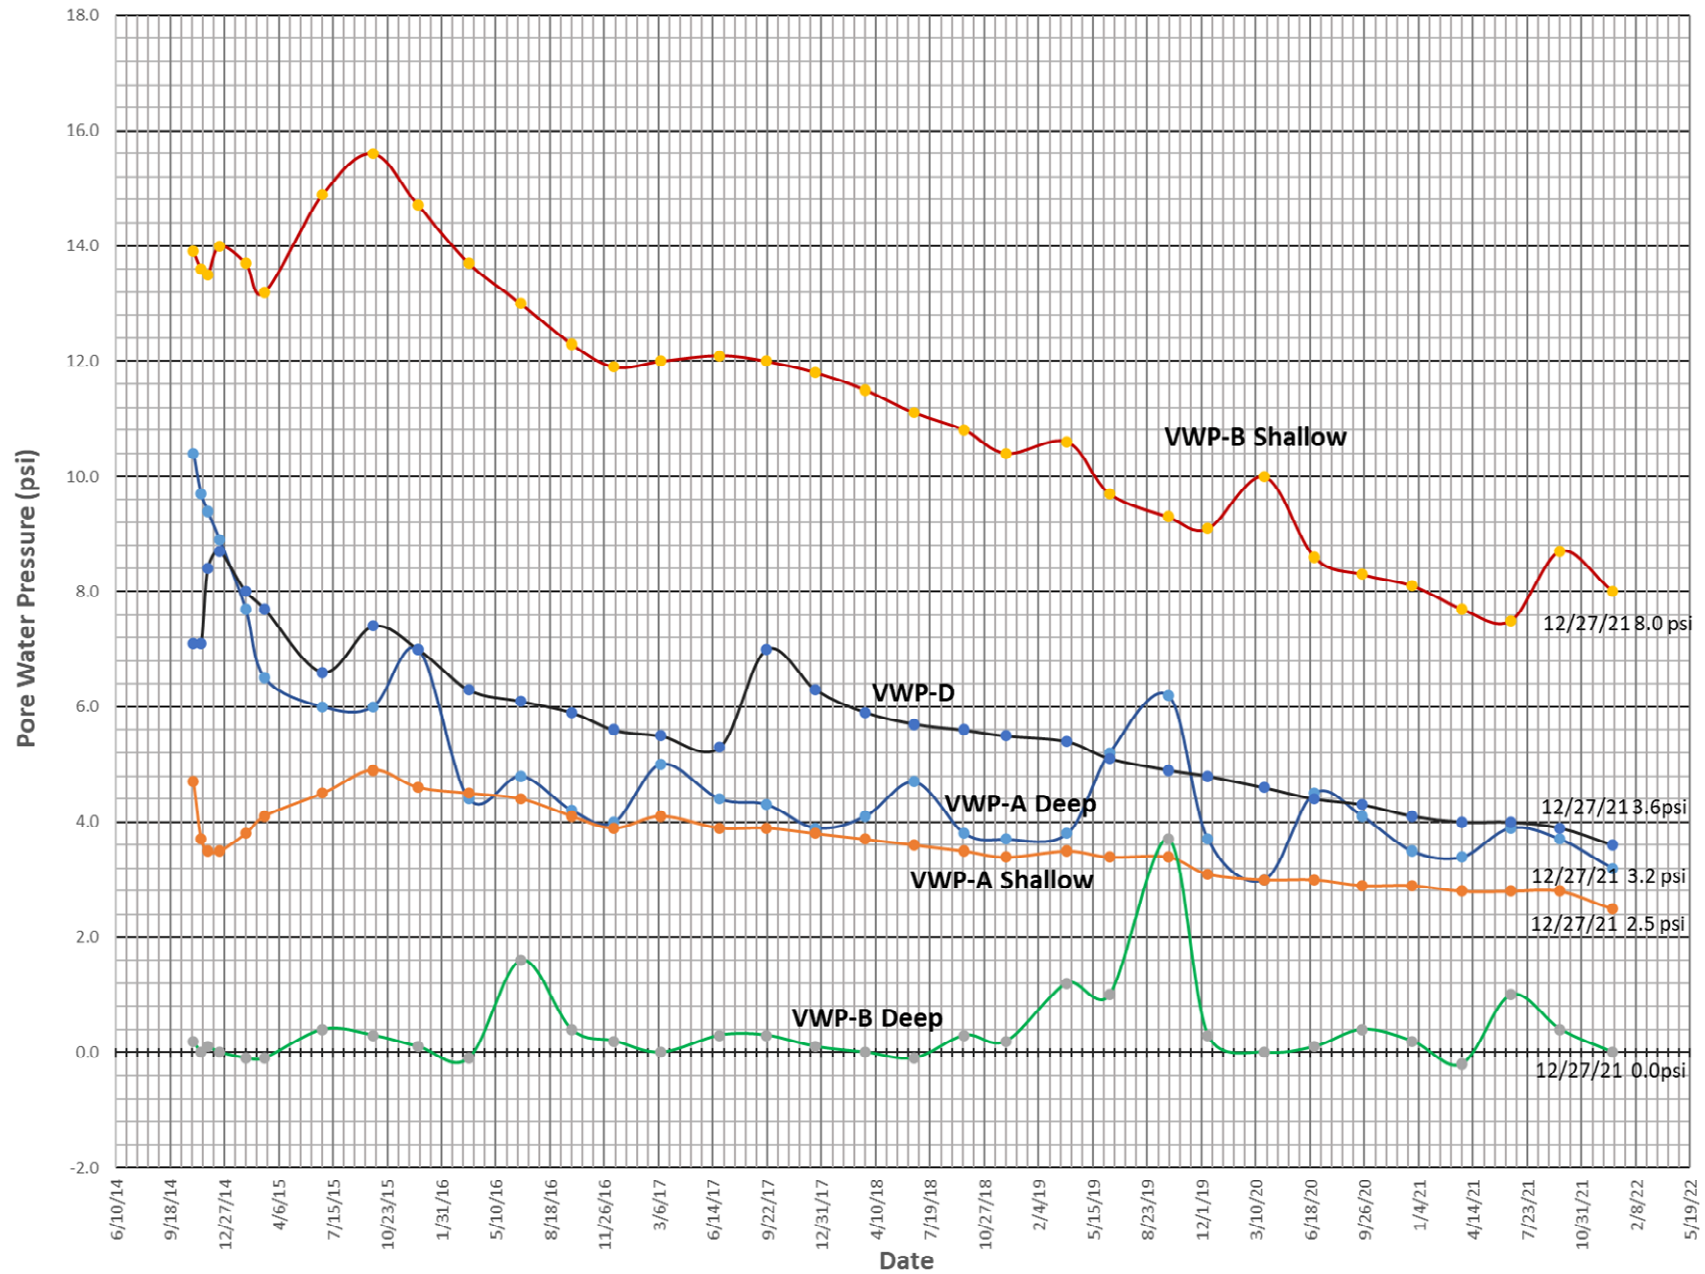
Figure 1 - Bowie Mine #2 - CWDA #3
Vibrating Wire Piezometer Data

As seen on Figure 1 and Table 1, all five VWP's decreased in pore pressure when compared with the previous quarter and when compared with the 4th quarter of last year. Also, all five VWP's have decreased in pore pressure since installation in 2014. Although there is a general trend of decreasing pore pressure over time, three of the piezometers (VWP-A Deep, VWP-B-Deep and VWP-B Shallow) have some erratic behavior in 2019 and some minor fluctuations in the summer readings.

We present a graph of measured pore pressures on the attached Figure 1 and numerically in Table 1 below. Table 1 is a summary of the initial, last year, last quarter and current readings. In addition, we present the difference between the current pore pressures and those at the time of installation, the previous quarter, and previous year.
