Re: Permit No. M-1980-244; Cripple Creek & Victor Gold Mining Company ("CC&V"); Cresson Project – Notification of Water Quality Analysis Parameter Exceedance February 2, 2022

In accordance with Rule 3, Section 3.1.7 (9) of the Mineral Rules and Regulations of the Colorado Mined Land Reclamation Board for Hard Rock, Metal, and Designated Mining Operations (Rules), the Cripple Creek and Victor Gold Mining Company (CC&V) hereby provide the Division of Reclamation, Mining, and Safety (Division) with a formal notification of water quality parameter exceedances.

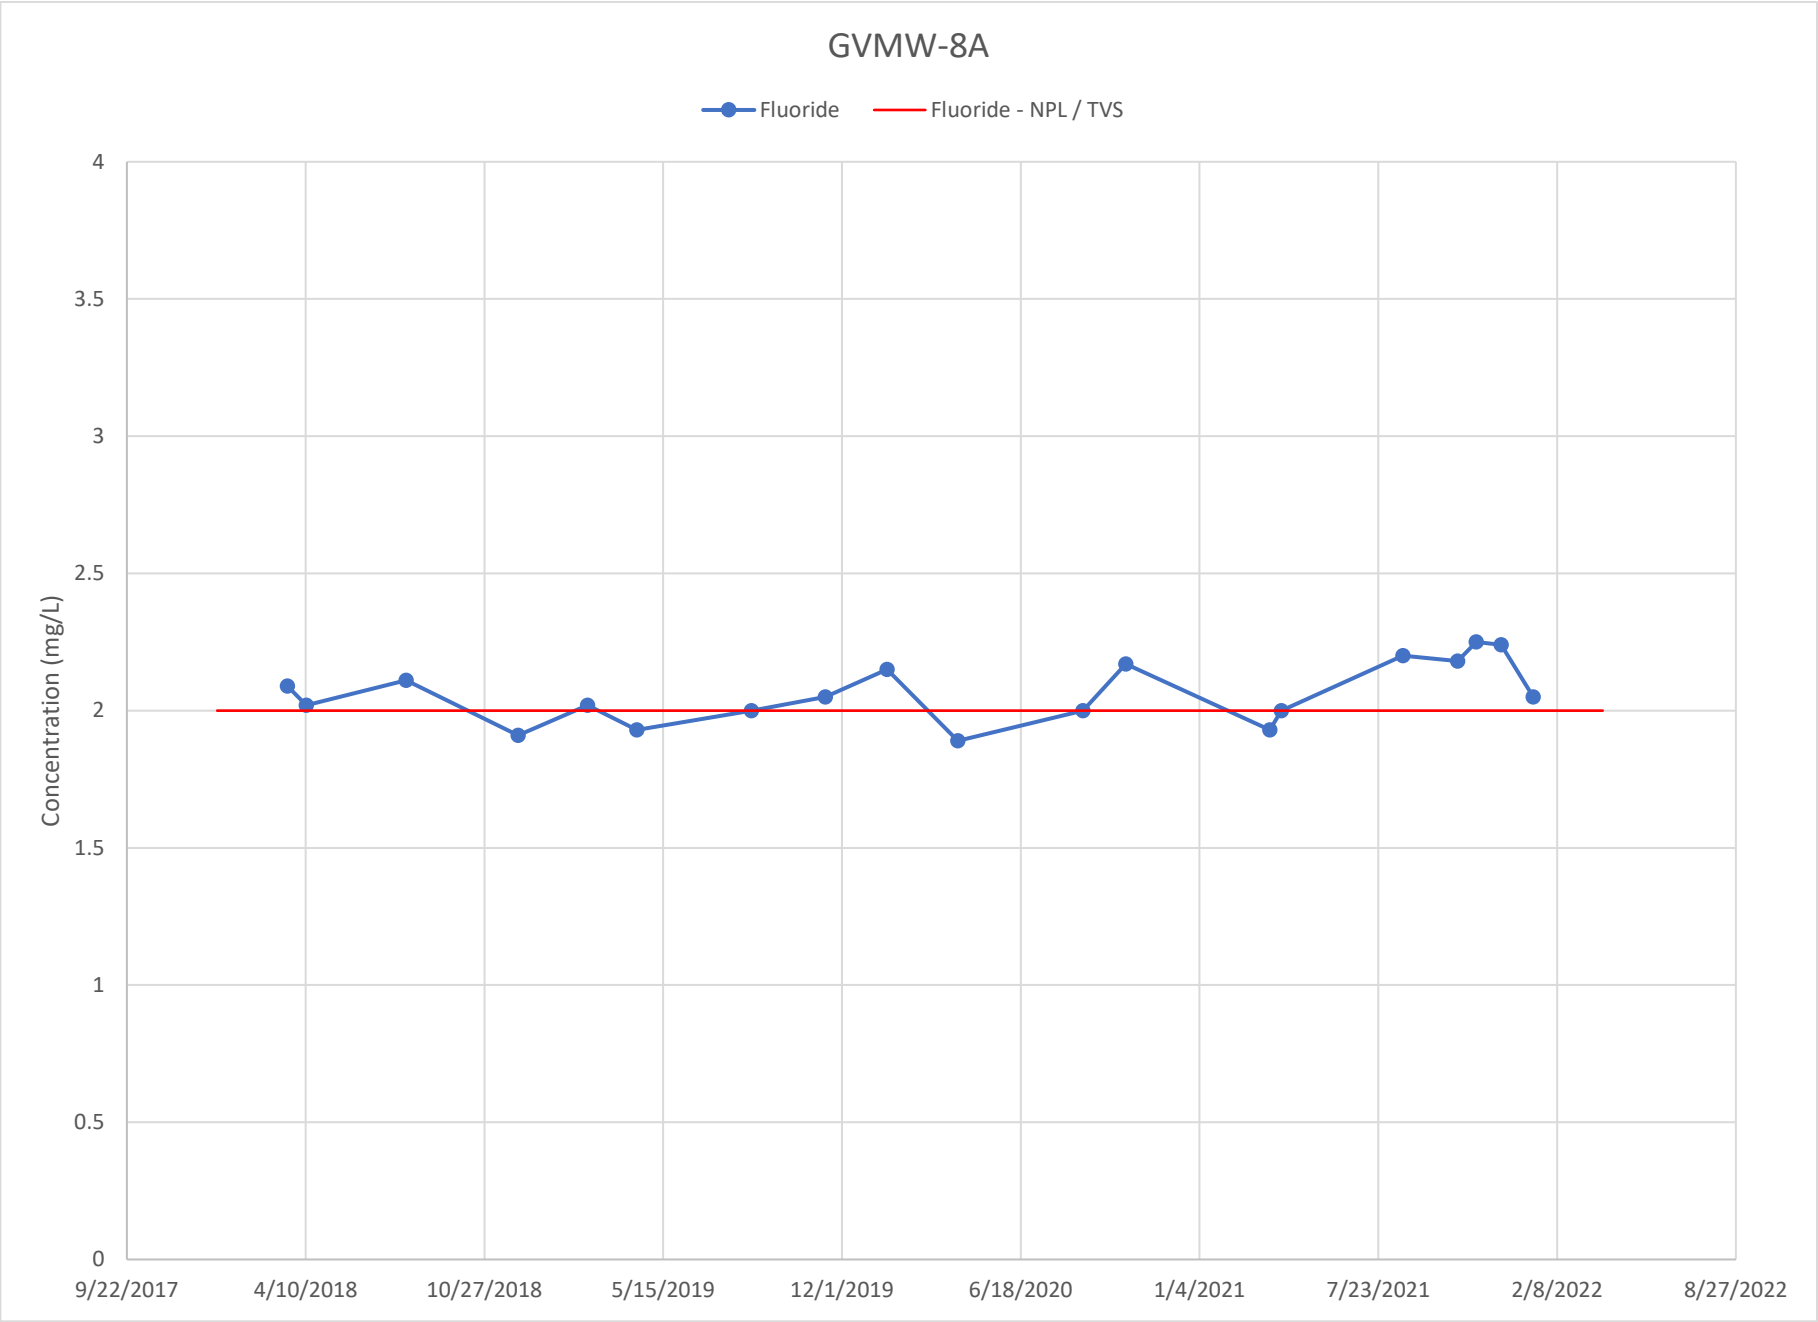
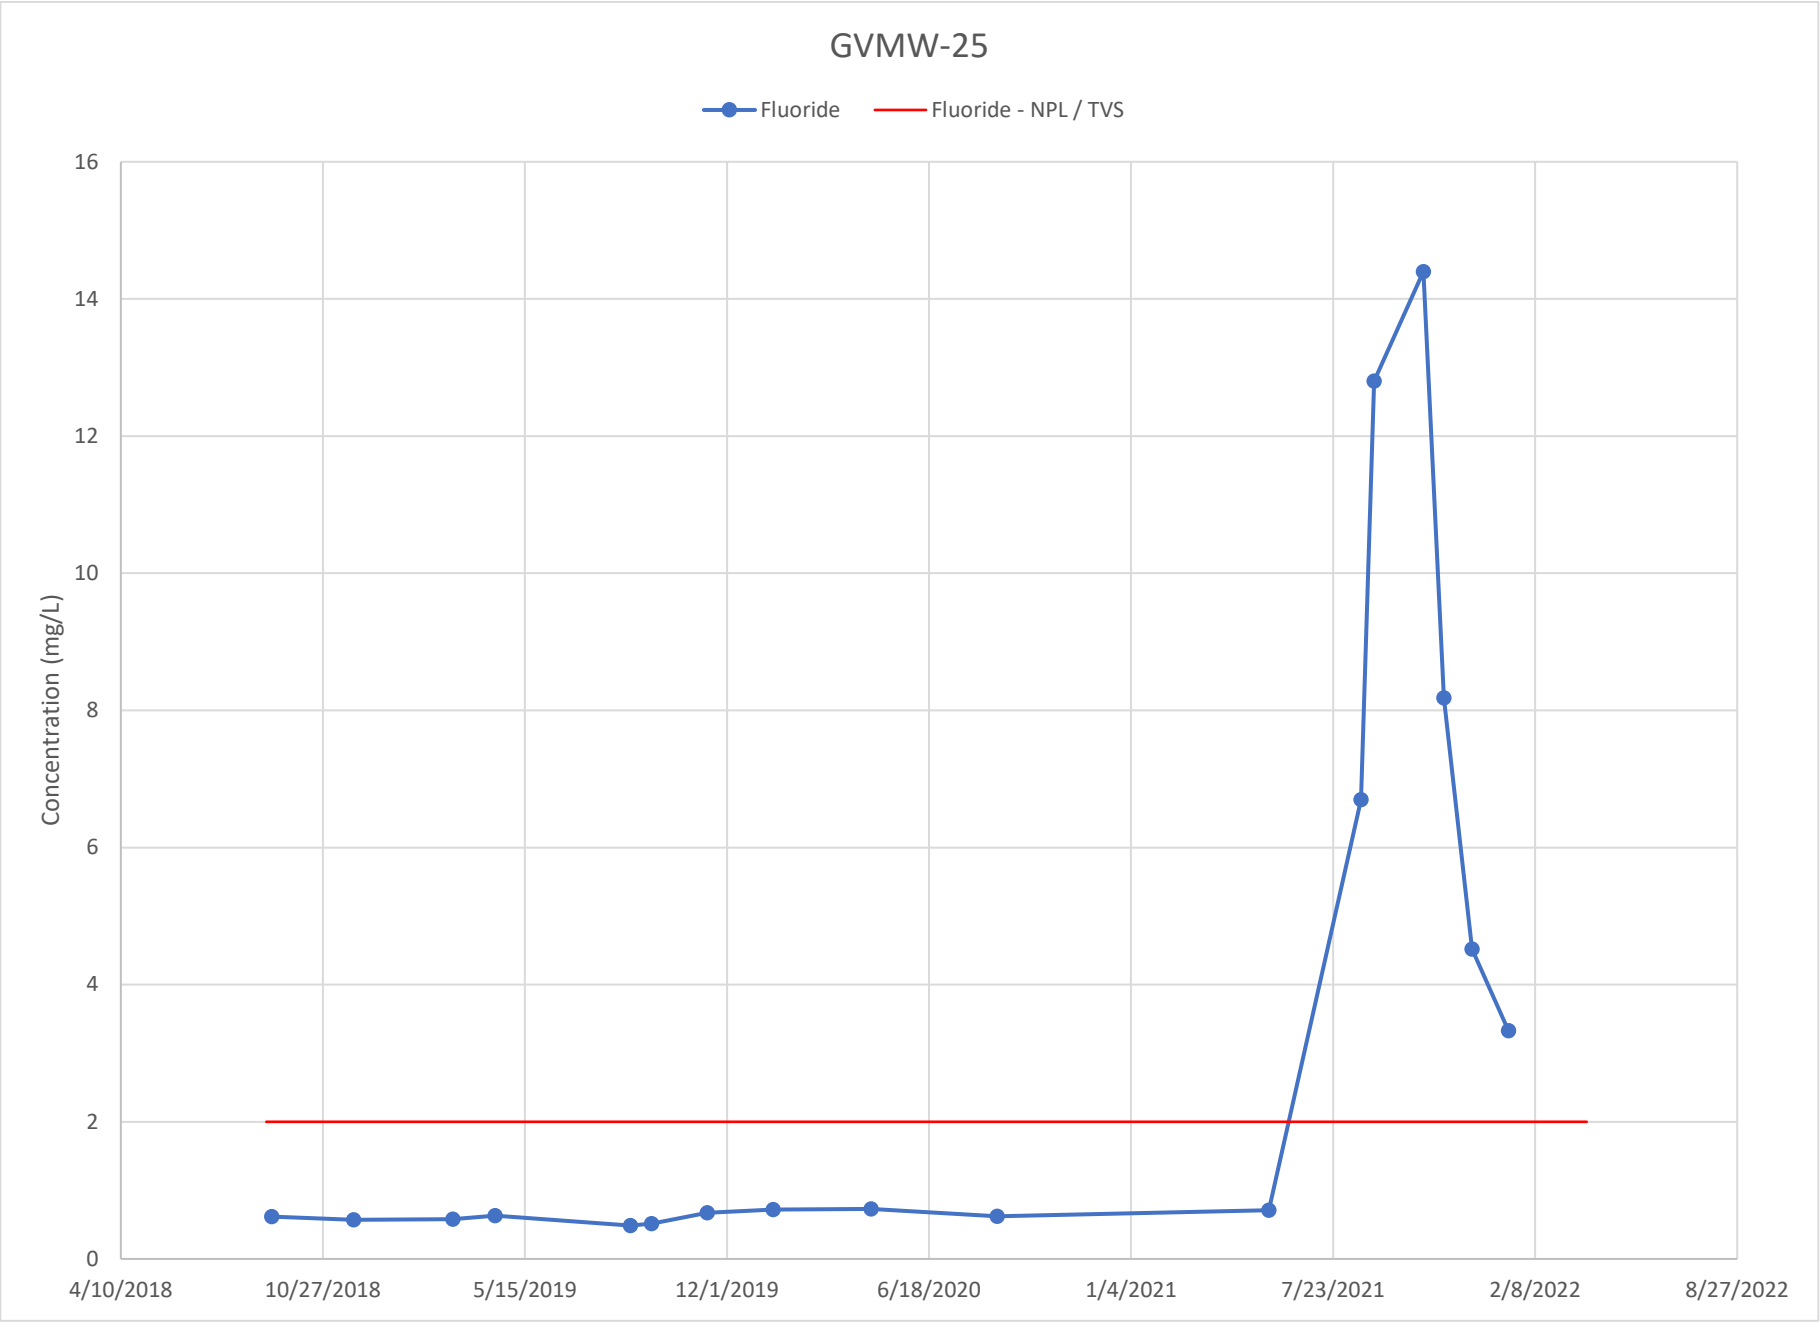
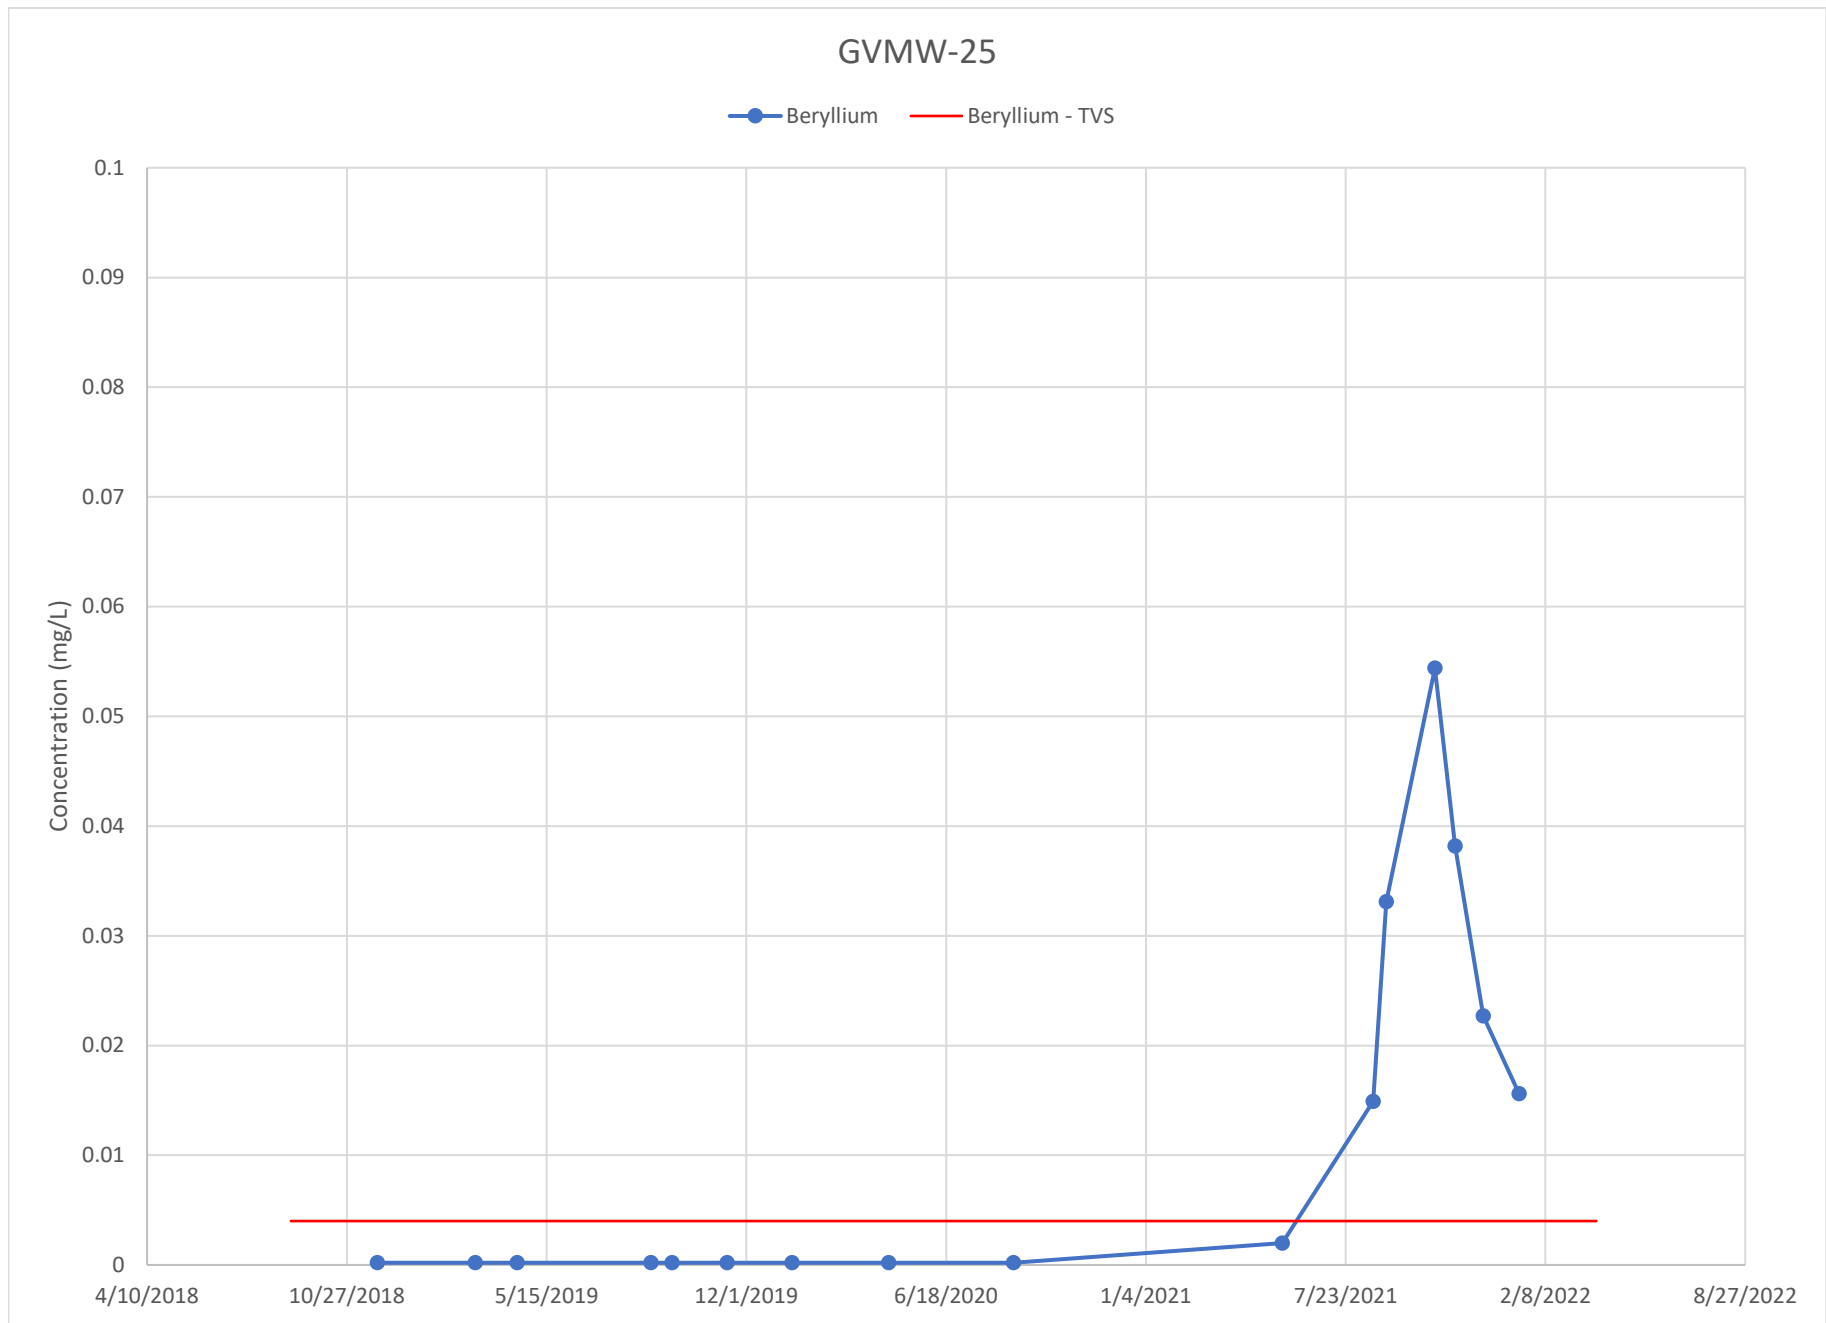
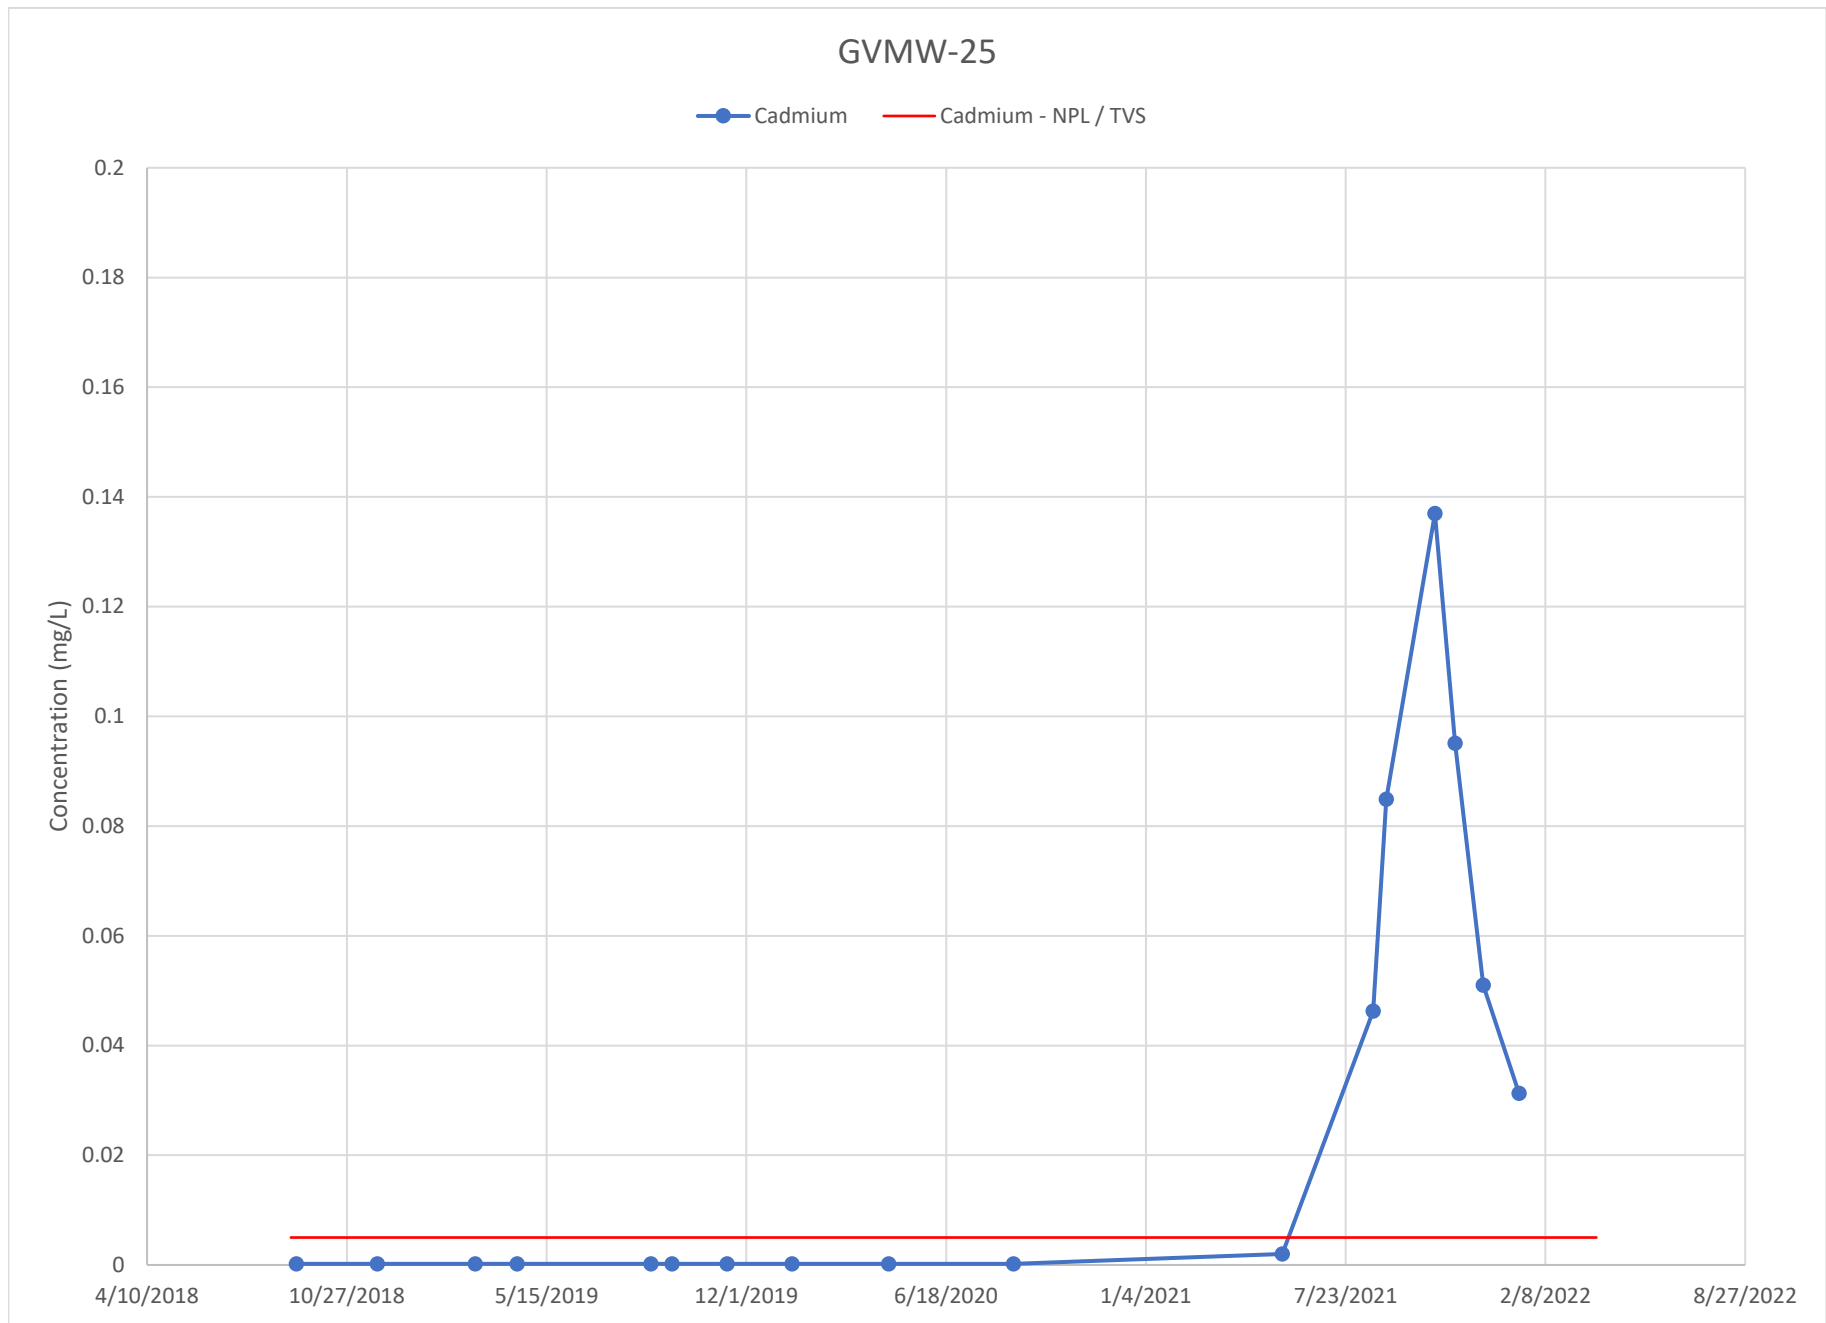
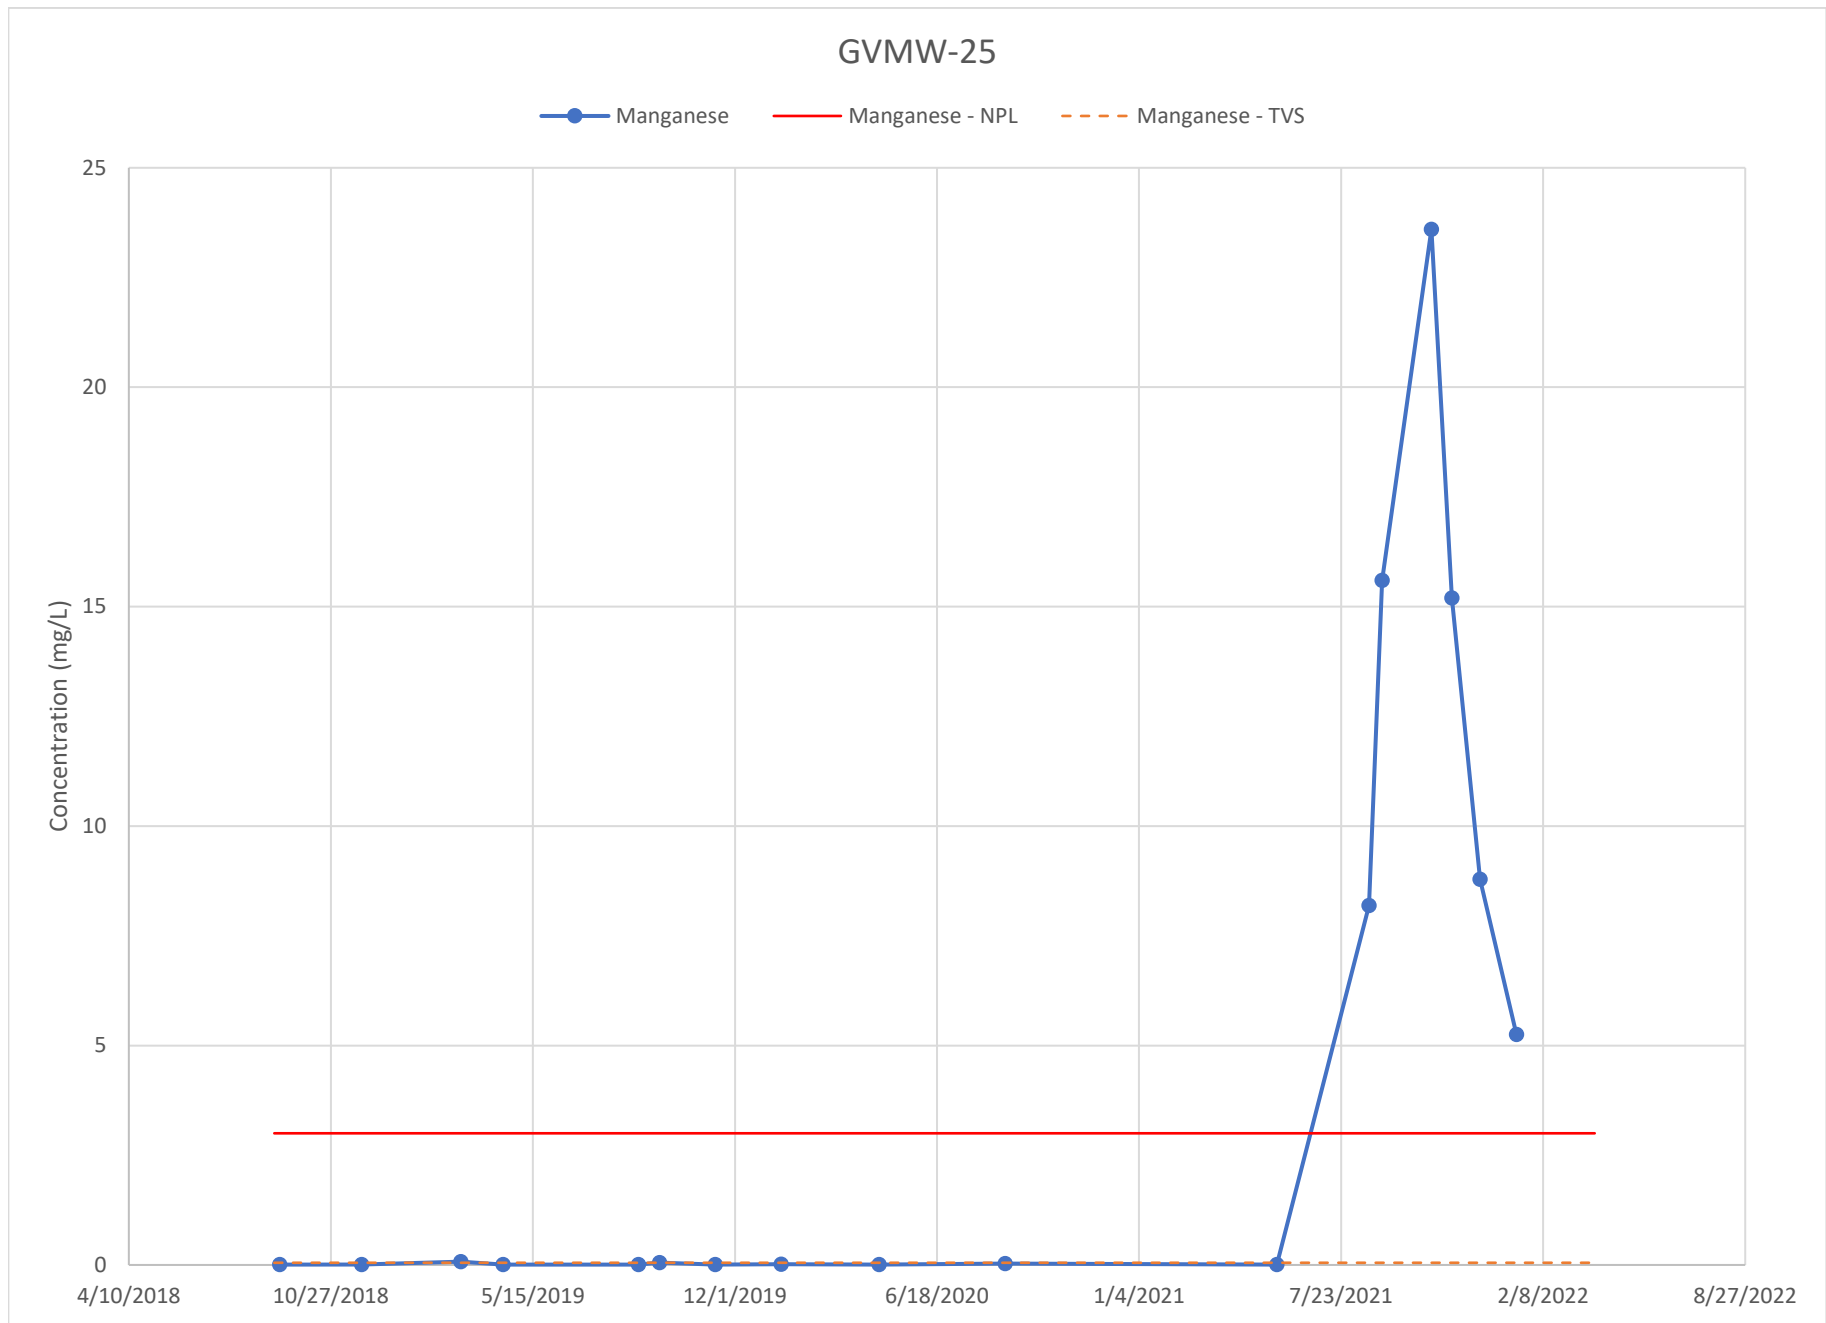
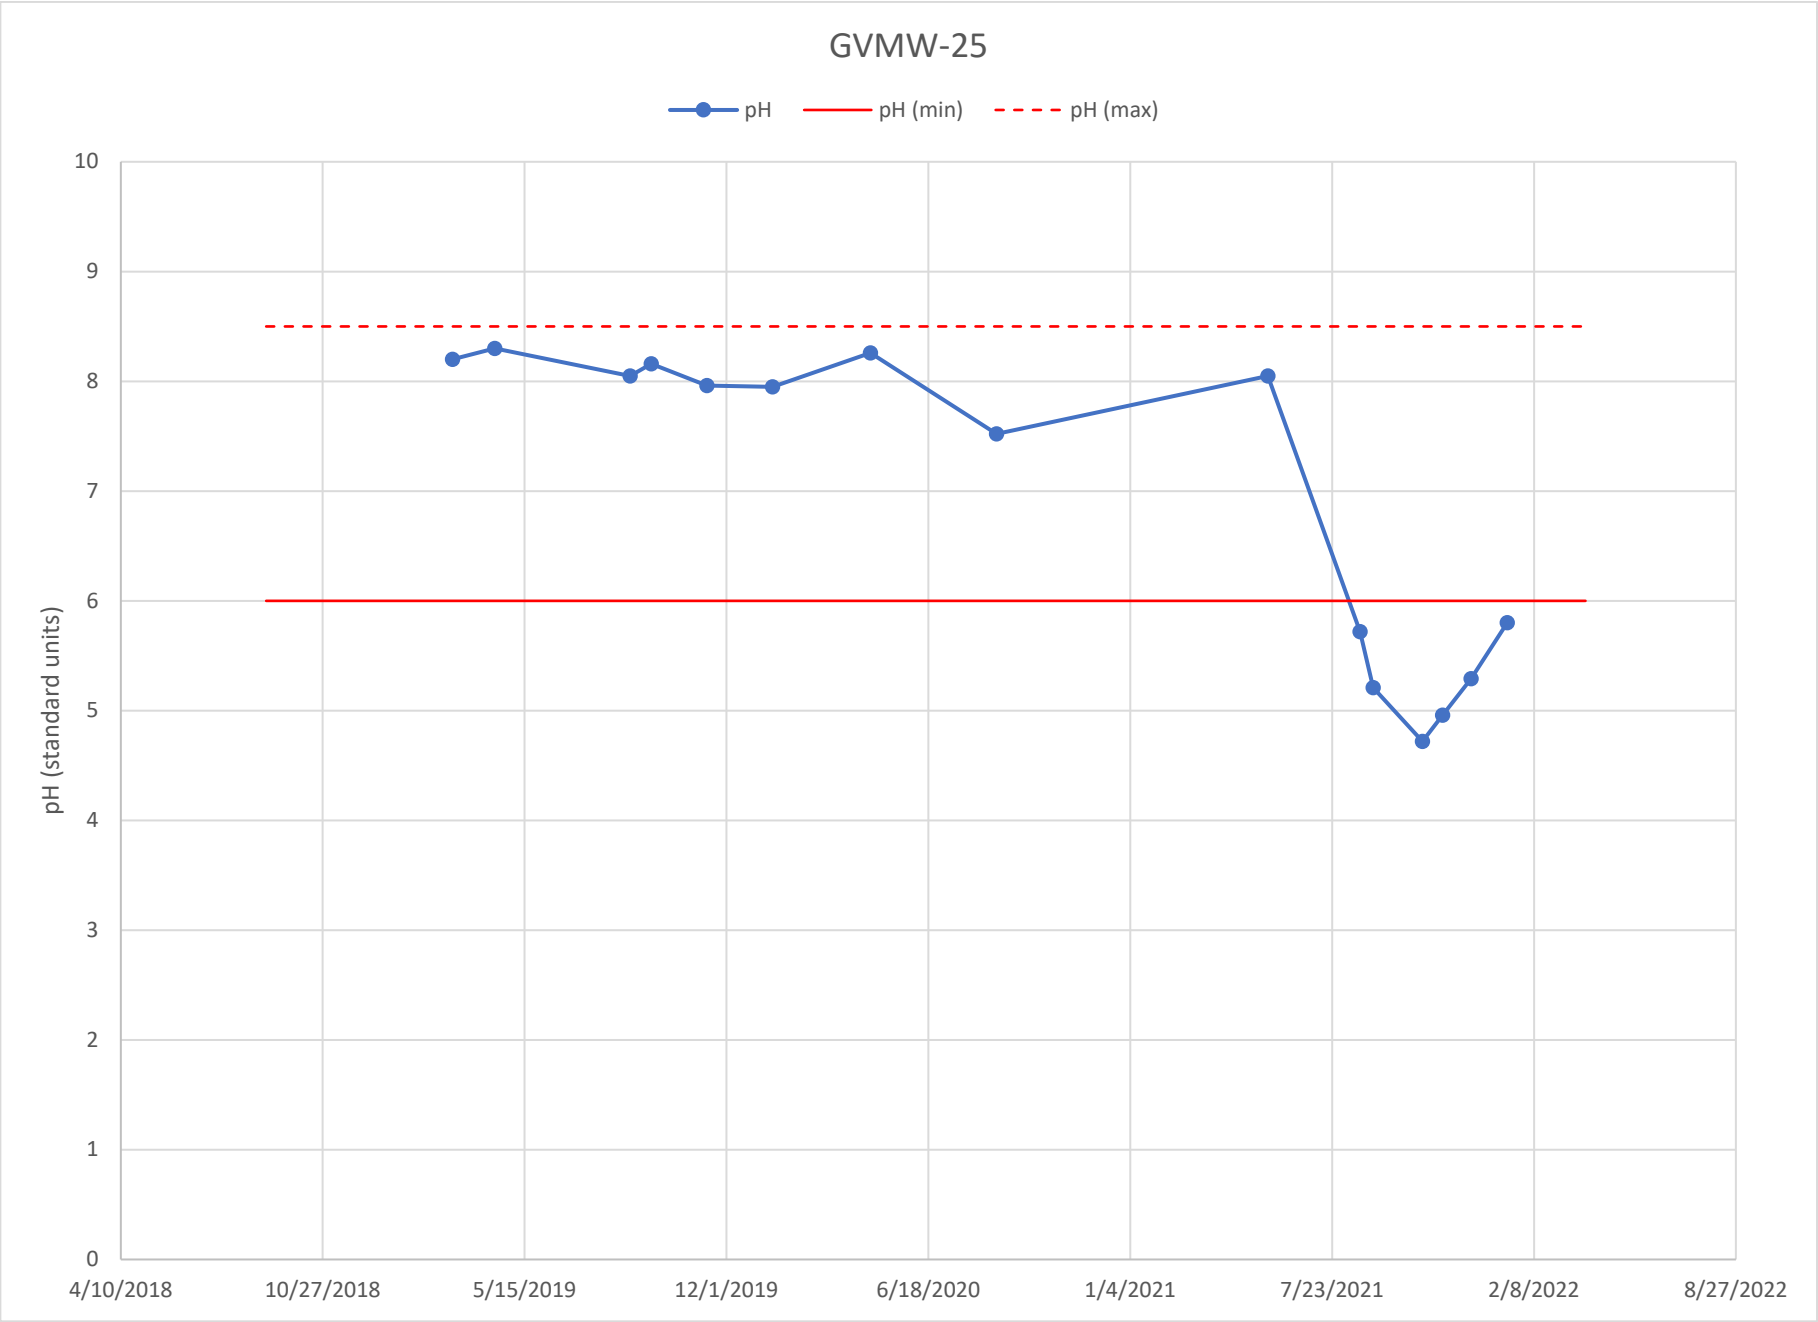
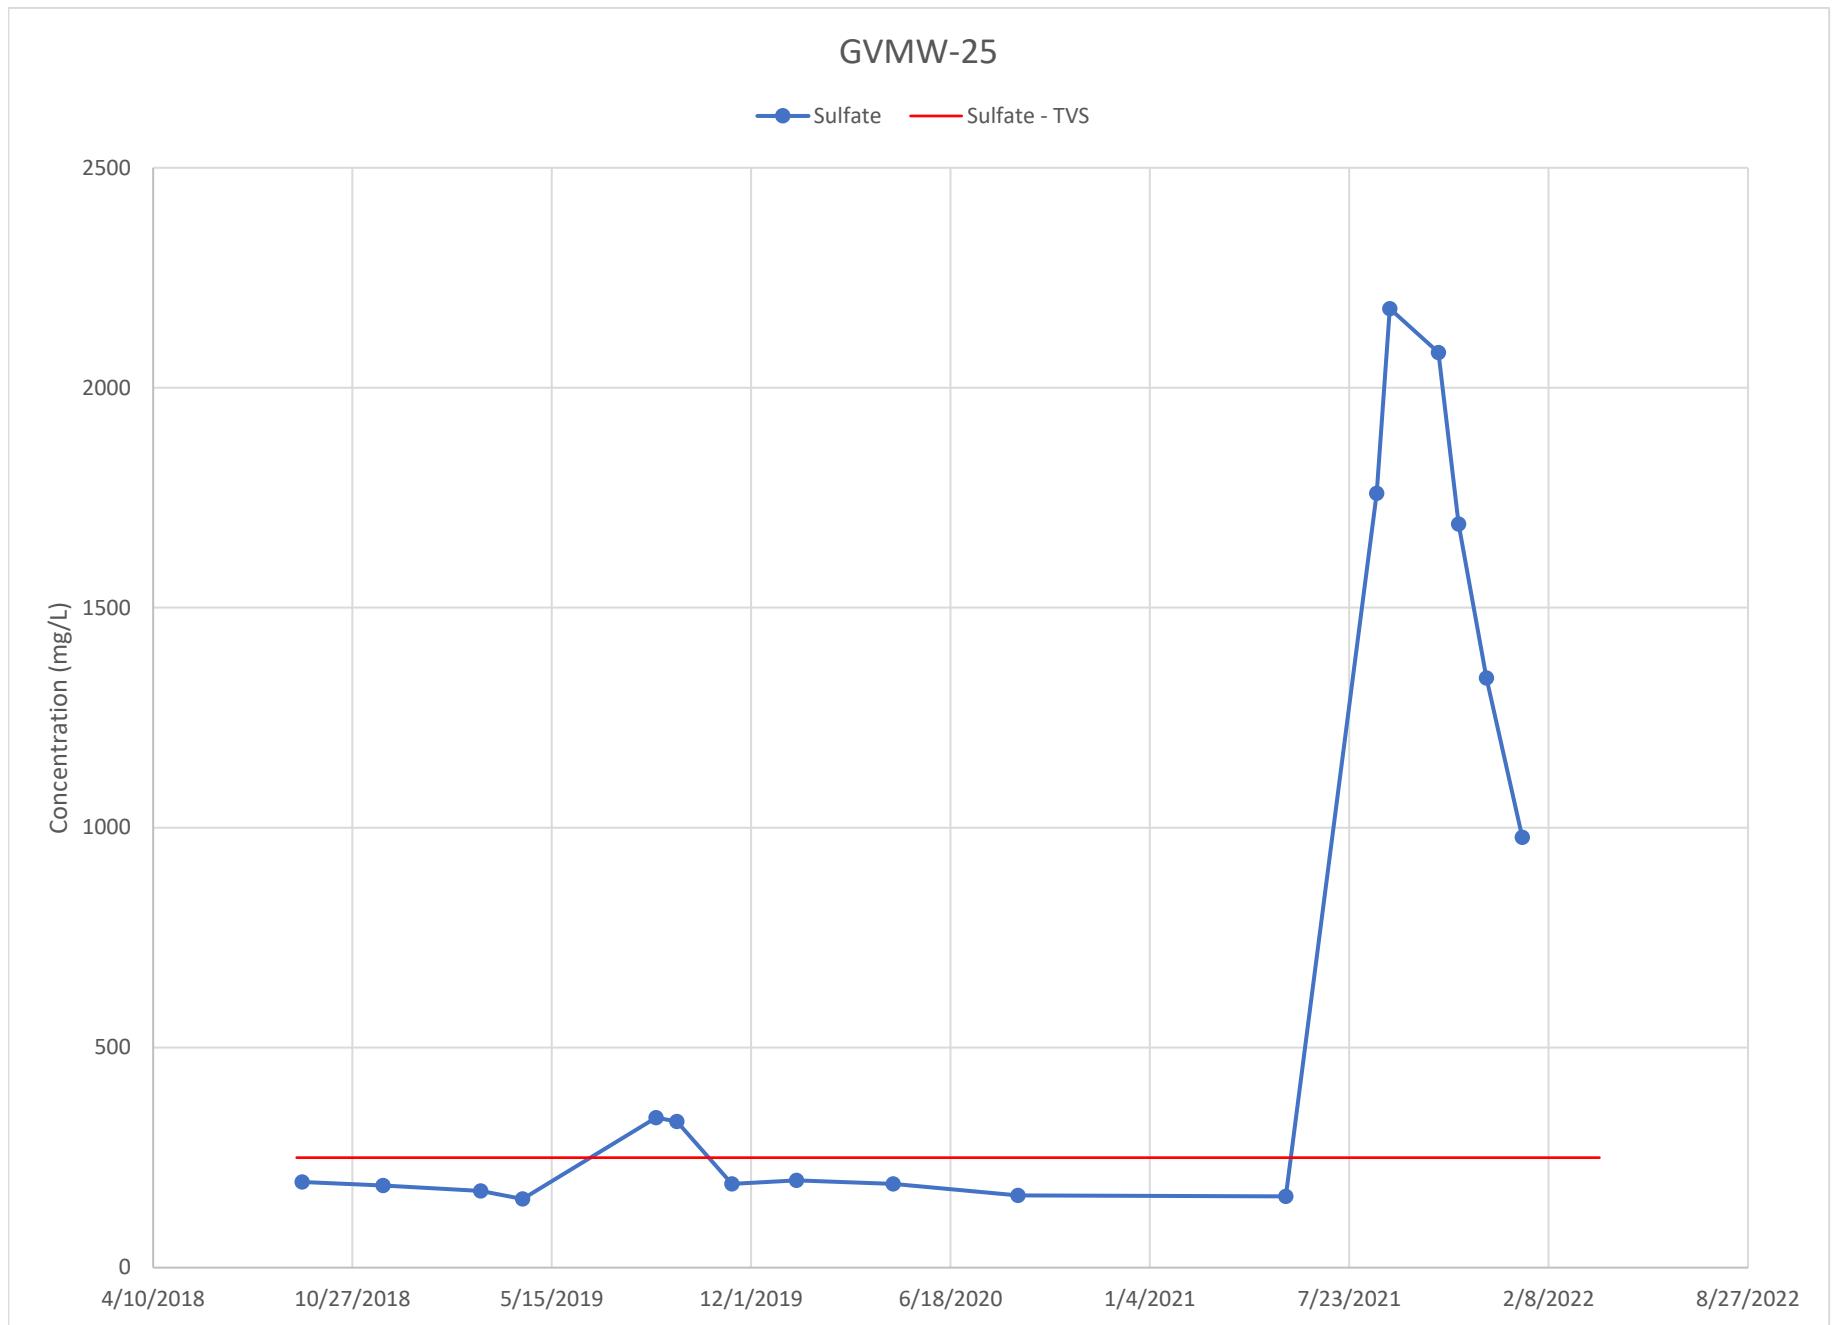
CC&V collected first quarter compliance groundwater samples from monitoring wells GVMW-8A, and GVMW-25 on January 12, 2022 and from monitoring wells CRMW-3B, CRMW-3C, and PGMW-3 on January 17, 2022. Upon review of received analytical reports, CC&V determined that monitoring well GVMW-8A exceeded established numeric protection limits for fluoride, GVMW-25 exceeded established numeric protection limits for cadmium, fluoride, manganese, and pH, and exceeded established table value standards for beryllium, and sulfate. Monitoring well CRMW-3B exceeded established numeric protection levels for fluoride, CRMW-3C exceeded established numeric protection levels for fluoride, and established table value standards for sulfate, and PGMW-3 exceeded established numeric protection levels for aluminum, cadmium, copper, fluoride, manganese, nitrate as N, and nitrite+nitrate. PGMW-3 also exceeded established table value standards for sulfate. The table below lists the exceedance for the location and the associated parameter. The attached graphs demonstrate the parameter trend for the collected data.
