Re: <u>Permit No. M-1980-244</u>; <u>Cripple Creek & Victor Gold Mining Company ("CC&V")</u>; <u>Cresson Project – Notification of Water Quality Analysis Parameter Exceedance March 8, 2022</u>

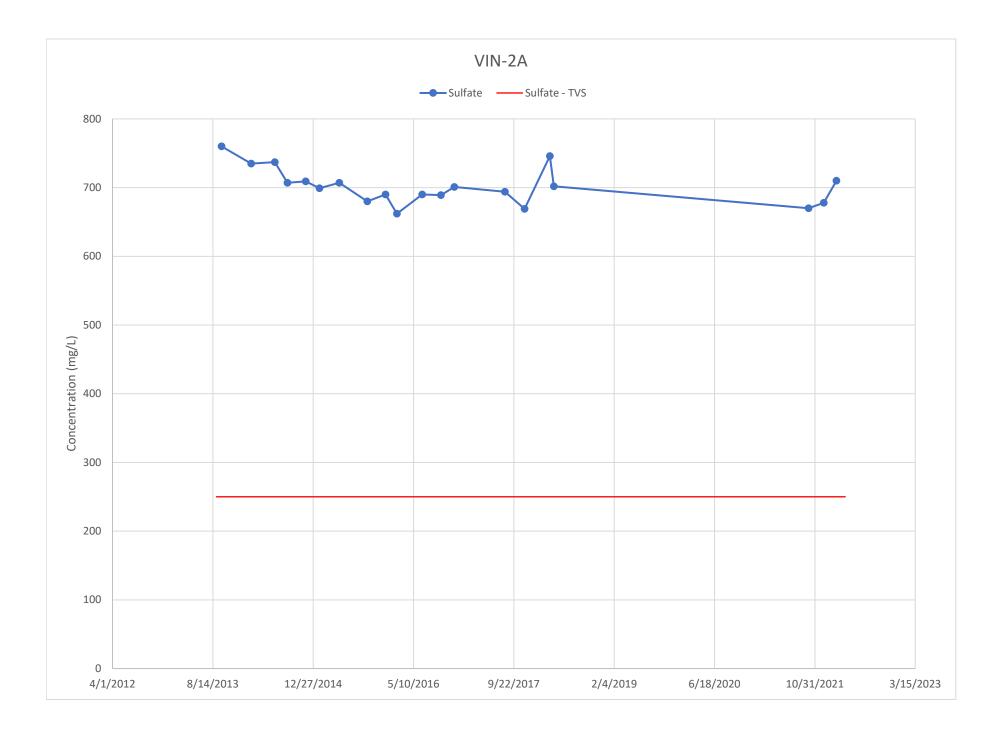
CC&V collected first quarter compliance groundwater samples from monitoring well VIN-2A on February 15, 2022. Upon review of received analytical reports, CC&V determined that monitoring well VIN-2A exceeded established table value standards for sulfate. The table below lists the exceedance for the location and the associated parameter. The attached graphs demonstrate the parameter trend for the collected data.

Location	Sample Date	Parameter	Value (mg/L)	NPL (mg/L)	Table Value Standard (mg/L)
Ī	VIN-2A	2-15-22	Sulfate	710		250
