Subject: Summary of Instrumentation Monitoring
1st Quarter 2022
Bowie Coal Waste Disposal Area No. 3
Paonia, Colorado

**SUBJECT: Summary Report, 1st Quarter 2022, Vibrating Wire Piezometers
January – March 2022, Bowie Mine #2
Coal Waste Disposal Area (CWDA) #3**

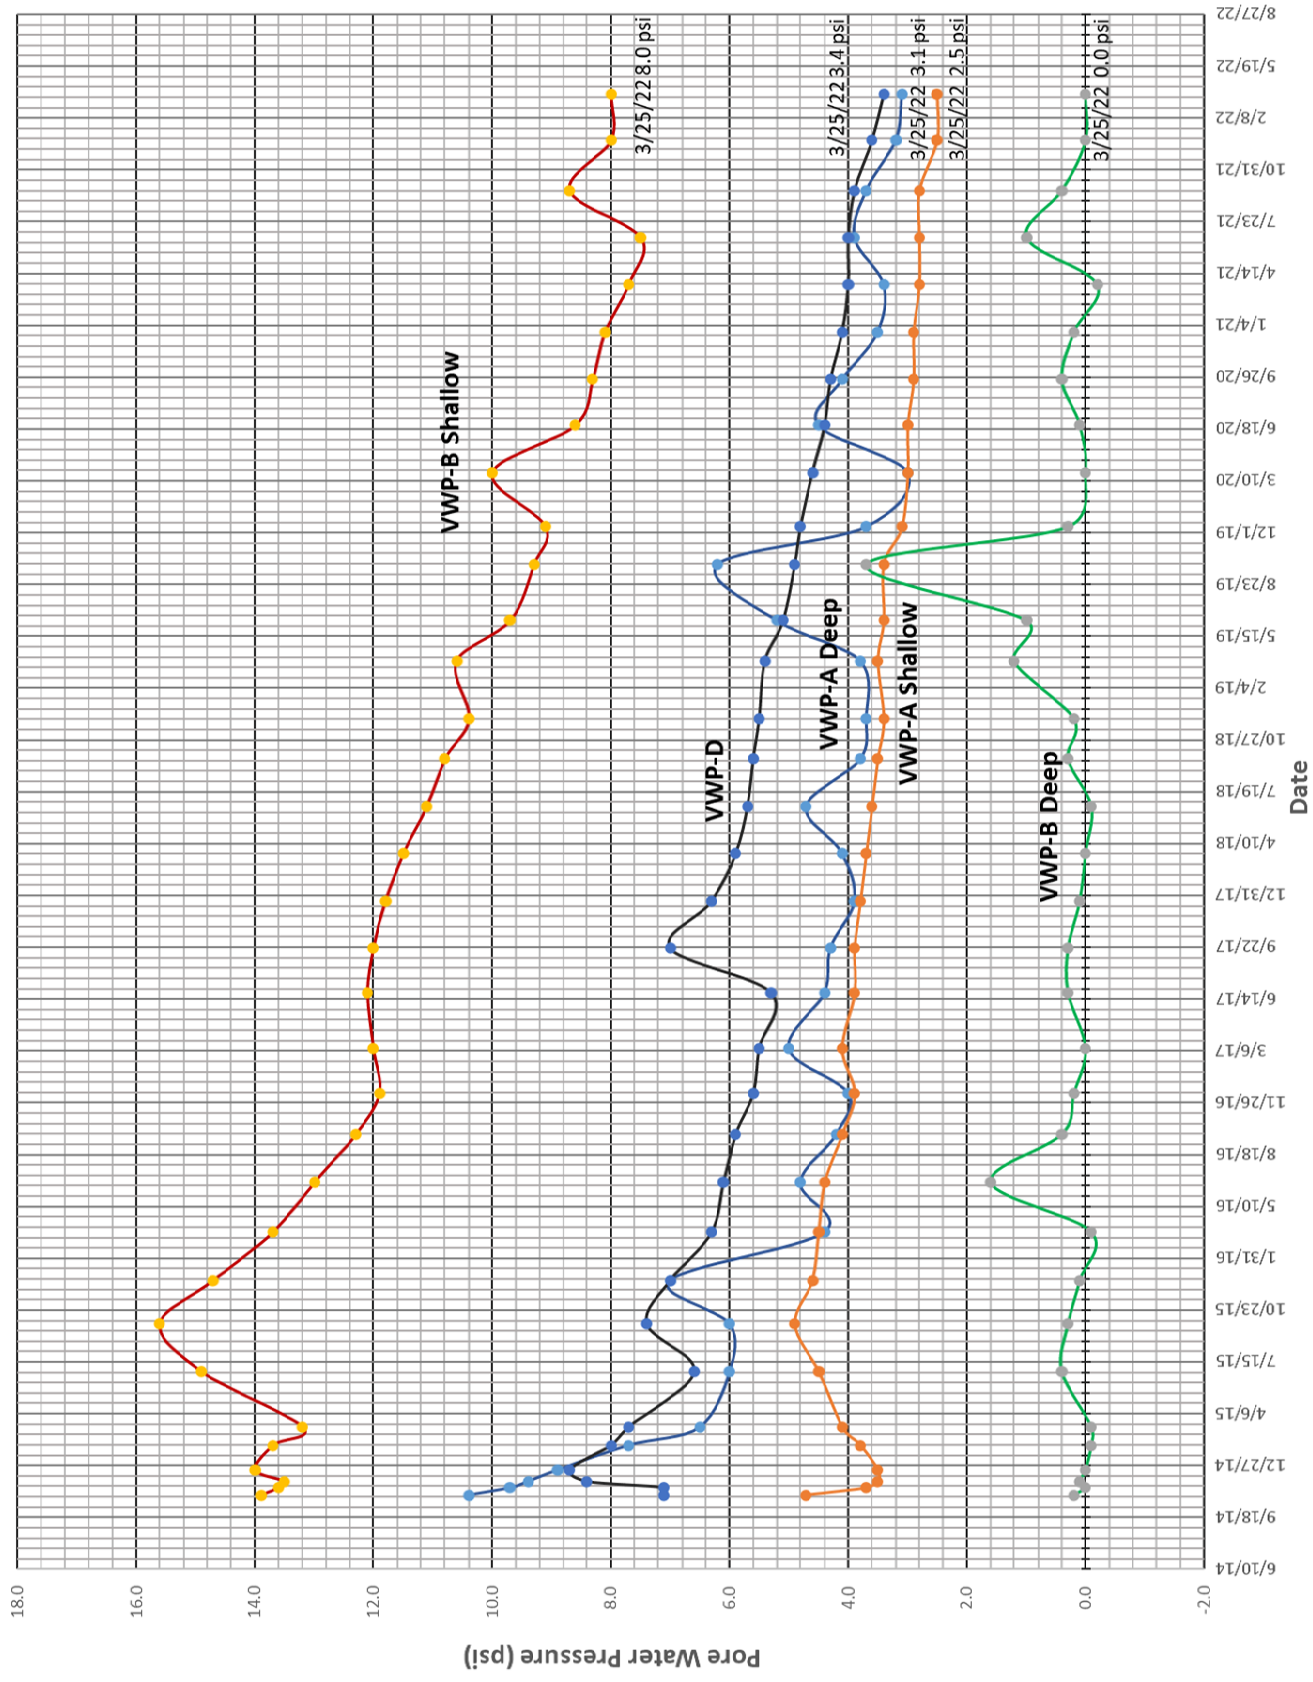
Figure 1 - Bowie Mine #2 - CWDA #3
Vibrating Wire Piezometer Data

We present a graph of measured pore pressures on the attached Figure 1 and numerically in Table 1 below. Table 1 is a summary of the initial, last year, last quarter and current readings. In addition, we present the difference between the current pore pressures and those at the time of installation, the previous quarter, and previous year.

As seen on Figure 1 and Table 1, all five VWP's decreased in pore pressure when compared with pressures at installation in 2014. Three of the five VWP's had no change in pressure since last quarter and the other two had a small (0.1-0.2 psi) decrease. When compared with the same quarter last year, two VWP's had slight increases (0.2-0.3 psi) in pressure, while two had decreases of 0.3-0.6 psi. Although there is a general trend of decreasing pore pressure over time, three of the piezometers (VWP-A Deep, VWP-B-Deep and VWP-B Shallow) have some erratic behavior in 2019 and some minor fluctuations in the summer readings.
