# **PERMIT INFORMATION**

Permit Number: C-1981-028	County: Weld			
Mine Name: Keenesburg Strip Mine	Operation Type: Surface			
<b>Operator:</b> Coors Energy Company	Permit Status: Permanent Cessation			
Operator Address:	Ownership: Private			
Mr. Ben Moline	-			
PO Box 4030	<b>Operator Representative Present:</b>			
Golden, CO 80402	_			
	None			
Operator Representative Signature: (Field Issuance Only)

# INSPECTION INFORMATION

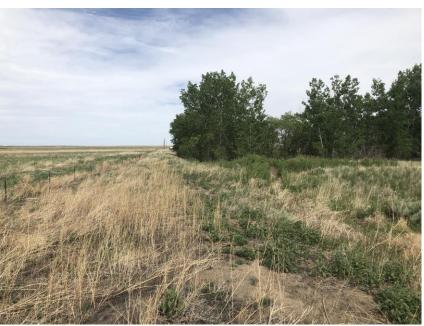
Sediment Pond 2 and the Dugout Pond contained little to no water (thick vegetation obscures the bottoms). They were not discharging during the inspection. There were no signs that either pond had discharged recently. No problems were observed.

**Sediment Pond 2**

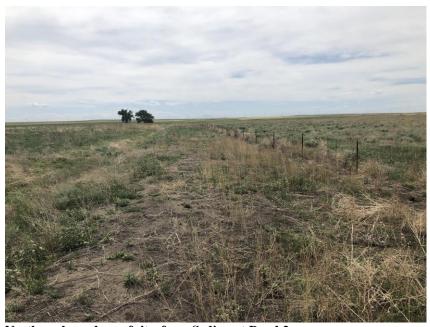
The northern boundary of the site (east side) was observed, and no signs of pollutant loading from the mine site, or any other problems, were seen.

Northern boundary of site, from Sediment Pond 2

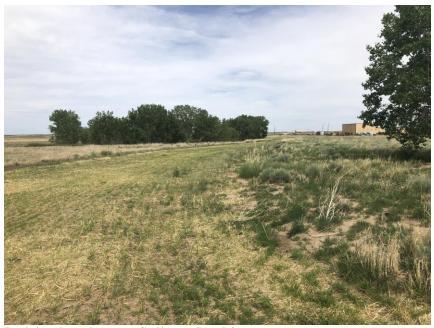
Green grass was seen emerging at several recently reclaimed locations, including (but not limited to) the reclaimed road near Sediment Pond 2.

**Reclaimed road next to Sediment Pond 2**

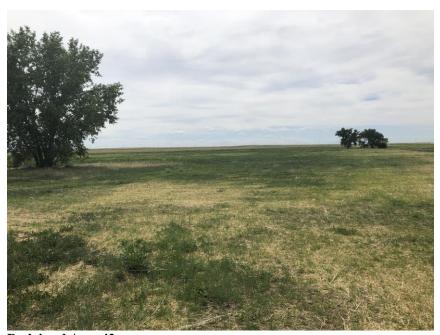
No erosion problems were seen onsite. The reclaimed areas that were inspected closely include the eastern portion of the Long Term Spoil Area and Area 42.

Reclaimed Area 42
