Colorado Alabaster Supply

Reclamation Plan

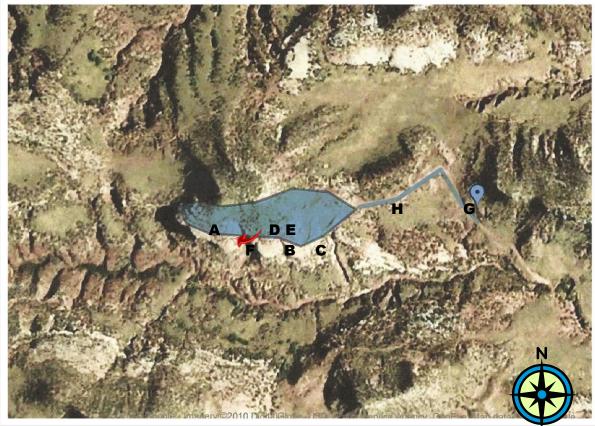
- A Current & projected working area
- **B** Soil Stockpile
- C Waste Stockpile
- D Dig Area

- E Product Stockpile
- F Direction in which mineral extraction will proceed
- G Permit Sign
- H Existing ranch road
