## Lorencito Canyon Mine, C-1996-084, Inspection Report

### PERMIT INFORMATION

### INSPECTION INFORMATION

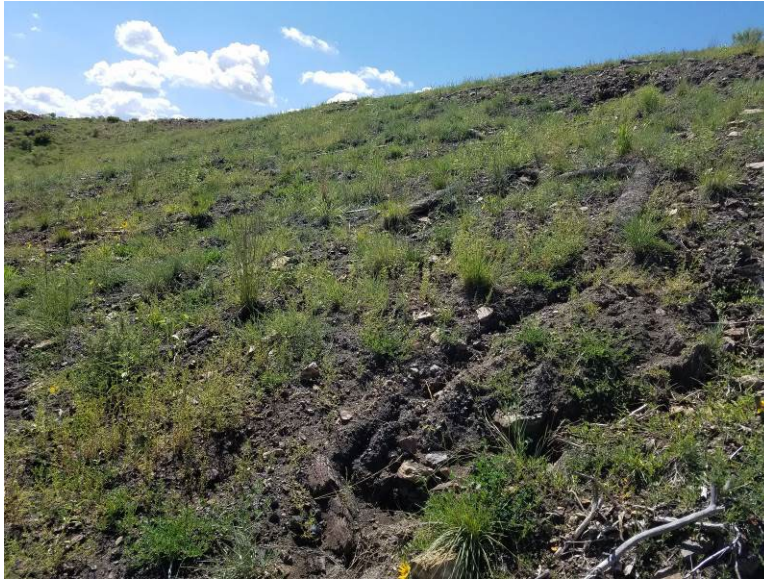
The reclaimed slope above the sediment storage area was observed. Given the recent precipitation that has occurred in the region, desired grasses and forbs have germinated on the steep slope above the sediment storage pile. We observed several species of wheatgrasses, bluestem, side oats grama, blue grama grass. However, Russian thistle has also germinated in this area and accounts for a substantial amount of vegetative cover. While Russian thistle is not desirable, it does provide vegetation cover that assists in stabilizing the slope from erosion. NECC will need to continue to monitor this area and may need to manage the Russian thistle growth if it hinders the development of the desired species. While the vegetation in this area appears better than previously observed by the Division, NECC should still explore actions to stabilize this highly erosive steep slope.

*Figure 1. Slope above the sediment storage pile.*

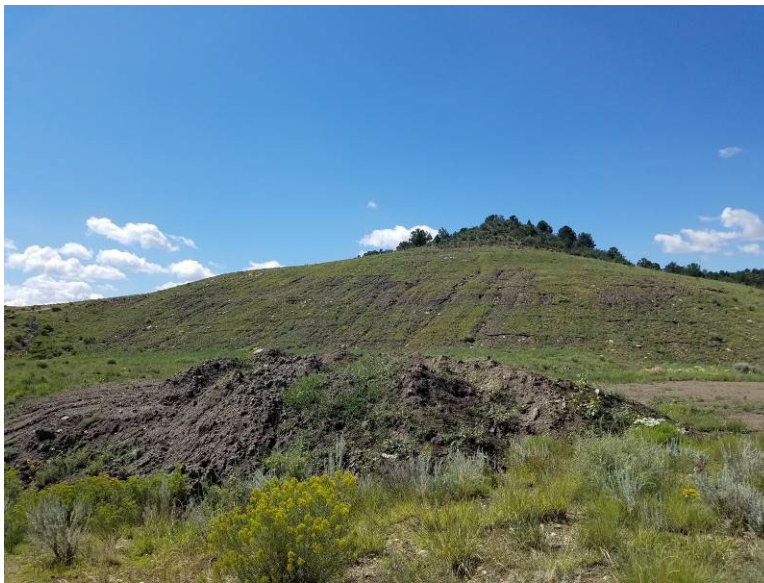
*Figure 2. Slope above sediment storage pile.*

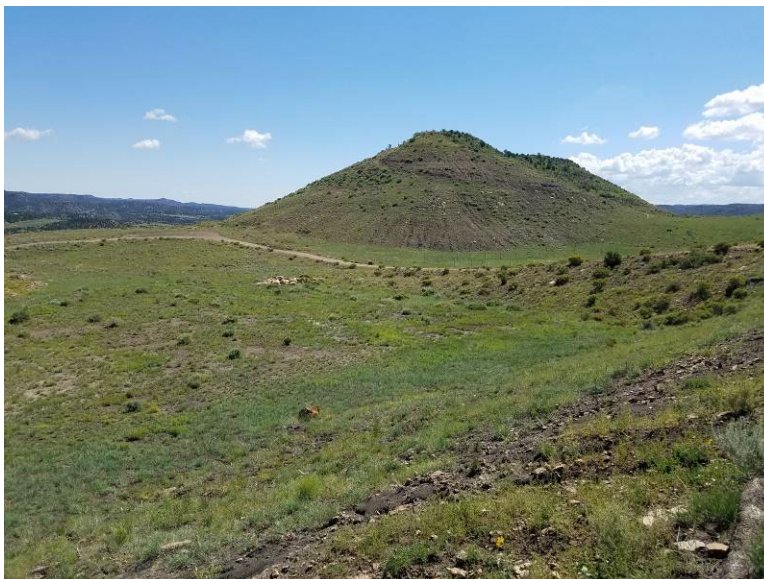
The slopes above Pond 006a are still heavily eroded as well as the slopes around the Knob. Previously noted erosional issues cited by DRMS inspection reports over the last year have not been addressed. According to Nick Mason with NECC, they are working on finding a contractor to conduct the needed repairs at the site. This issue is also noted in the adequacy review for NECC's application to renew the permit for the site (RN5). NECC has been asked to review and evaluate how these areas will be stabilized from erosion in accordance with Rule 4.14.6 as previous attempts have had mixed success.

*Figure 3. View of the Knob from above the sediment storage pile.*

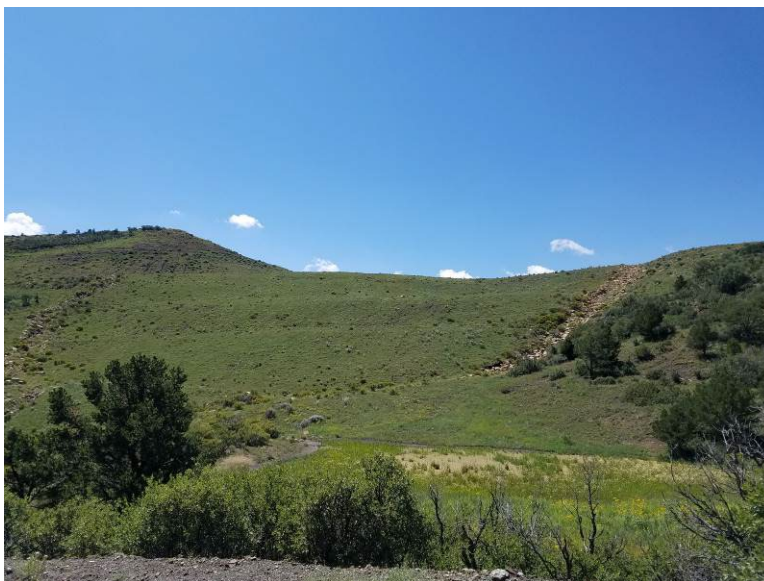
Fills 8, 7 and 9 were observed. These fills are well vegetated and stable. Signs of instability and structural weakness were not observed.

*Figure 4. Fill 8.*

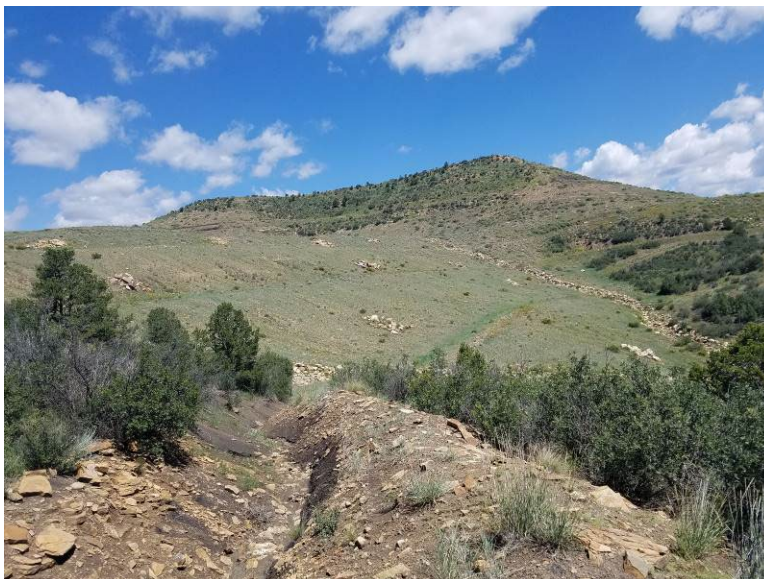
*Figure 5. Fill 7*

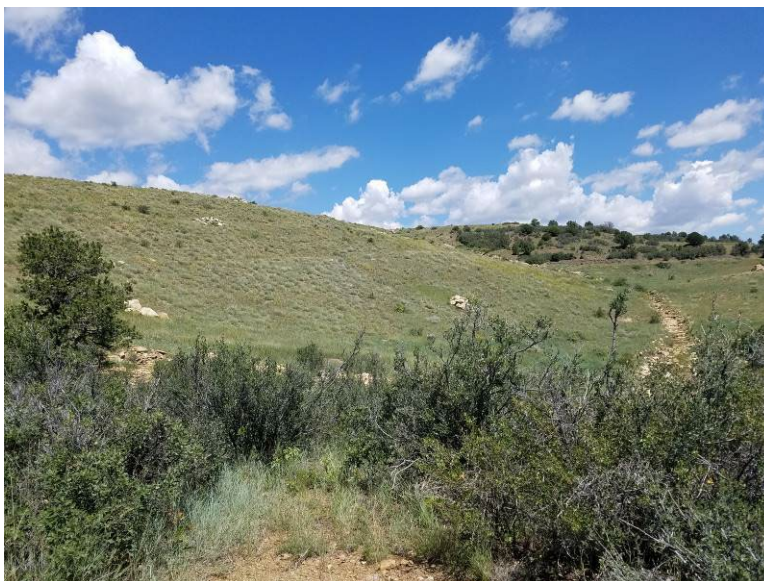
*Figure 6. Fill 9*
