Cross Shaft Surface Depression Remediation

RE: Cross Gold Mine, Permit No. M-1977-410, Cross Shaft Surface Depression Remediation

Remediation Summary

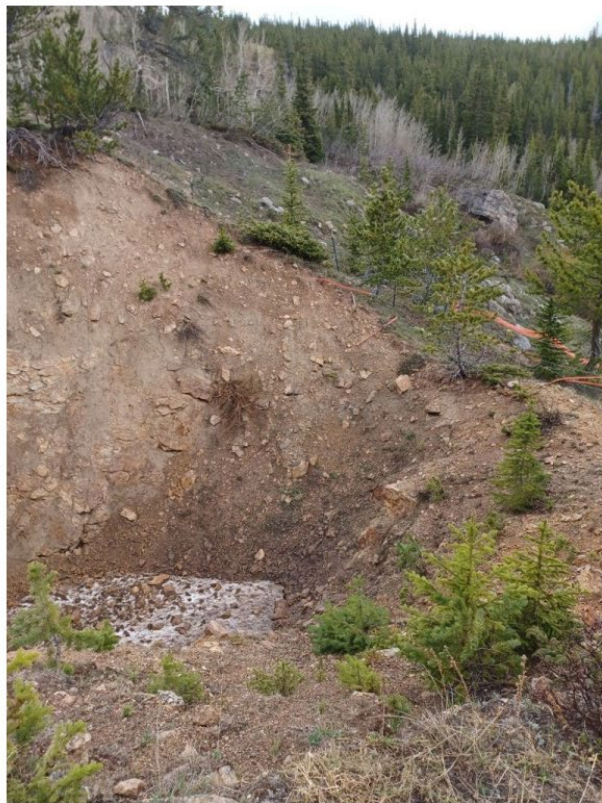
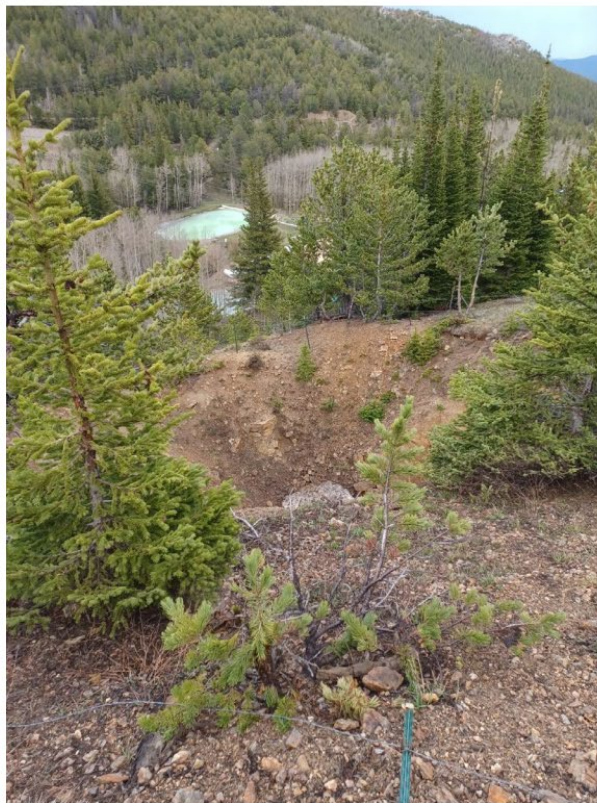
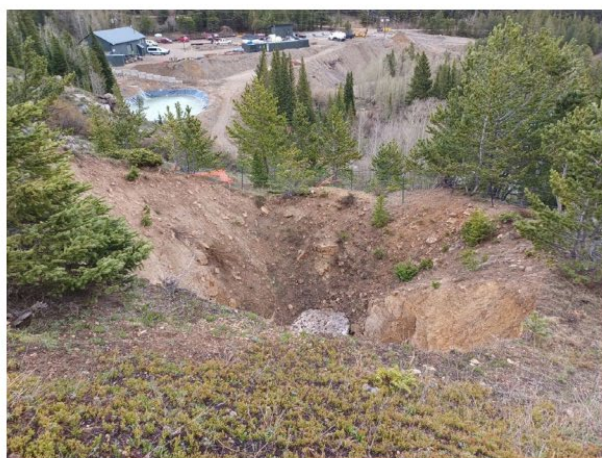
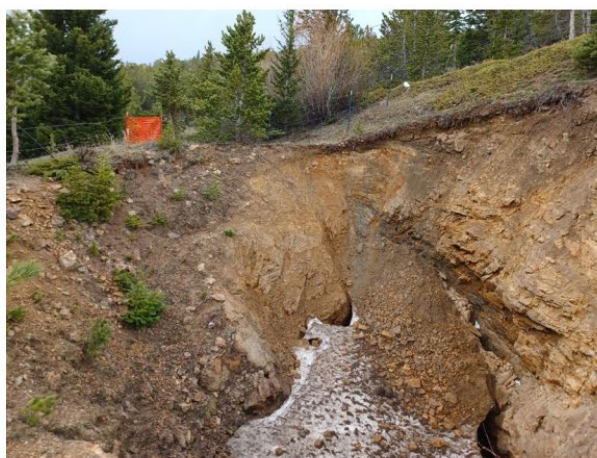
Pre-Remediation Photographs

On June 10, 2022, Grand Island Resources (Operator) requested approval from DRSM to perform reclamation of a surface feature consisting of a land depression that had the potential of increasing surface water influx into the underground workings of the Cross Mine. The Operator discussed remediation details and rationale with DRMS on June 3, 2022, during a Site Inspection. DRMS approved the request on June 23, 2022.

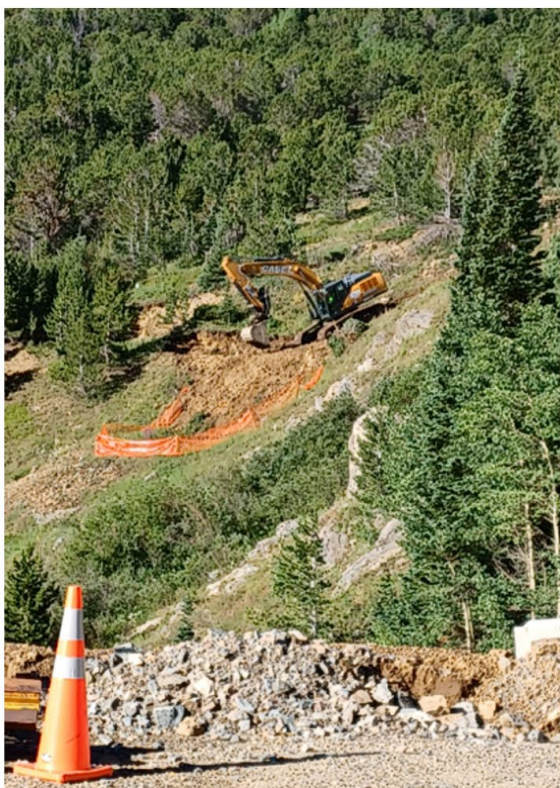
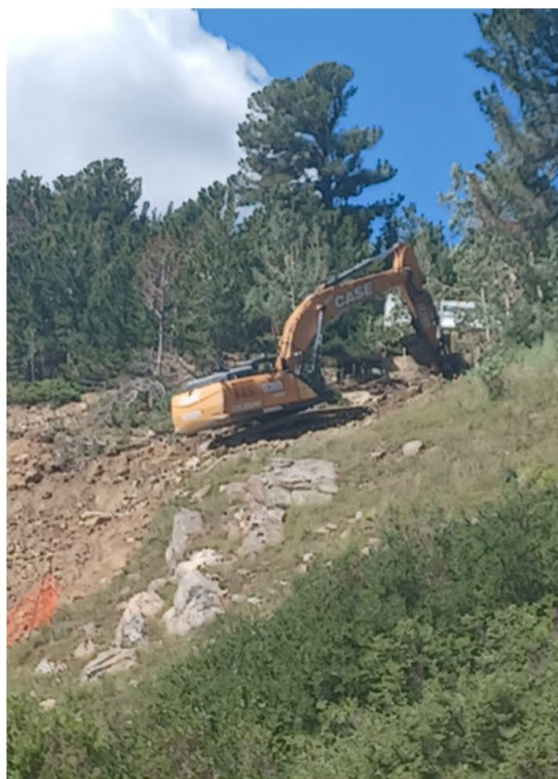
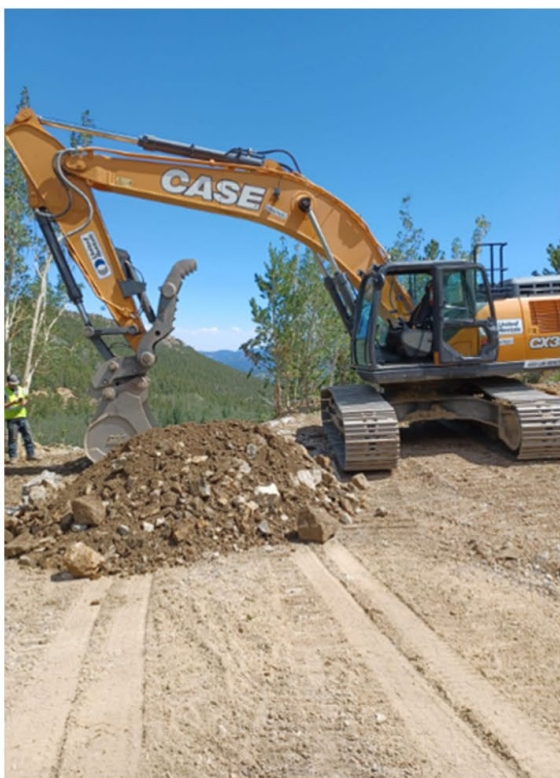
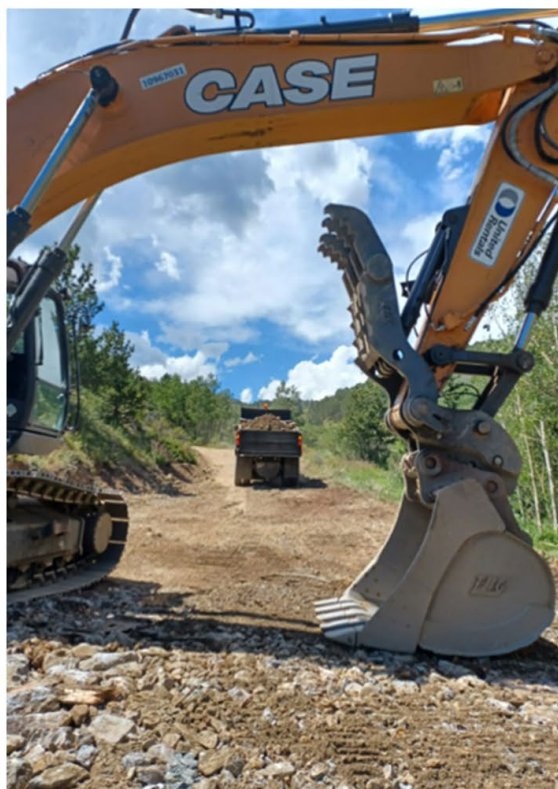
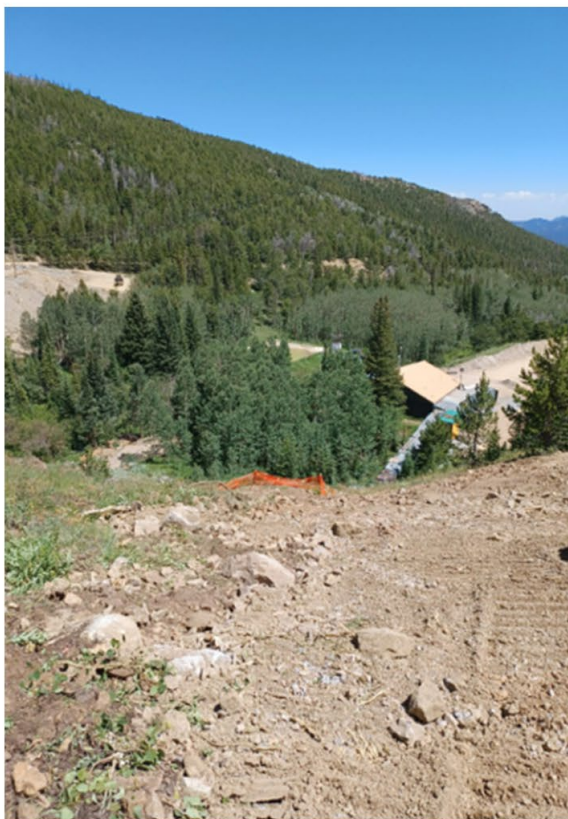
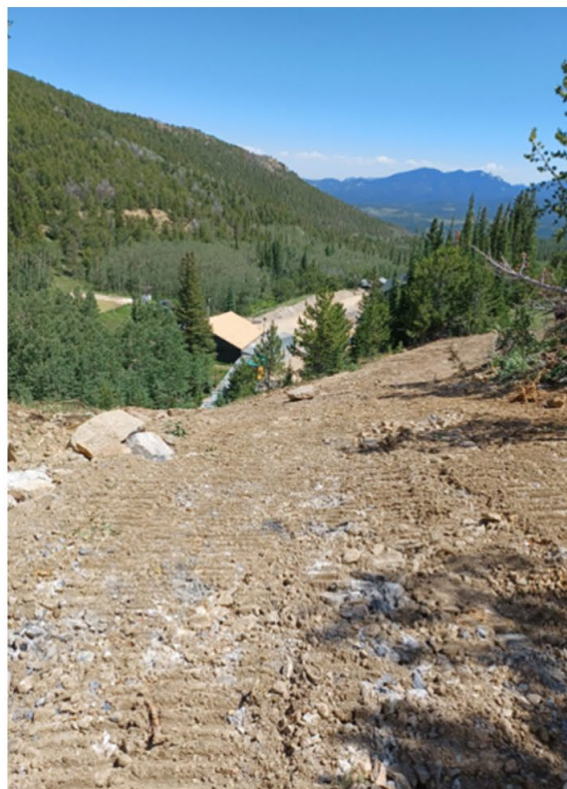
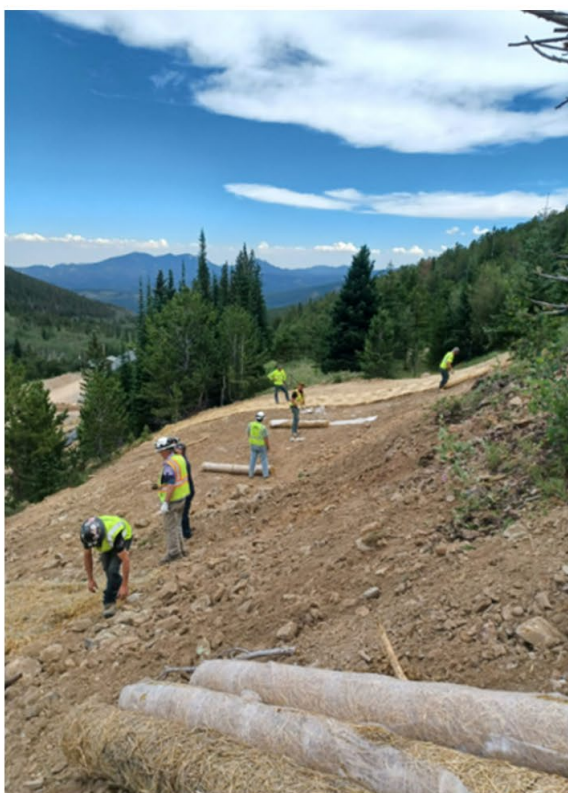
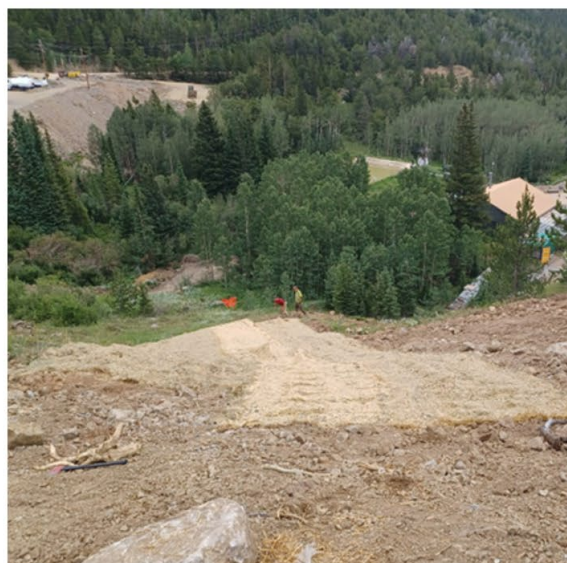
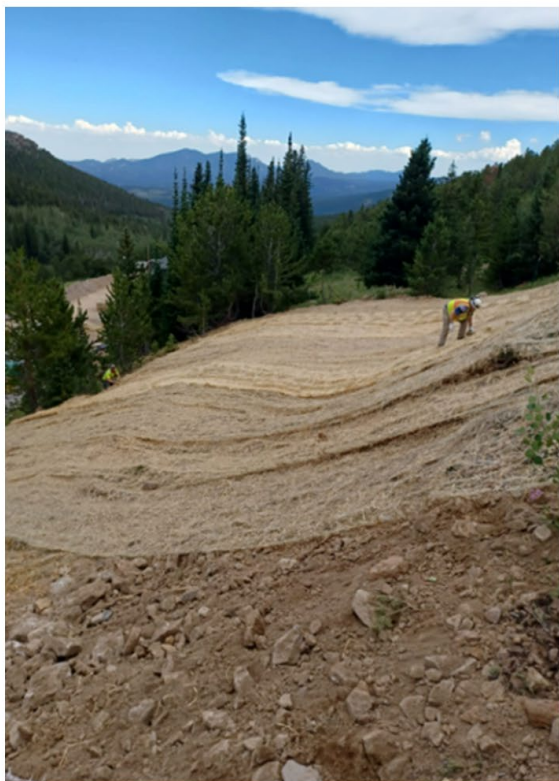
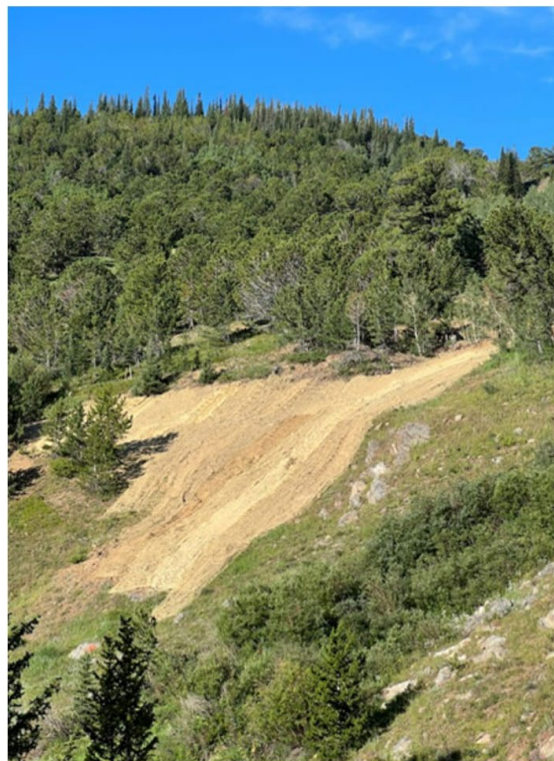
During Reclamation and Post-Remediation Photographs

On the 1st of August, the activity began with clearing an equipment access path to the depression (excavator and dump trucks). Sequential backfilling and fill material activities were performed. Upon reaching the lower rim of the depression, compaction was increased via excavator tracking. The final slope of the reclaimed slope was graded to a slope of 2 horizontal to 1 vertical in accordance with Amendment #2.

Revegetation of the filled depression and access path were covered with a layer or screened soil mixed with soil amendments. A native seed mix was broadcasted over the amended soil mix at approximately 1lbs per 1,000 square feet. To prevent erosion while vegetation is established, erosion control blankets were placed over the reclaimed area.
