MINERALS PROGRAM INSPECTION REPORT
PHONE: (303) 866-3567

| MINE NAME: Golden Sacramento | MINE/PROSPECTING ID#: P-2015-010 | MINERAL: Gold | COUNTY: Park |
| INSPECTION TYPE: Monitoring | WEATHER: Clear | INSP. DATE: July 21, 2022 | INSP. TIME: 11:00 |

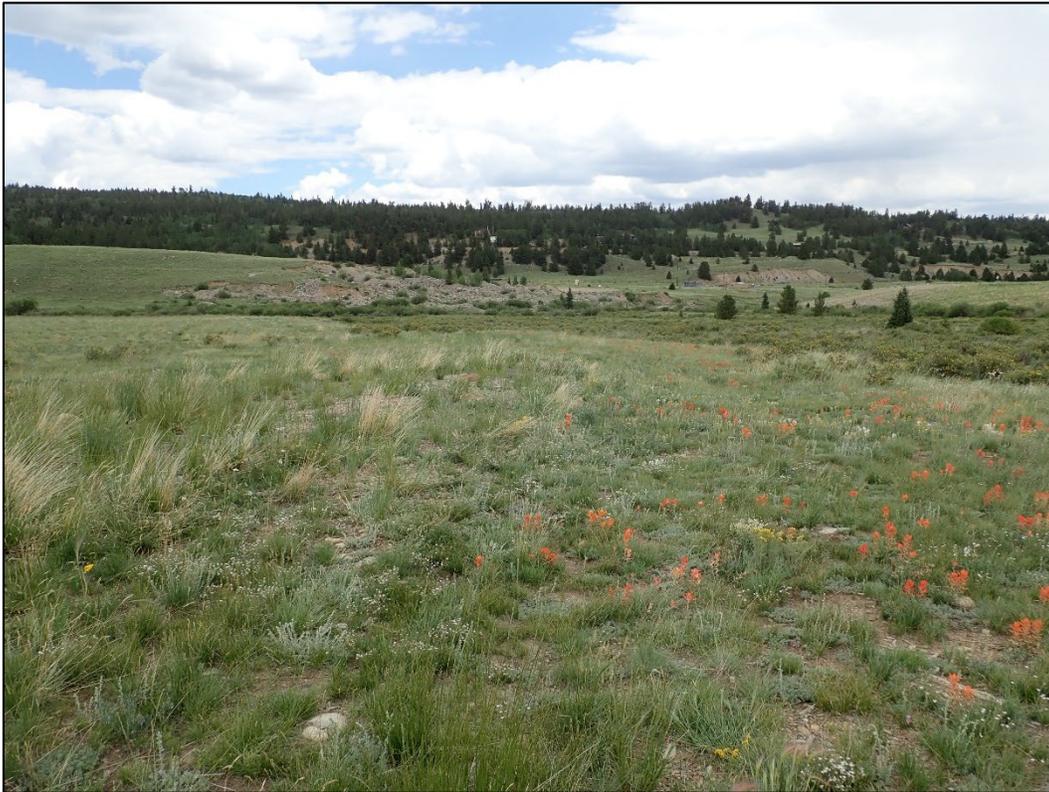
Photo 1. Reclaimed access road off of Platte Drive; looking northeast.

Backfilling and Grading: The access road and borehole area have been appropriately backfilled and graded to blend with the surrounding area.

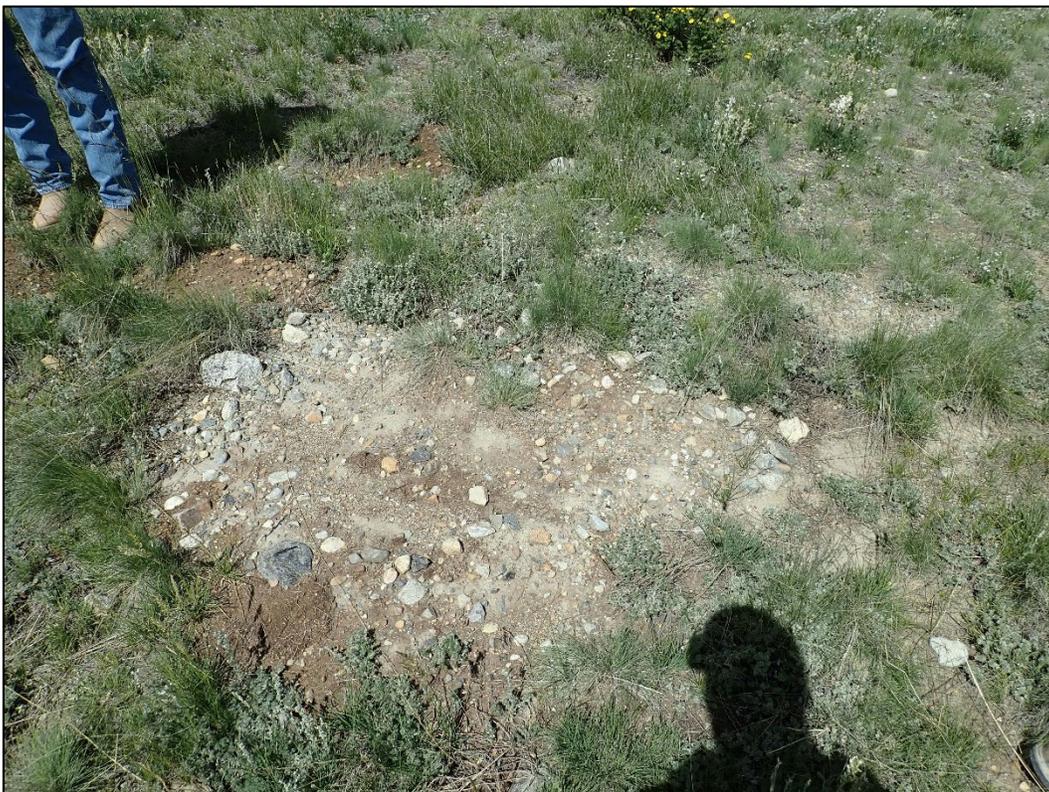
Photo 2. Backfilled borehole; looking southwest.

Availability Of Records: On August 9, 2022, the Division received the final reclamation report and the request for reclamation liability release in accordance with Rule 4.16.1(2). The Prospector indicated that only one of the two boreholes was drilled. Within the Prospector's Drill Hole Abandonment Final Report, they indicated the borehole was 120 feet deep and was abandoned with bentonite below the groundwater level and crushed rock and sand above the groundwater level; this is in compliance with the abandonment procedures within the approved NOI application form.

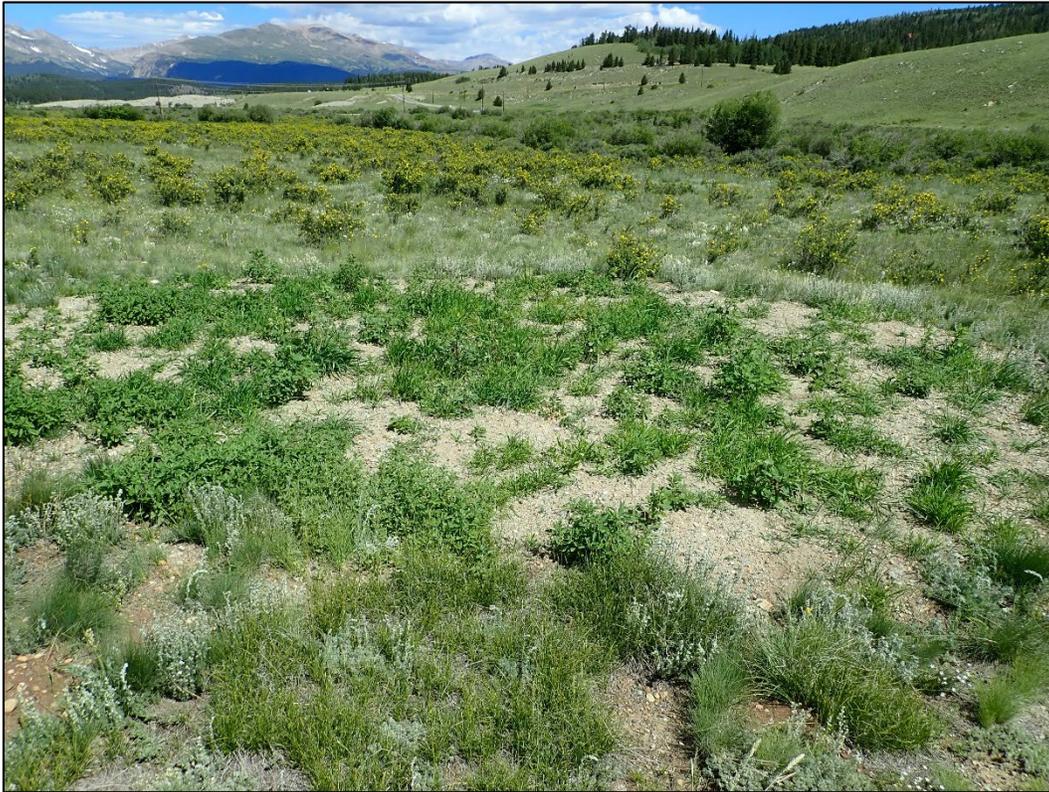
Photo 3. Backfilled and revegetated mud pit area; looking northwest.

Revegetation: The disturbance areas had topsoil replaced and were seeded with approved reclamation seed mix. The vegetative cover reestablished on the disturbance areas matches adjacent off-site areas. No noxious weed infestations were observed on the revegetated disturbances.
