***RE: Gleason Pit, Permit # M-1983-159, Notice of Hearing for Consideration of 2nd Period of Temporary Cessation***

**RE:** Gleason Pit; DRMS File No. M-1983-159; Board Action – Consideration of request for second five year period of Temporary Cessation

**MINERALS PROGRAM INSPECTION REPORT**  
**PHONE: (303) 866-3567**

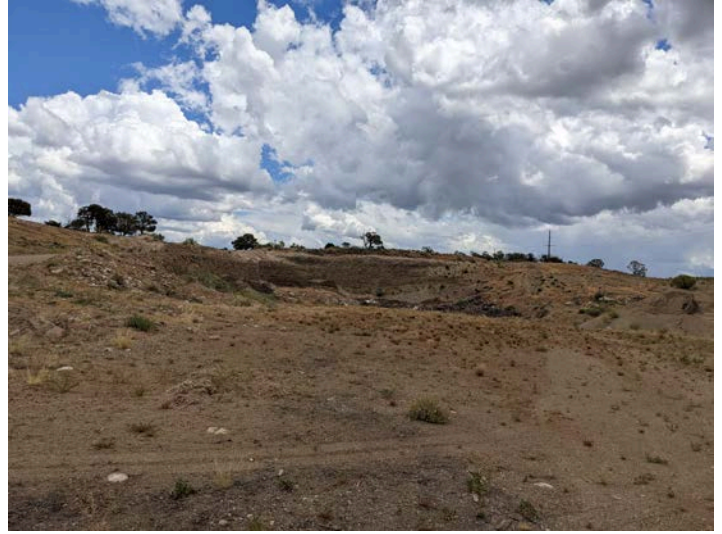
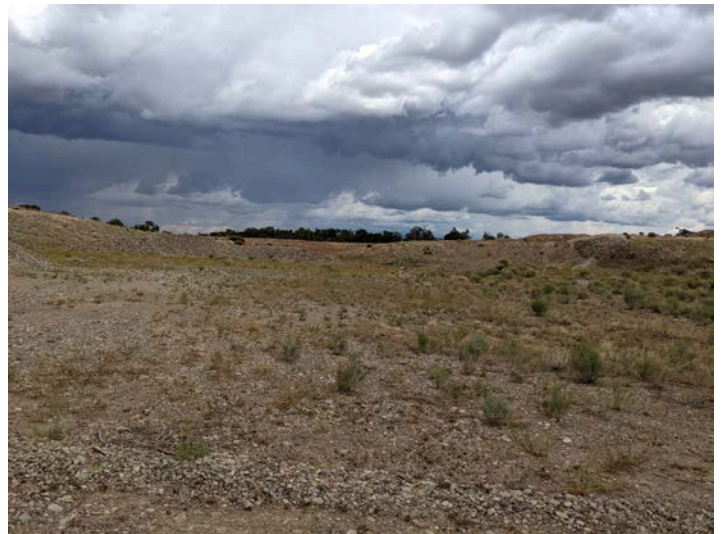
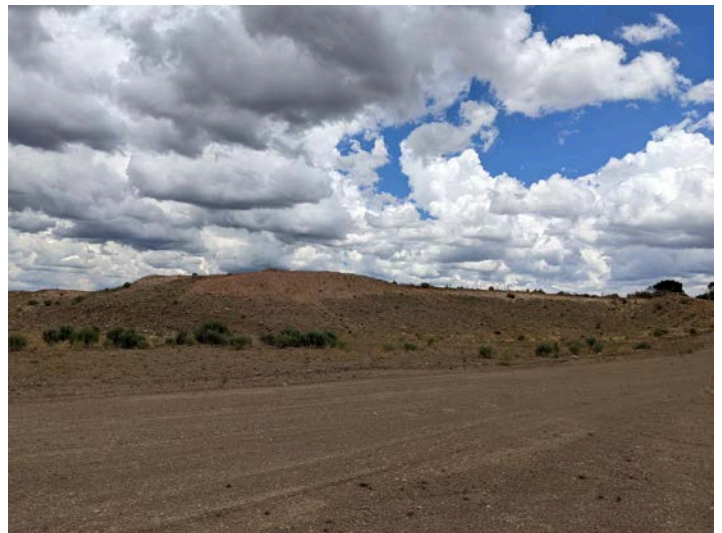
No evidence of any recent mining activity was observed. Conditions at the site appear relatively unchanged from the Division's last inspection, which took place on May 1, 2019. A scale and scalehouse are located near the site entrance. Various equipment and refuse are stored in the area south of the scale. The existing highwalls were left at random grades, from near vertical to 3H:1V. A near vertical highwall exists on the south side of the access road in the east side of the pit. Highwalls around the power poles are approximately 0.5H:1V. Except for a section of 0.5H:1V slope in the central part of the north pit wall, the west and north slopes are graded from 2H:1V to 3H:1V.
