**Huddleston-Berry**  
Engineering & Testing, LLC

Subject: Summary of Instrumentation Monitoring  
4<sup>th</sup> Quarter 2022  
Bowie Coal Waste Disposal Area No. 3  
Paonia, Colorado

**SUBJECT: Summary Report, 4<sup>th</sup> Quarter 2022, Vibrating Wire Piezometers  
October through December 2022, Bowie Mine #2  
Coal Waste Disposal Area (CWDA) #3**

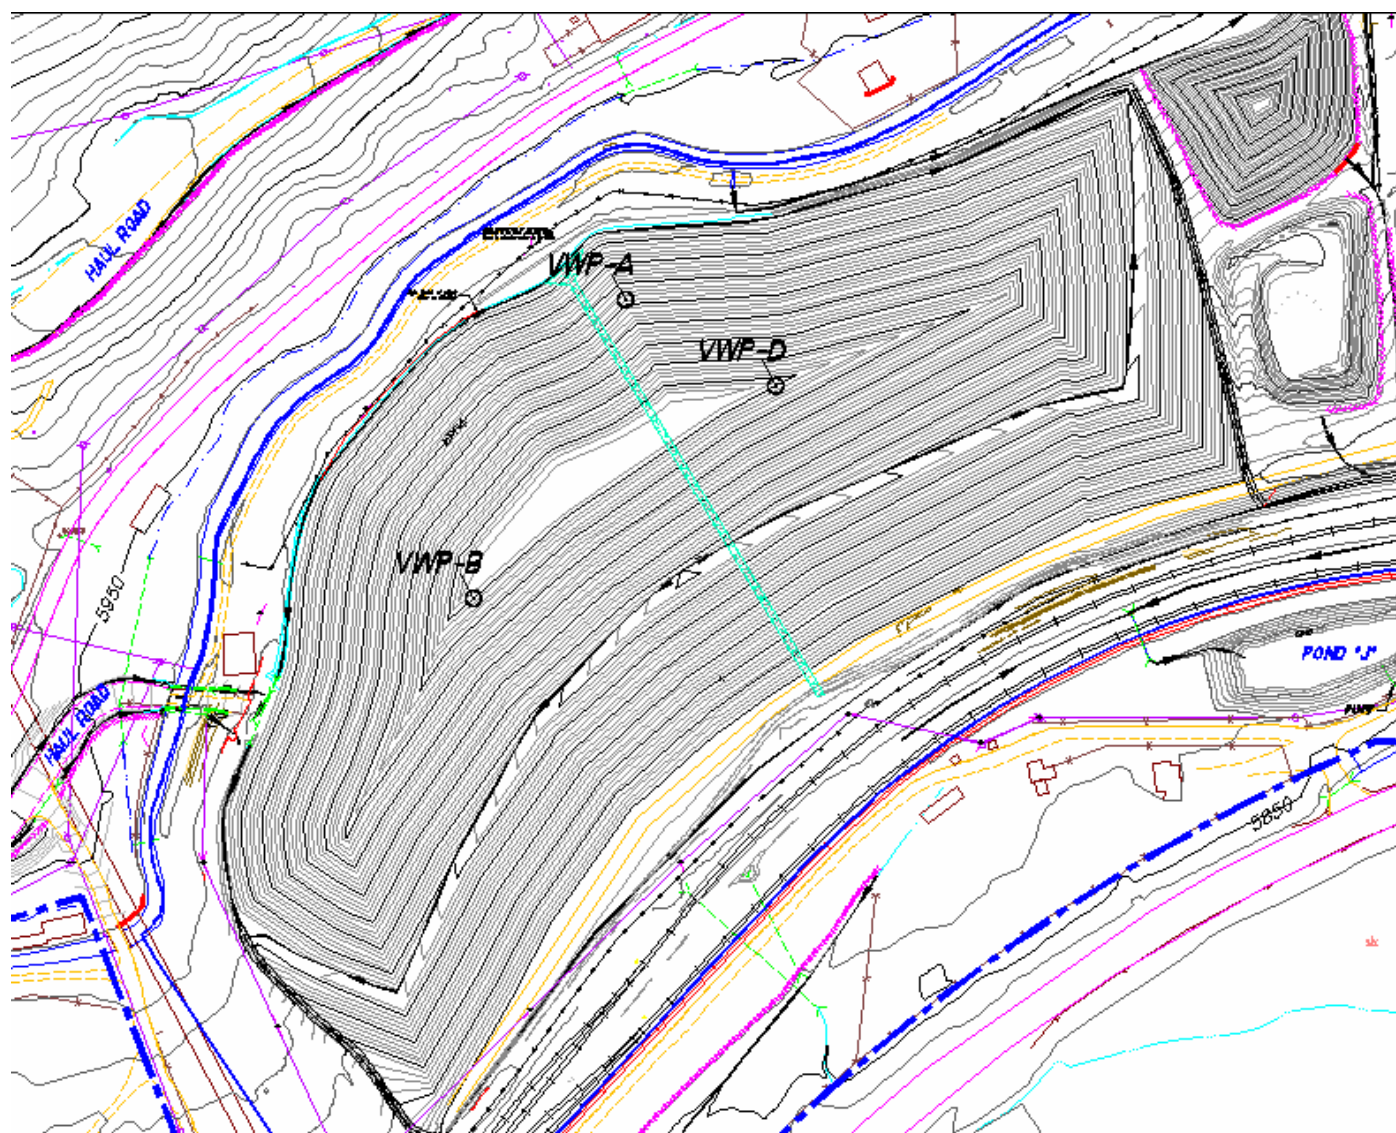
Five vibrating wire piezometers were installed in CWDA No. 3 in October 2014. The piezometers were installed at three locations within the footprint of the gob pile as shown on the attached figure. Monitoring of the functioning piezometers was completed by Buckhorn Engineering (Buckhorn) on December 23<sup>rd</sup>, 2022. The attached monitoring report prepared by Buckhorn includes the piezometer monitoring data and the data is summarized in the following table.

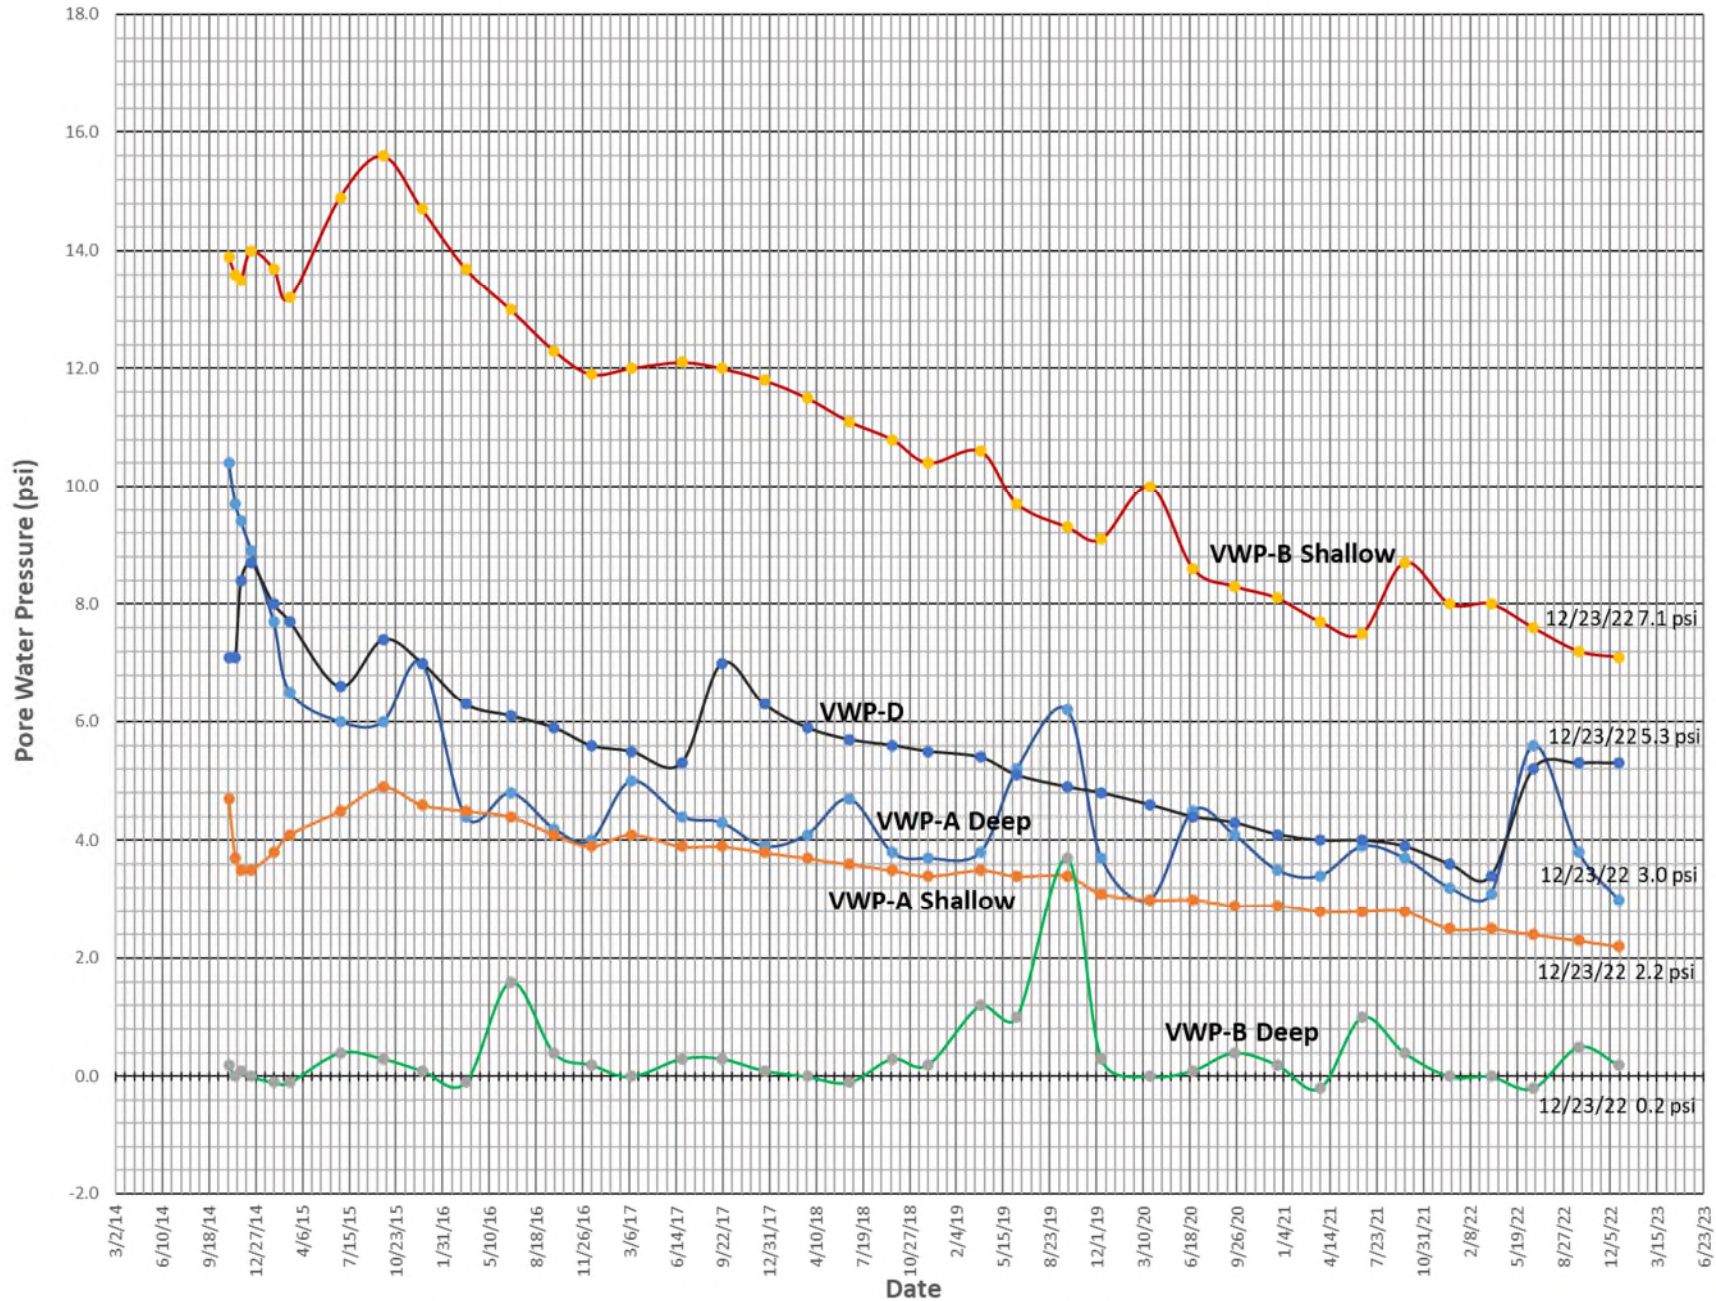
Figure 1 - Bowie Mine #2 - CWDA #3  
Vibrating Wire Piezometer Data

We present a graph of measured pore pressures on the attached Figure 1 and numerically in Table 1 below. Table 1 is a summary of the initial, last year, last quarter and current readings. In addition, we present the difference between the current pore pressures and those at the time of installation, the previous quarter, and previous year.

As seen on Figure 1 and Table 1, since last quarter, four of the five VWP's decreased in pore pressure by 0.1-0.8 psi and the fifth VWP (VWP-D) did not change in pore pressure. Since installation in 2014, four of the five VWP's have decreased in pore pressure (-1.8 to -7.4 psi), while VWP-B Deep has not changed in pore pressure. Although there is a general trend of decreasing pore pressure over time, three of the piezometers (VWP-A Deep, VWP-B-Deep, and VWP-D) have more recent erratic behavior since early 2019.
