MINERALS PROGRAM INSPECTION REPORT
PHONE: (303) 866-3567

MINE NAME: Younell Industrial Park	MINE/PROSPECTING ID#: M-2022-052	MINERAL: Gravel, soil	COUNTY: Weld
INSPECTION TYPE: Illegal(Unpermitted Operation)	WEATHER: Cloudy	INSP. DATE: January 6, 2023	INSP. TIME: 10:00
OPERATOR: NA	OPERATOR REPRESENTATIVE: Shelby Masden	TYPE OF OPERATION: ILL - Illegal	
REASON FOR INSPECTION: Citizen Complaint	BOND CALCULATION TYPE: None	BOND AMOUNT: No Bond Held	
DATE OF COMPLAINT: December 8, 2022	POST INSP. CONTACTS: Complainant, landowner	JOINT INSP. AGENCY: None	
INSPECTOR(S): Robert Zuber, P.E.	INSPECTOR'S SIGNATURE:

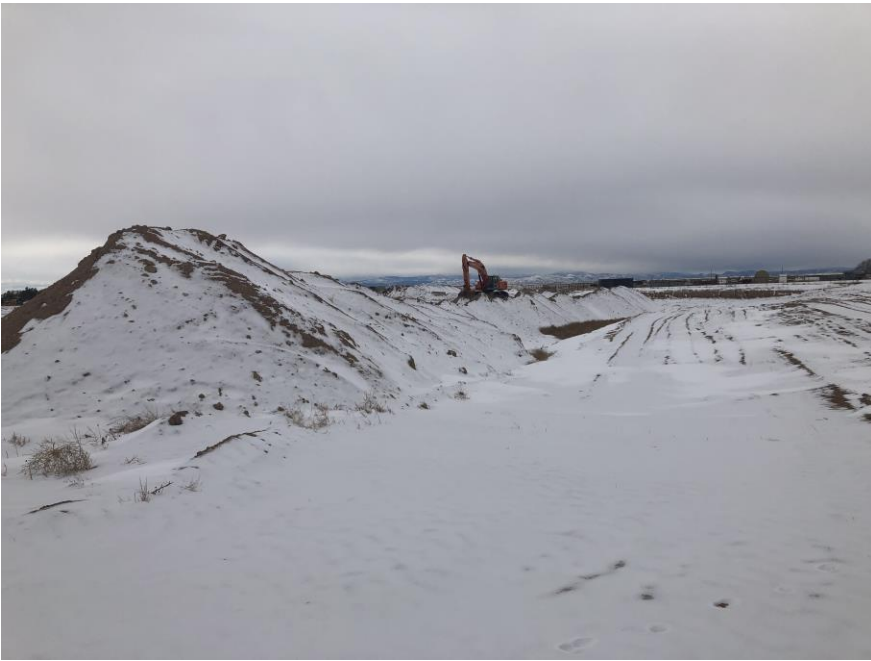
The site appeared to be a development in early stages. The area of excavation, about five feet deep, is for a stormwater pond, per Ms. Masden. The area of excavation is perhaps a quarter acre, which is the size of a typical stormwater pond. Within the excavation area, there is a large soil pile that is approximately 200' x 20' and approximately 10 feet tall. Several much smaller piles were also seen. Some have been used for bike ramps, per Ms. Masden. No piles of gravel were seen.

Large soil pile in area of apparent detention pond

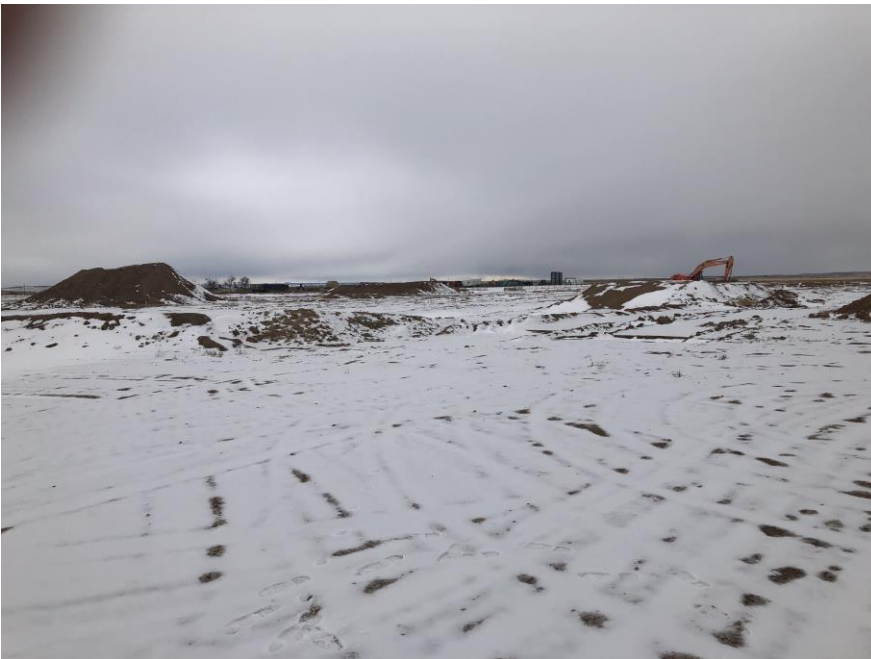
Smaller soil piles in southern portion of site
