RE: Bowie No. 1 Mine
Permit No. C-1981-038
2022 Annual Reclamation Report

Annual Reclamation Report for Calendar Year – 2022

Bowie No. 1 Mine

BOWIE RESOURCES LIMITED
BOWIE NO. 1 MINE
2022 ANNUAL RECLAMATION REPORT
PERMIT NO. C-81-038

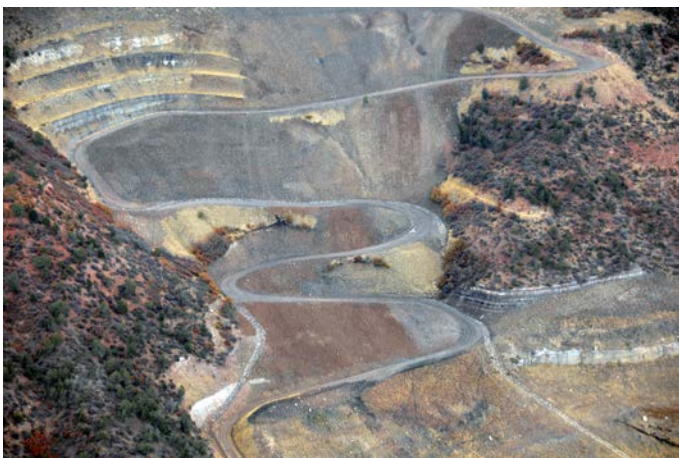
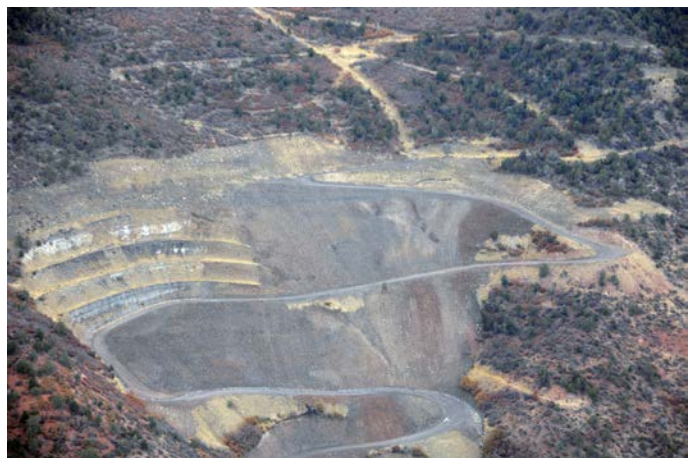
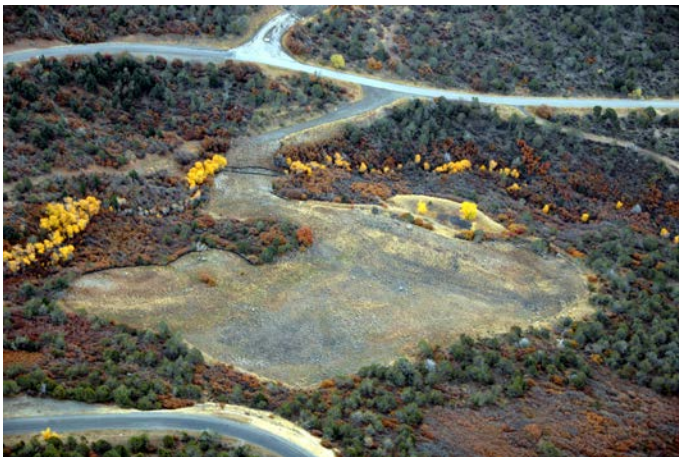
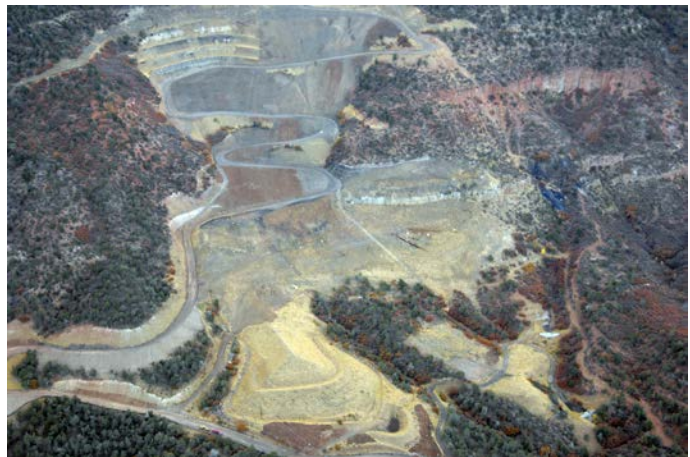
During the reporting year 2009, Bowie completed final grading of the Bowie #1 East Mine (*excluding required sediment control structures*). The 2009 reclamation activities, which was a continuation of the 2008 activities, included the final grading and hydro seeding with an approved permanent seed mix and mulched with wood fiber mulch at a rate of 2,000 lbs/acre of the following areas. (See "2009 Reclamation Map")

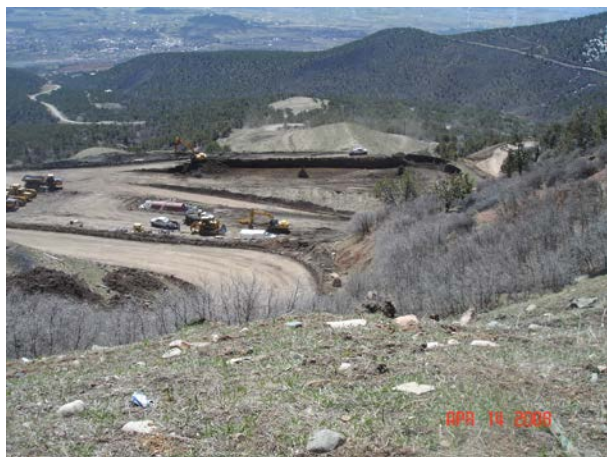
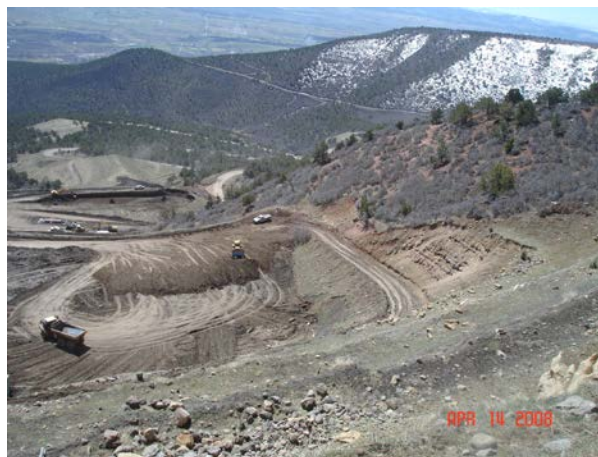
During the reporting year 2008, Bowie Resources LLC continued with the partial reclamation of the Bowie No. 1 East Mine. (*The 2008 reclamation is a continuation of the 2001 activities in which surface structures were removed.*) The 2008 reclamation consisted of returning portions of the disturbed area back to approximate original original contours and hydro seeding with a permanent seed mix and wood fiber mulch. The following zones were completed during the 2008 reporting period. (Reference attached Drawings “Reclamation Zones East Mines and “ROM Coal Stockpile Area”)

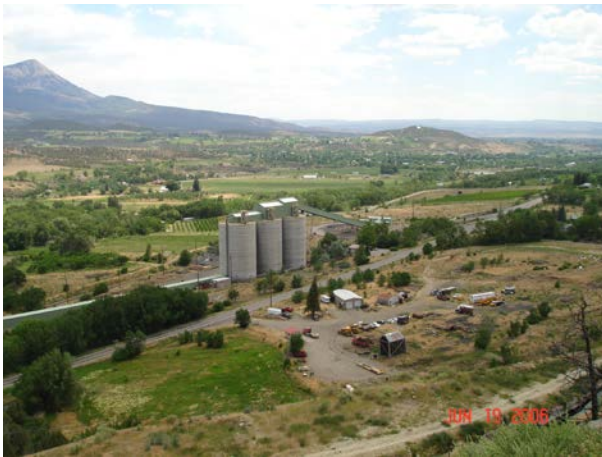
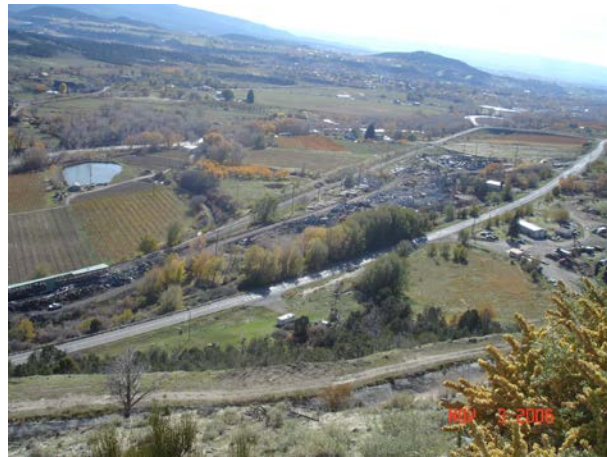
Bowie Resources LLC began partial reclamation of the Bowie No. 1 Mine Loadout facilities. The partial reclamation project consisted of demolition of the following structures:

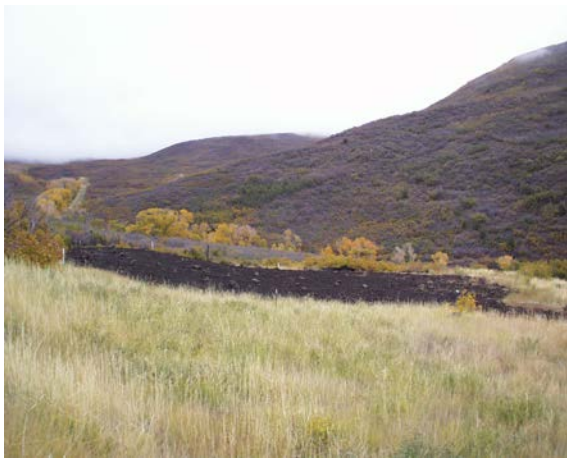
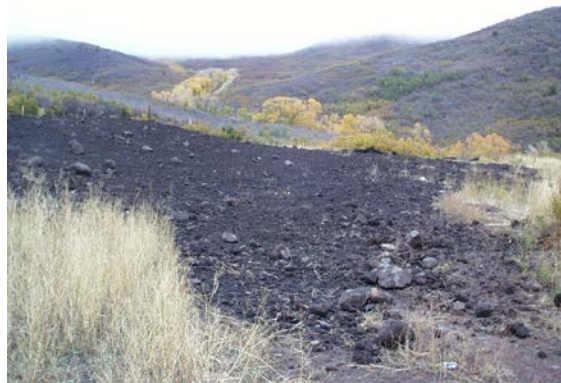
During the reporting year of 2005, Bowie Resources continued with the reclamation of the Bowie #1 West Mine Ventilation shaft site. Reclamation consisted of distributing and grading of topsoil back to its approximate original contour over shaft site. Upon completion of the grading, the entire area was re-seeded with the approved permanent seed mix and covered with straw mats.

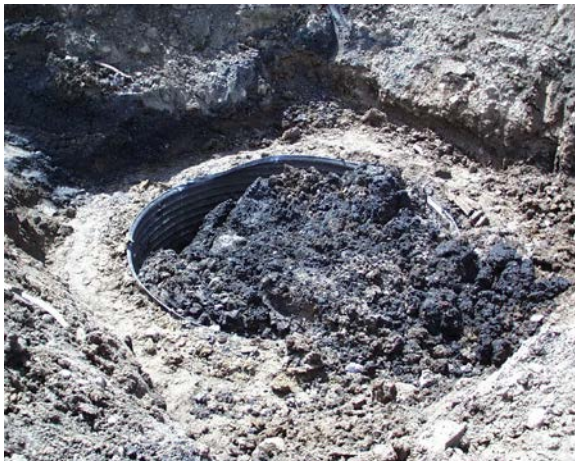
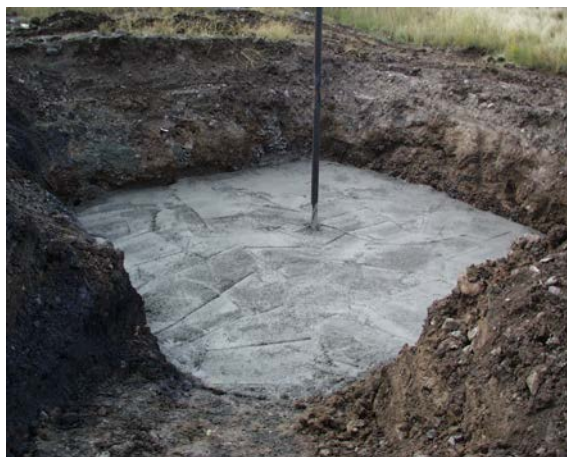
During the reporting period of 2003, Bowie Resources completed sealing the Bowie 1 West Mine ventilation shaft. A 12-inch concrete cap with steel reinforcement, extending 2 feet beyond the shaft liner was completed in September of this year. This included one 4-inch vent pipe as required and backfilling. The following photographs are of the shaft-sealing project.

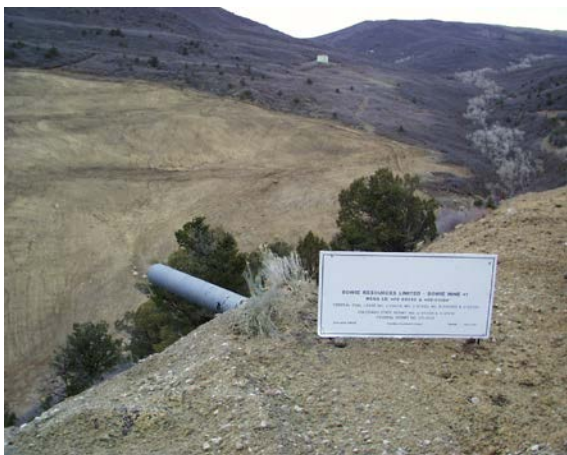
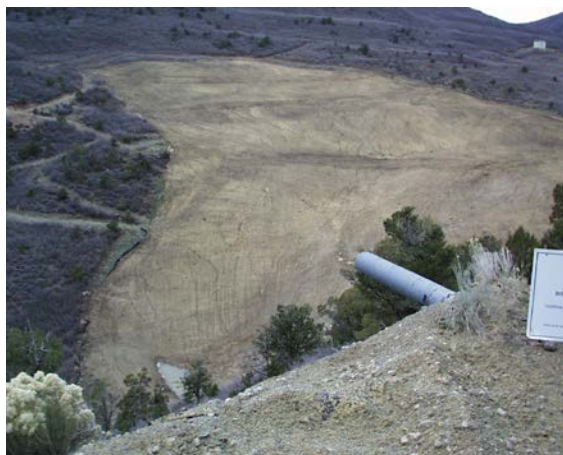
For the reporting year 2002, Bowie Resources, Ltd., continued with the reclamation of the Bowie No. 1 West Mine Site. Reclamation consisted of distributing and grading of nearly 49,000 yrd³ of subsoil and topsoil back to its approximate original contour. Two new sedimentation control ponds have been established near the bottom of the reclaimed area. Upon completion of the grading, the entire area was hydro-seeded with the approved permanent seed mix and using cellulose mulch at a rate of 1,500 pounds per acre and a tackifier at 100 pounds per acre. In conjunction with the hydro seeding, a fertilizer was applied at a rate that applied at least 30 pounds per acre of nitrogen and 60 pounds of phosphorus.

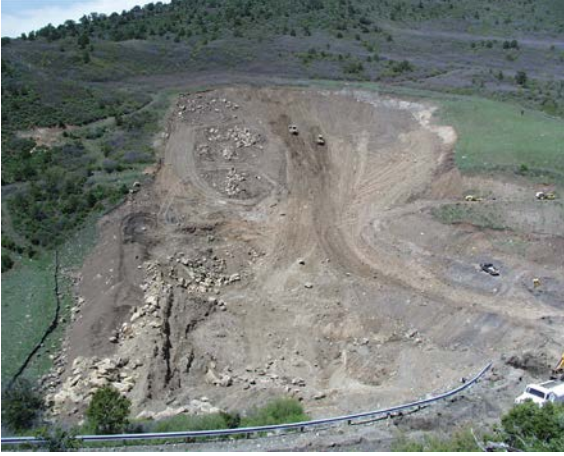
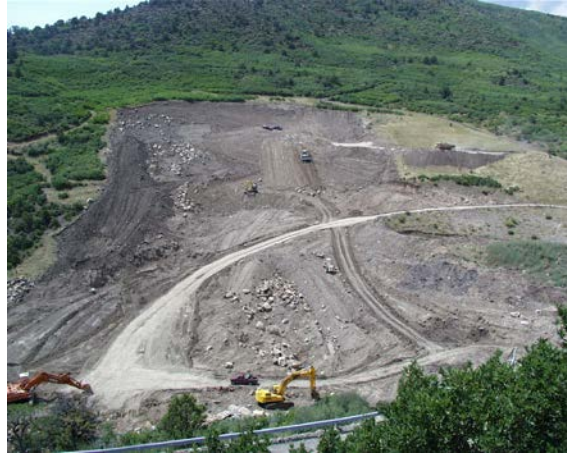
During the year 2001, the Bowie No. 1 West Mine continued to be reclaimed. At the end of the 2001 reporting year, Bowie Resources Ltd. had completed approximately 80 percent of the backfilling. Topsoil located on the fill outcrops was moved to a temporary storage location during the backfilling process. The West Mine Ventilation Shaft was filled during this same period.

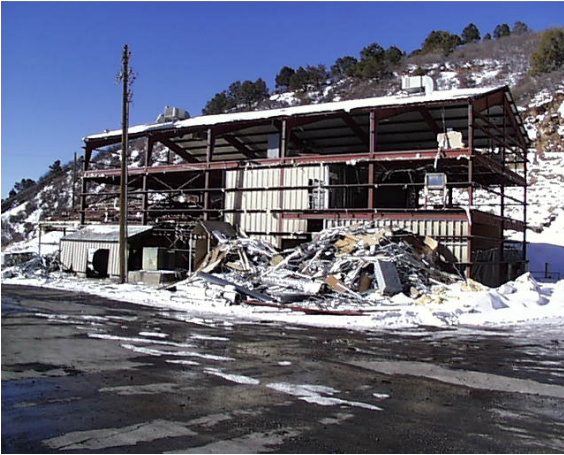
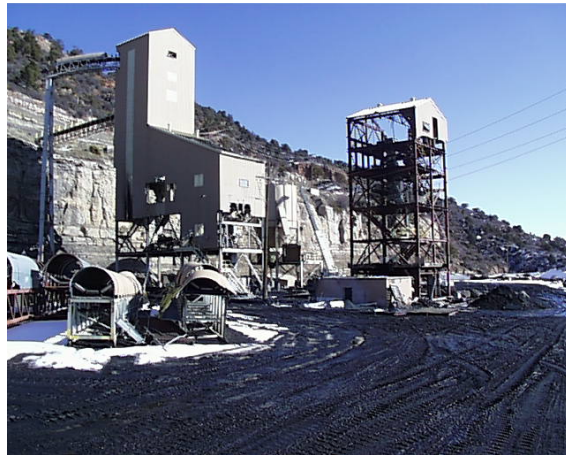
The Bowie East Mine reclamation during 2001 consisted of demolition and removal of permanent structures. The following structures were removed; bathhouse/office, storage tanks, MCC buildings, fire house, belt structures, transfer towers, shop/warehouse, tire shop, loading bin, fire house, belt structure, the majority of the 2,000-ton bin, guard shack, sewage treatment plant, crushing and screening plant, truck loadout, and stacking tube.
